# Ap1300 Drop Test 1

## Ap1300 Drop Test 2

# Ap1300 Packaged Kit - Drop Test 1

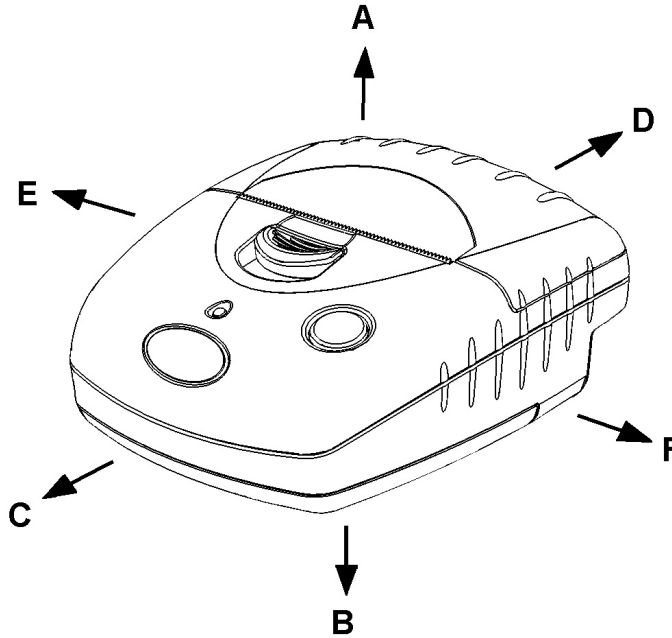
Test - 1 metre	Mechanical damage?	Self Test Print?
Drop A	Lid opened – Roller Came out	okay
Drop B	Lid opened – Roller Came out	okay
Drop C	Lid opened – Roller Came out	okay
Drop D	Lid opened – Roller Came out	okay
Drop E	Lid opened	okay
Drop F	Lid opened – Roller Came out	okay

Other than minor external abrasions, there was no visible mechanical damage to the unit, and the printer remained fully functional.

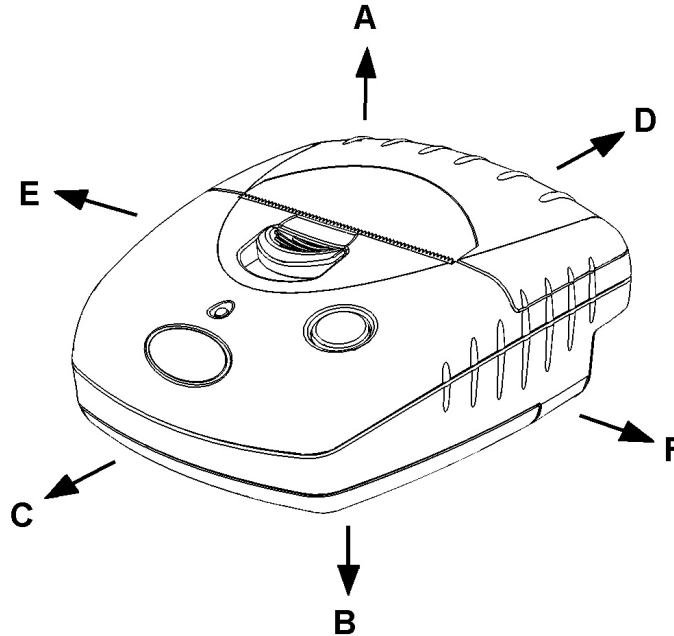
Test - 1 metre	Mechanical damage?	Self Test Print?
Drop A	Lid opened – Roller came out – One of the battery door clips broke off	okay
Drop B	Lid opened – Roller Came out	okay
Drop C	Lid opened – Roller Came out – Other battery door clip broke off – Plastic around battery door screw broke and battery door came off	okay
Drop D	Lid opened – Roller Came out – Battery door is now not held.	okay
Drop E	Lid opened – Roller Came out – Battery door is now not held.	okay
Drop F	Lid opened – Roller Came out – Battery door is now not held.	okay

Plenty of external abrasions.

Mechanical damage to the Battery Door which meant it would only just stay on the unit. There was no other visible mechanical damage to the unit, and the printer remained fully functional.

The Battery Door would certainly need replacement.

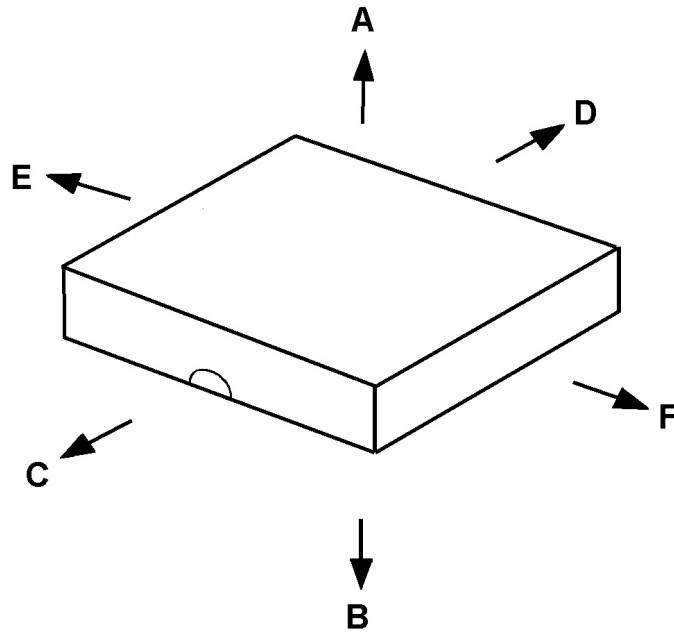
Test - 2 metre	Mechanical damage?	Self Test Print?
Drop A	Non	okay
Drop B	Non	okay
Drop C	Printer shifted forward, slight creasing to inner cardboard	okay
Drop D	Printer shifted backward, further creasing to inner cardboard	okay
Drop E	Damage to internal cardboard	okay
Drop F	Damage to internal cardboard	okay

After the 6 drops, the internal cardboard had sustained creasing and slight tear damage. The contents of the packaging remained intact and free of any marks, scratches or mechanical damage.
