**FORD:**  
2003-2004 Expedition

**LINCOLN:**  
2003-2004 Navigator

This article supersedes TSB **04-07-04** to update the Service Procedure.

Some vehicles may exhibit a condition of the climate controlled seat(s) shutting off after less than 10 minutes of run time during the first heat cycle. The climate control seat may operate for less than one (1) minute, or for more than one (1) minute but less than the normal 15 minute heat cycle, before shutting down. Symptoms may also include poor seat cooling performance when in cooling mode, during the first and subsequent run cycles.

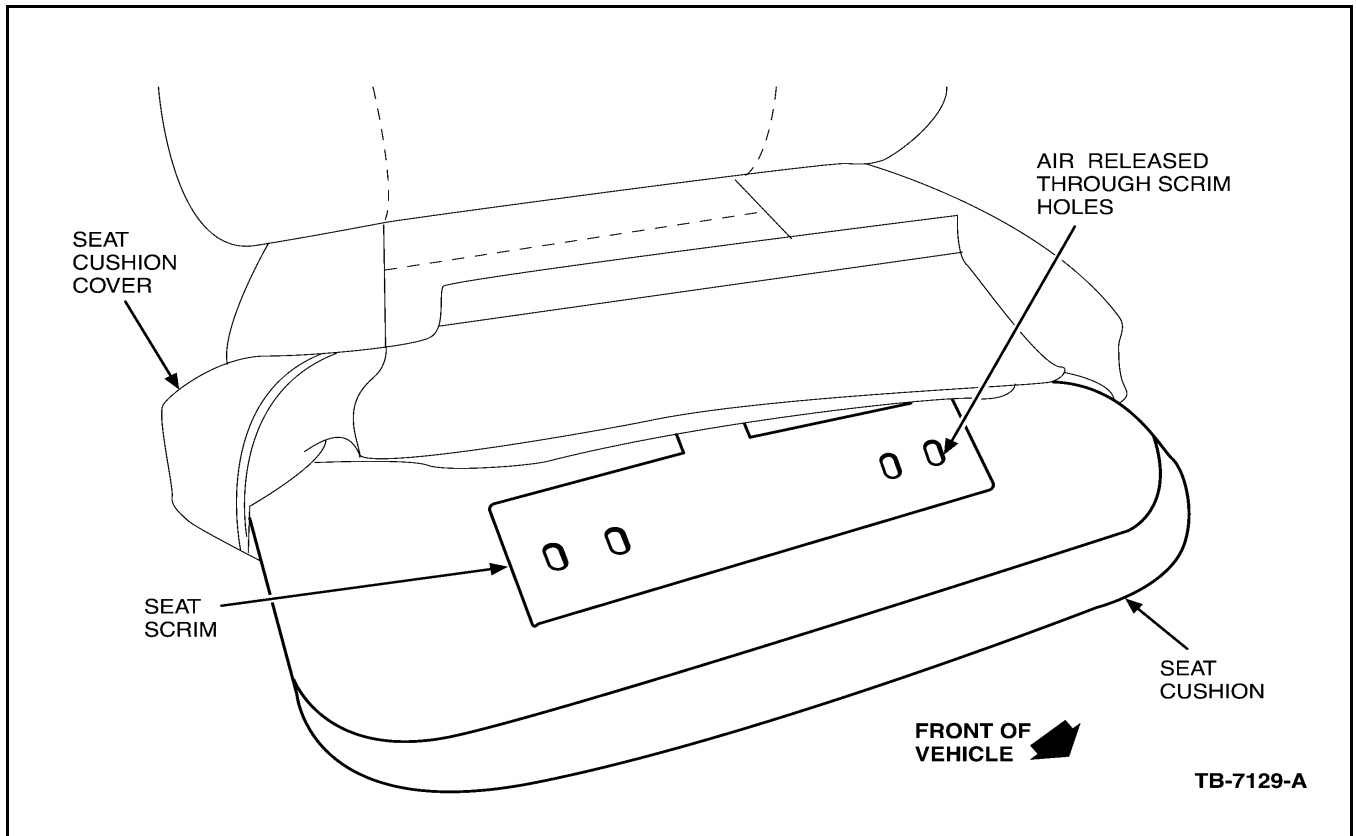
Figure 1 - Article 04-26-19

- Make sure that there are air channels in the seat cushion. The channels are indentations in the foam under the seat scrim (Figure 1). If channels do not exist in the cushion, the cushion is for a non-climate controlled seat and must be replaced with the correct part.
- Make sure that the air channeling holes in the scrim (the thin, white covering that adheres to the seat cushion - see Figure 1) line up with the cushion air channels, and that the scrim is not compressed or crushed to the point of damage.

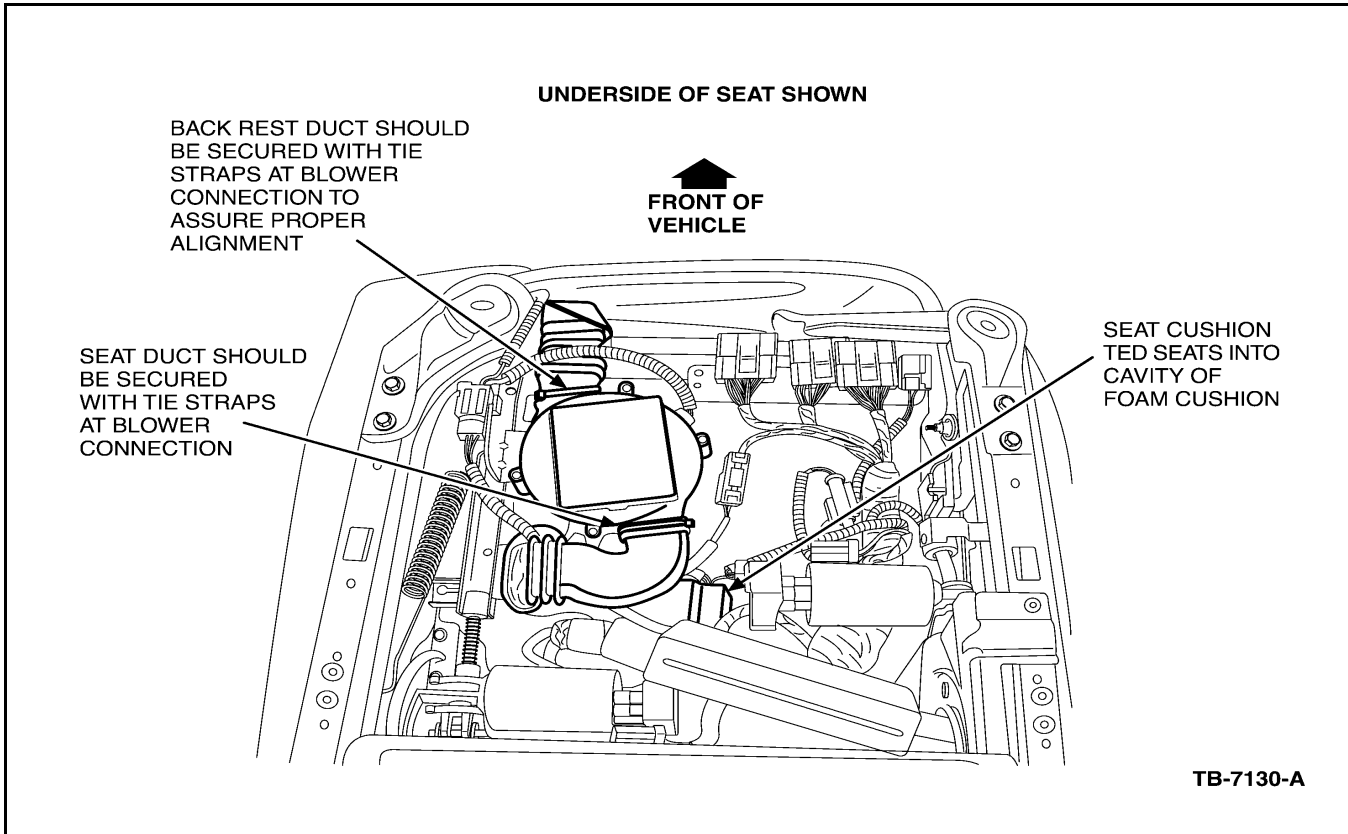
Figure 2 - Article 04-26-19

- Check the TED to make sure it is properly aligned. The underside of the seat cushion integrates a round cavity into which the TED must seat (see Figure 2). If the TED is misaligned or is incorrectly seated in the cavity, the seat may overheat and shut down.
- Check to make sure that the seat cushion ducts are properly fastened and aligned (see Figure 2). The cushion duct attaches to the blower with a cable (zip) tie. Make sure that this connection is secure.

Carefully reach under the seat to check to make sure that the seat backrest ducts are properly fastened and aligned (see Figure 2). The backrest duct attaches to the blower with a cable (zip) tie. Make sure that this connection is secure.

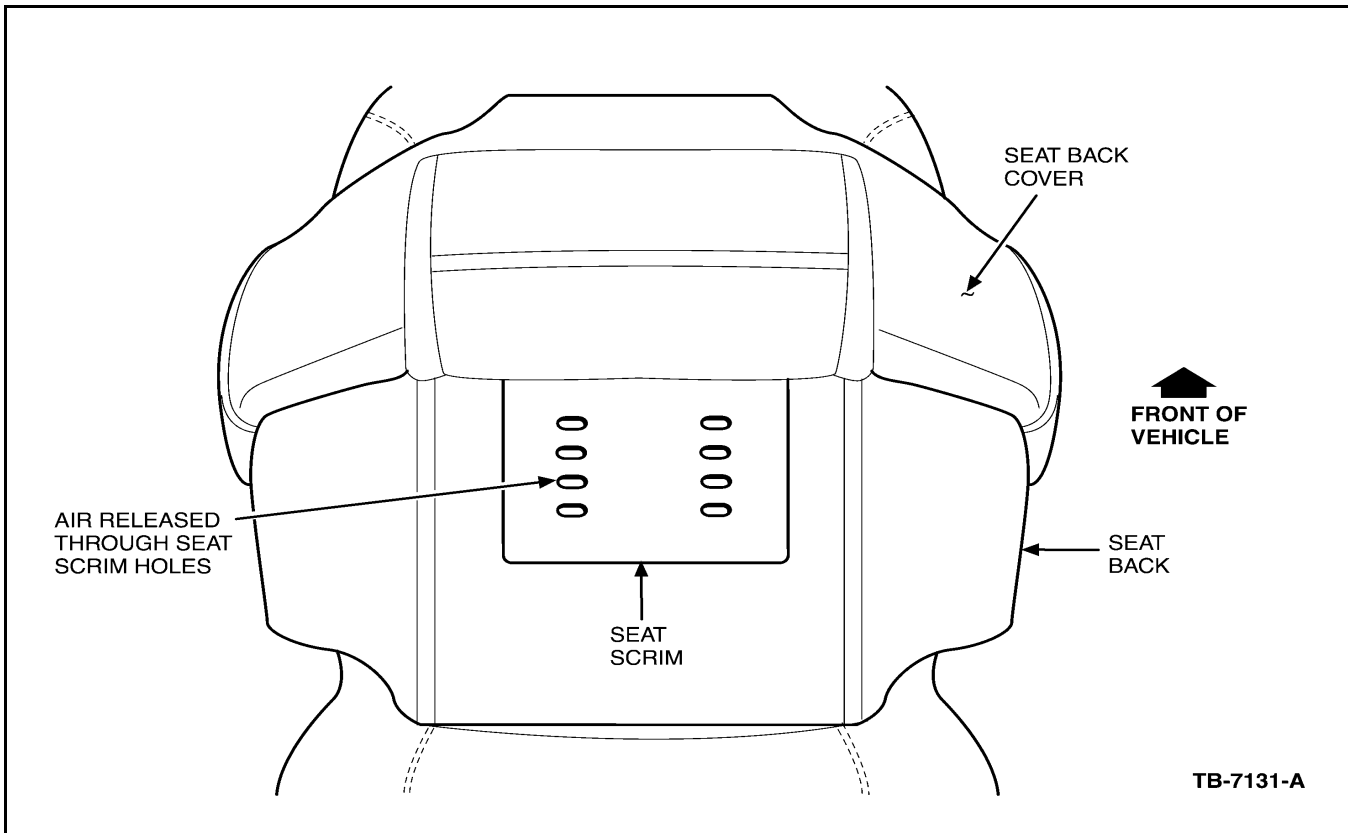
Figure 3 - Article 04-26-19

- Make sure that there are air channels in the seat backrest cushion. The channels are indentations in the foam under the seat scrim (see Figure 3). If channels do not exist in the cushion, the cushion is for a non-climate controlled seat and must be replaced with the correct part.
- Make sure that the channeling holes in the scrim (the thin, white covering that adheres to the seat backrest cushion - see Figure 1) line up with the backrest cushion air channels, and that the scrim is not compressed or crushed to the point of damage.

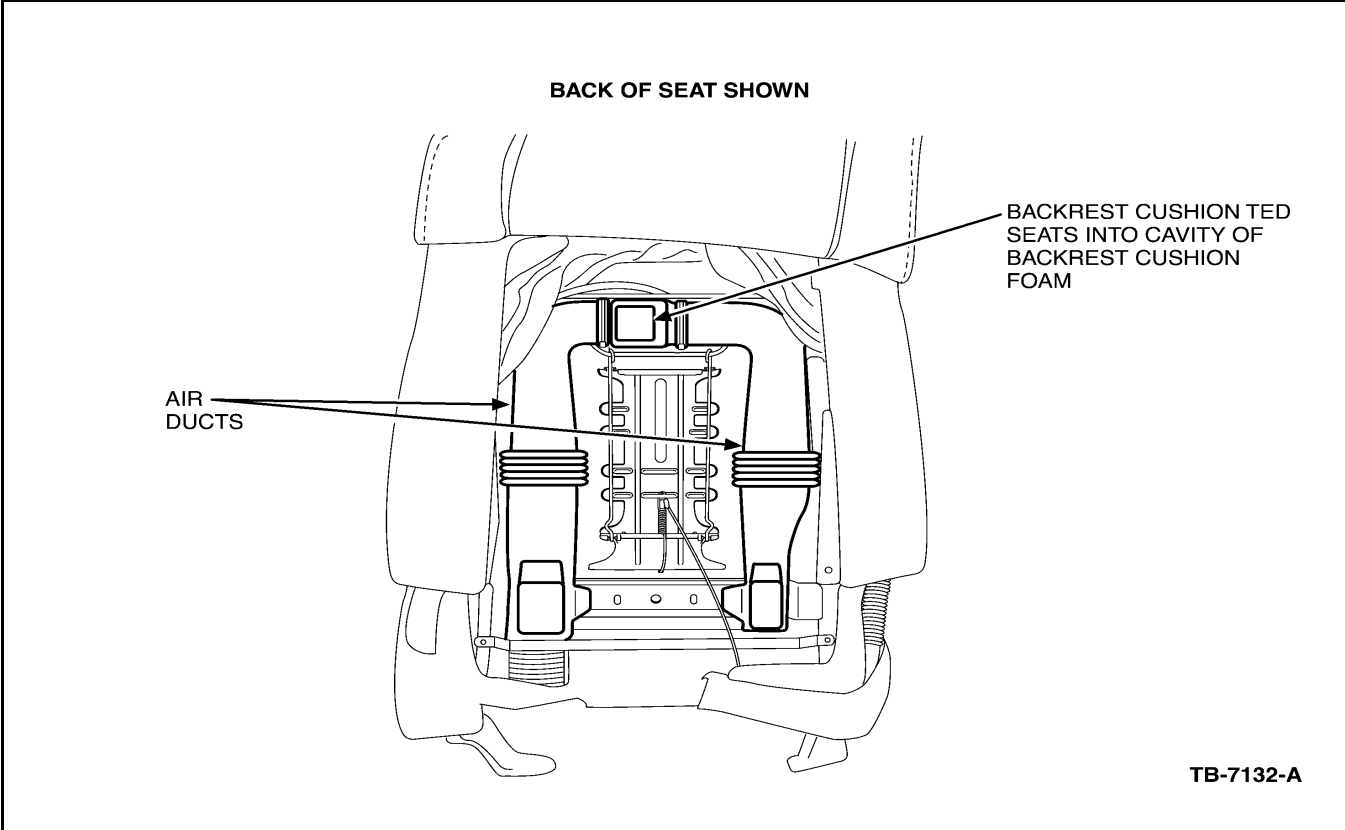
Figure 4 - Article 04-26-19

- Check the seat backrest TED to make sure it is properly aligned. The seat backrest cushion integrates a round cavity into which the TED must seat (see Figure 4). If the TED is misaligned or is incorrectly seated in the cavity, the seat may overheat and shut down.
