# REPORT

Serious Incident which occurred on **29 March 2010**  
**at Nice aerodrome (06)**  
involving **Raytheon 390 Premier 1A** registration **M-FROG**  
and **CRJ200** registration **EC-HHV**

**BEA**

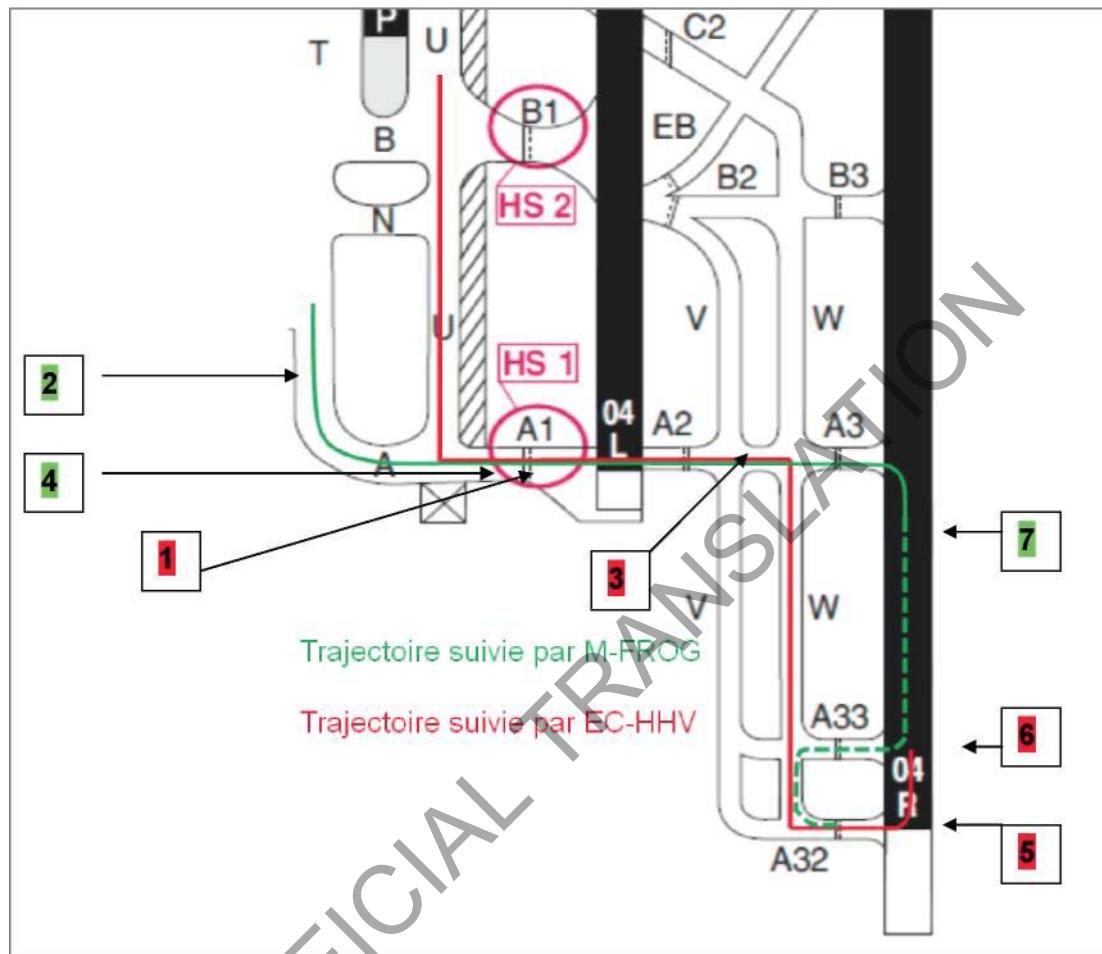
Figure 1: extract from the aerodrome chart (source: IAC) and trajectories on the ground

The controller then instructed the crew of the M-FROG to leave the runway, take the first right and return to taxiway W. The crew, who were already on the runway, interpreted the controller's instruction "first right" as an instruction to leave the runway at A33. They therefore went to holding point A33 via the runway (trajectory shown as a dotted line in Figure 1), whereas the controller thought they would go there via taxiway W. The crew of the M-FROG therefore found themselves facing the EC-HHV. The crew of the EC-HHV had to move aside slightly to allow the M-FROG to pass and thus vacate the runway via A33.

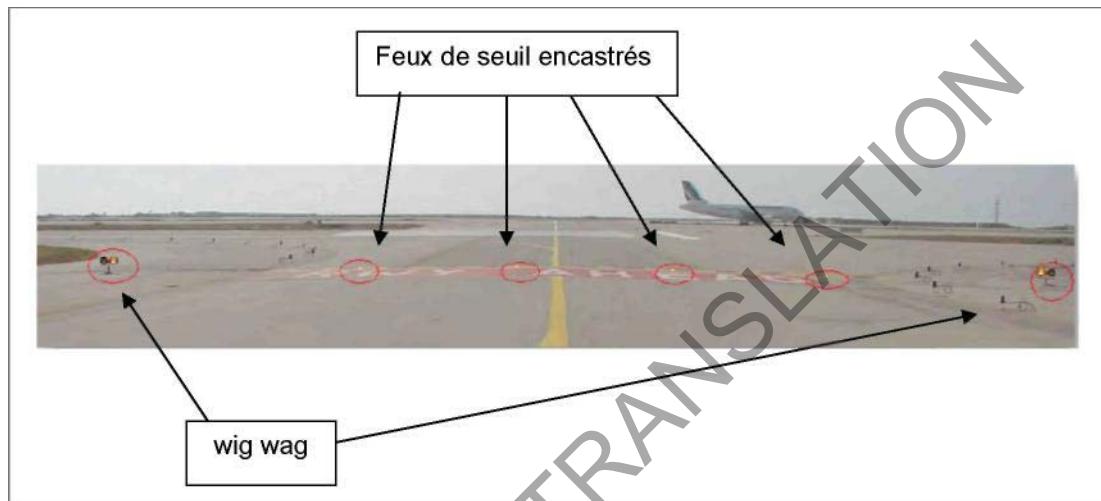
Figure 2: Example of re-emphasised holding point lighting  
[feux de seuil encastrés = embedded threshold lights]

This lighting was switched on and working normally at the time of the incident.

The installation of additional wig wag-type lighting and embedded threshold lighting at the holding point was unable to prevent the crew of the M-FROG from crossing the holding point and encroaching onto runway 04R.

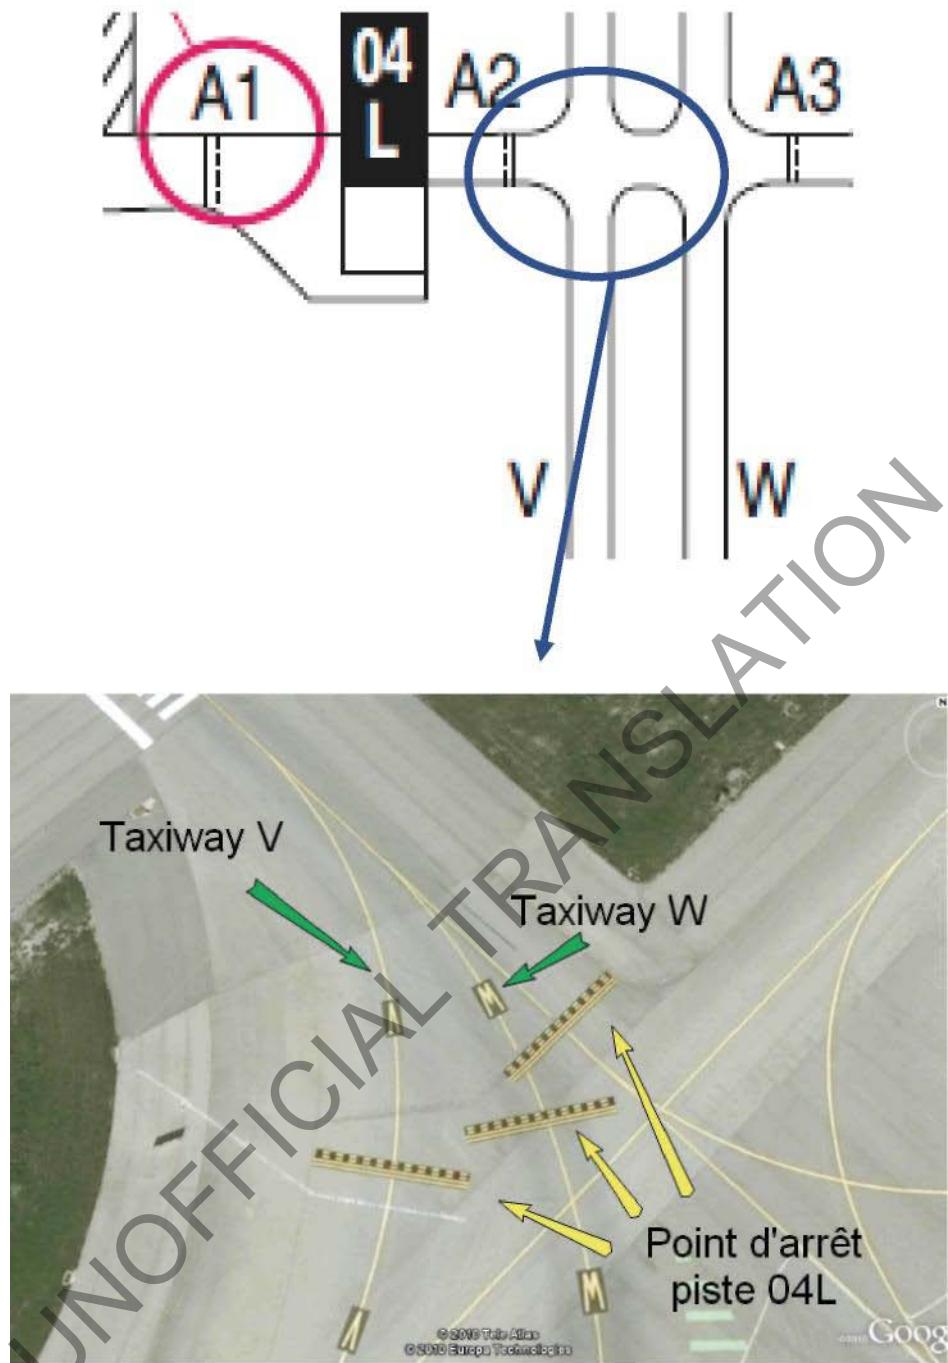
At the aerodrome, the junction of taxiways V and W is before holding point A2. On the IAC chart diagram (and the Jeppesen chart), the junction of taxiways V and W is after holding point A2 (see Figure 3 below).

Figure 3: aerodrome chart diagram (source: AIP) and aerial photograph of the junction of taxiways V and W [Point d'arrêt piste 04L = holding point runway 04L]

A sign indicating taxiway W could not be seen clearly from the junction of taxiway W.

- in line with the documentation, the crew expected to find the V junction after holding point A2, whereas it was in fact before it;
- the green centreline lighting of taxiway V had been switched off, and the crew proceeded straight to the taxiway W junction, doubtless thinking that this was the taxiway V junction. It thus continued to taxi using the green lighting, which took it to holding point A3.

- **that the DSNA should ensure that, at all aerodromes, that the aerodrome charts precisely reflect the reality of the infrastructure.**

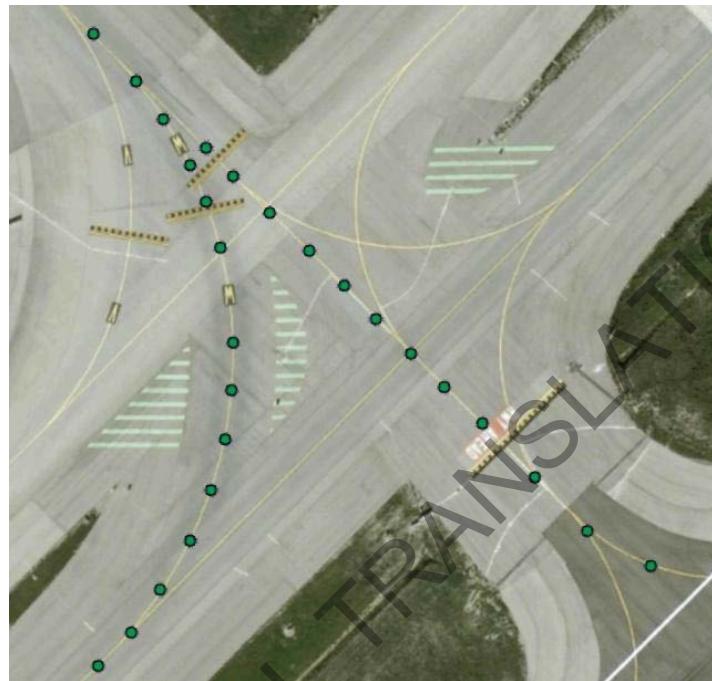
Between runway 04L and runway 04R, the taxiways have green centreline lighting. At the time of the incident, the taxiway V lighting was switched off,

and the taxiway W lighting was switched on. The route between holding points A2 and A3 was also lit at the time of the incident (see Figure 4).

Figure 4: diagram of the status of the taxiway lighting between runways 04L and 04R at the time of the incident

The intensity of the lighting of the taxiways (other than V) was set to position 2 (on a scale of 4).

Note 2: since the event, the centreline lighting leading to A3 has been concealed and the use of this connecting taxiway has been prohibited at night.

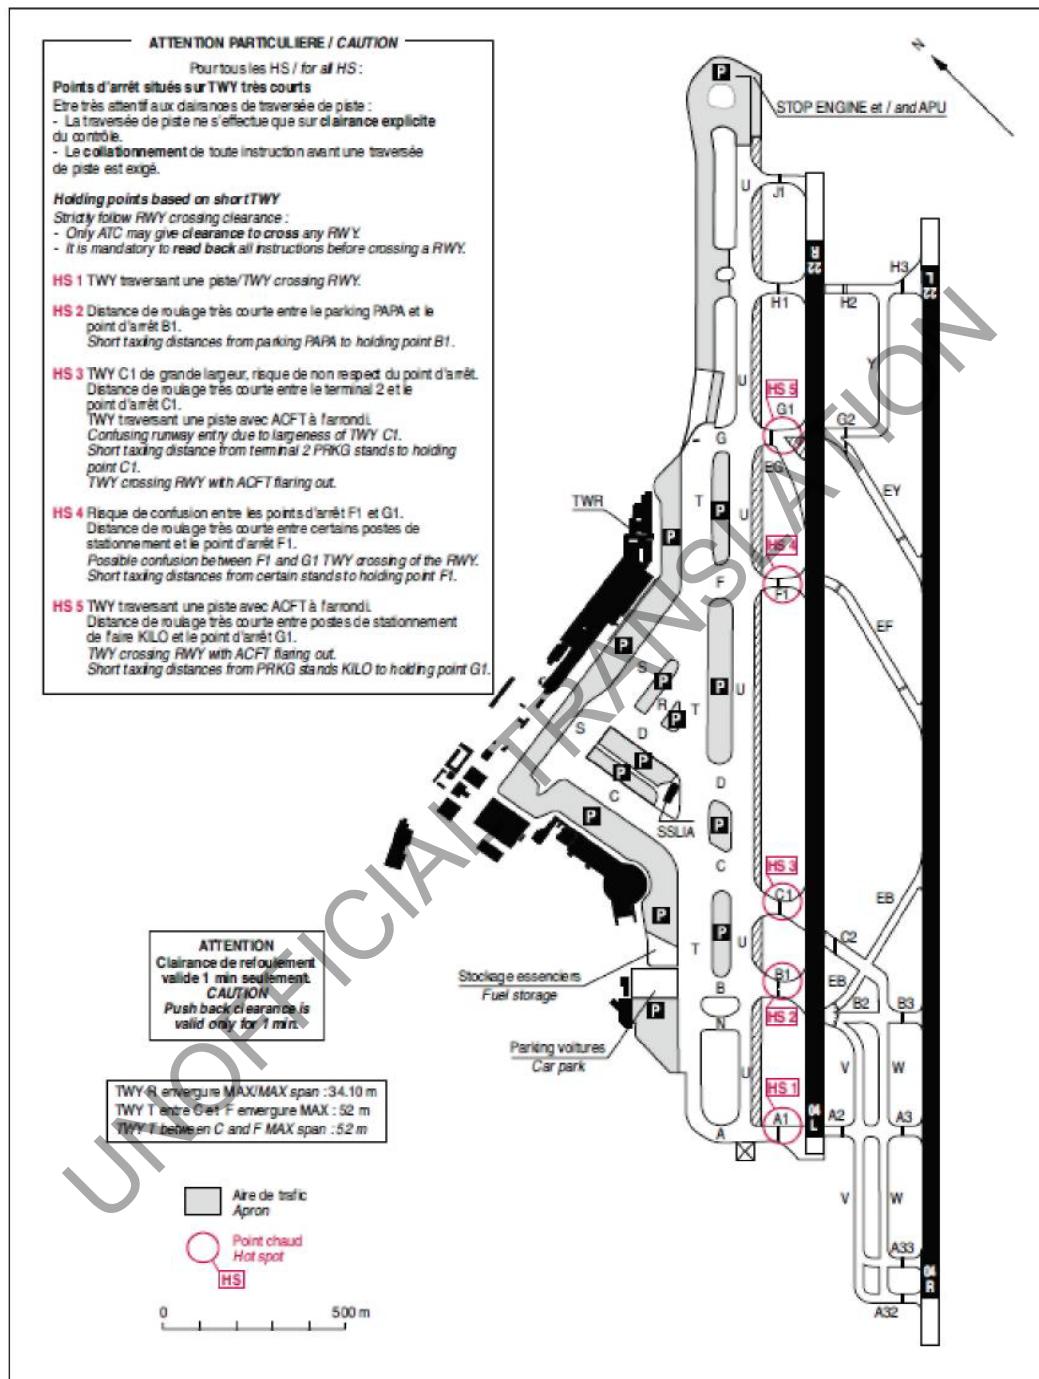
Also, in order to raise the awareness of crews when reading the aerodrome chart, some holding points have been designated as hot spots (HS) and are circled in red on the chart (see Annex 1). These holding points are located mainly between the stands and runway 04L. On the date of the incident, holding point A3 was not listed as an HS.

NB: since the incident, holding point A3 has been added to the HS list.
