AIRCRAFT ACCIDENT REPORT 1/92

Air Accidents Investigation Branch

**Report on the accident to
BAC One-Eleven, G-BJRT
over Didcot, Oxfordshire
on 10 June 1990**

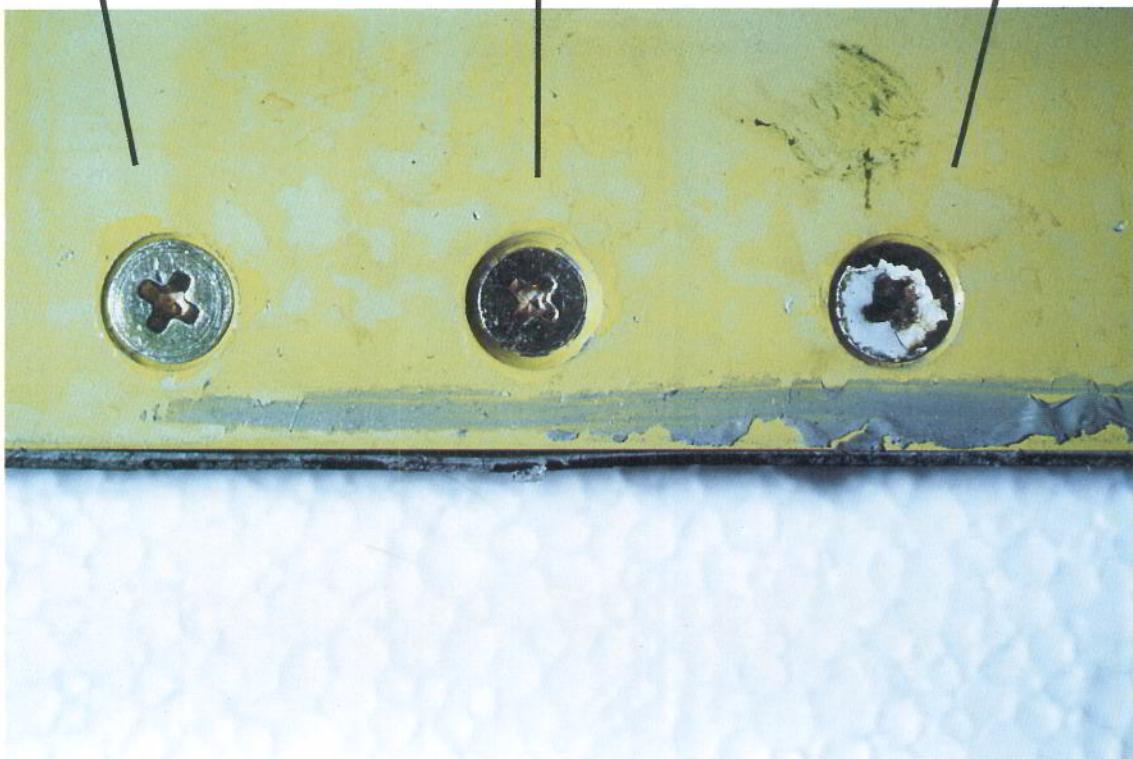
The window was finished in primer and had countersunk holes for the bolts; an A211-8C bolt head sits significantly further below the surface of the window, down in the countersink, than does an A211-8D bolt head, leaving an annulus of unfilled countersink which is easily discernable when viewed under good conditions. This excessive annulus of unfilled countersink was not seen.

New 8 UNC

Old 10 UNF

Comparison of bolt heads in countersinks
(shown approximately 1.9 life-size)
