Audio Restoration Project – Repair Arcam CD92 dCS Ring DAC CD Player

This applies to all similar type models CD72 , CD73 , CD82 , and their TEXT readout derivatives, the FMJ CD23 and the previous range Alpha 7SE , Alpha 8SE , and Alpha 9 which share common circuit boards.

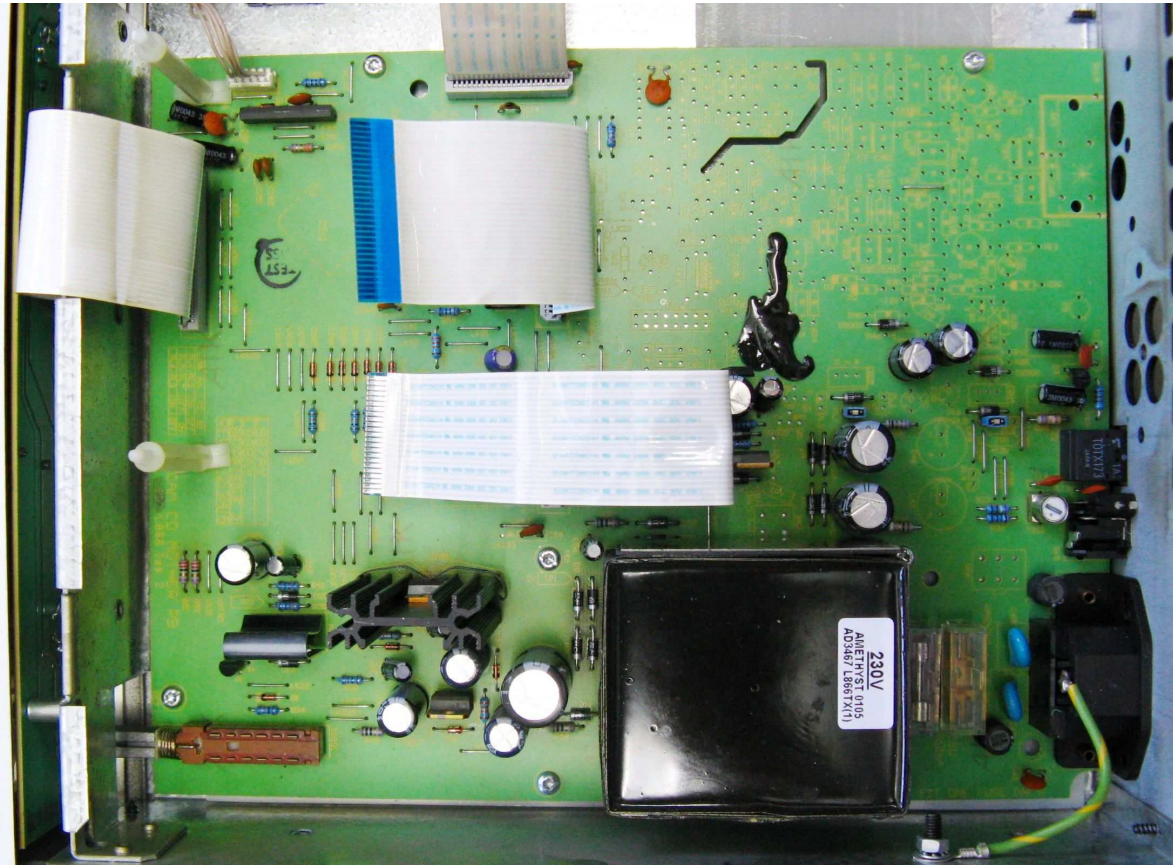
This is the Main PCB, with the power supply components at the bottom of the board. The unpopulated upper 1/3rd of the PCB is the space normally occupied by the DAC components on the CD72, CD73, and CD82 models. On the CD92, the dCS Ring DAC is on a separate daughter-board.

DC Ripple was absolutely unacceptable on all test-points (except for the +11VDC input to Z206), and obviously this was the major contributor to the customer's original complaint of distortion.

At this point, just to confirm my suspicions, I got busy with my ESR meter, and of the 19 Rubycon 85°C YK electrolytic capacitors, 15 exceeded ESR limits.

However, while ripple was within limits, some voltages were definitely not.

1. At TP2, the +5VDC output to the DAC was +6.9VDC. The cause was traced to the 7805 5V regulator, which I replaced. Arcam missed that, and it was no surprise that the 7805 rippled itself to death whilst connected to decoupling capacitors which had died long ago.
2. At TP6, the voltage was -2.3VDC, instead of the expected -12VDC. I traced the problem to R45, a 1-ohm fusible resistor, which was open. I replaced it.

The first thing I did was remove the 8 1N/UF4003 bridge-rectifier diodes and replace them with 8 Schottky 11DQ10 diodes. These diodes are proven to contribute to a major increase in sound-quality, as compared with regular 1N400x, or even the high-speed UF400x diodes.

I decided that, as it appeared to be a wholesale degeneration of these capacitors, I would replace 17 of the 19, leaving only the Sanyo OsCon 25uF 20V (now Vishay OsCon) and the newly-replaced 3300uF 25V PSU decoupling capacitor (with a 2007 date-code).

The voltage check was now perfect, and I considered the Main PCB 100% serviceable, and useable for at least the next 5 years with no problems expected.

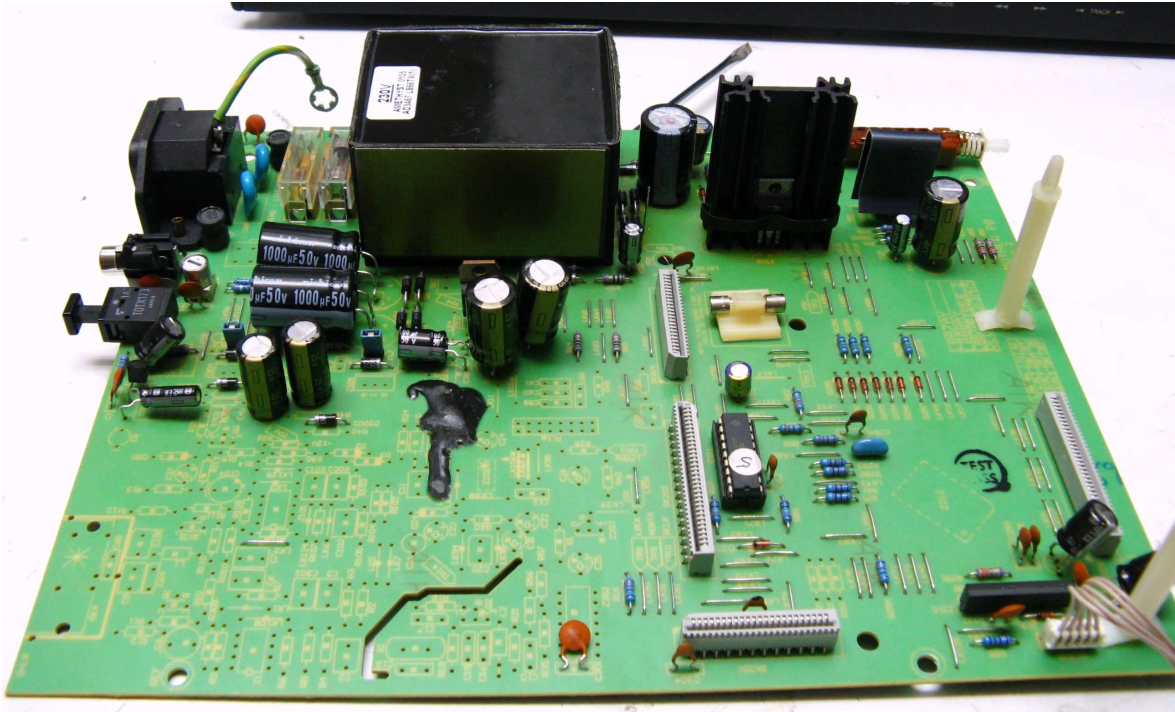
Here are all the 17 new capacitors, mostly much larger (physically) than the original, which requires them to be mounted horizontally, in order to not interfere with the DAC daughter-board mounted from above

I connected power to the Main PCB, to check the results of installing these high-quality capacitors. As expected, the DC ripple was now well within acceptable limits. This by itself would account for the elimination of most of the distortion experienced by the customer, and I cannot understand why Arcam did not complete at least this level of an elementary repair.

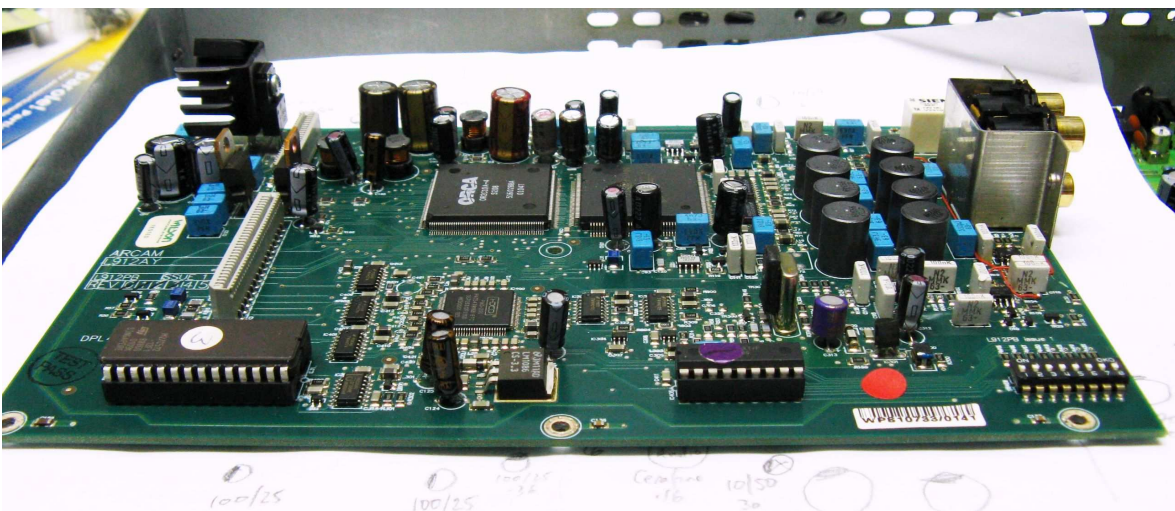
Here is the dCS Ring DAC daughter-board prior to restoration.

Of the 27 Electrolytic capacitors on this PCB, 16 exceeded ESR limits. All of them were Rubycon YK types (The CD73 PCB had the highest quality audiophile capacitors everywhere – why such mediocre quality capacitors in the CD92?).

There was evidence of 3 x 10uF 50V capacitors having been recently replaced by (I'm very disappointed to say) el-cheapo no-name Chinese capacitors. If this was Arcam's doing, there is no excuse and they could have done much better than this.

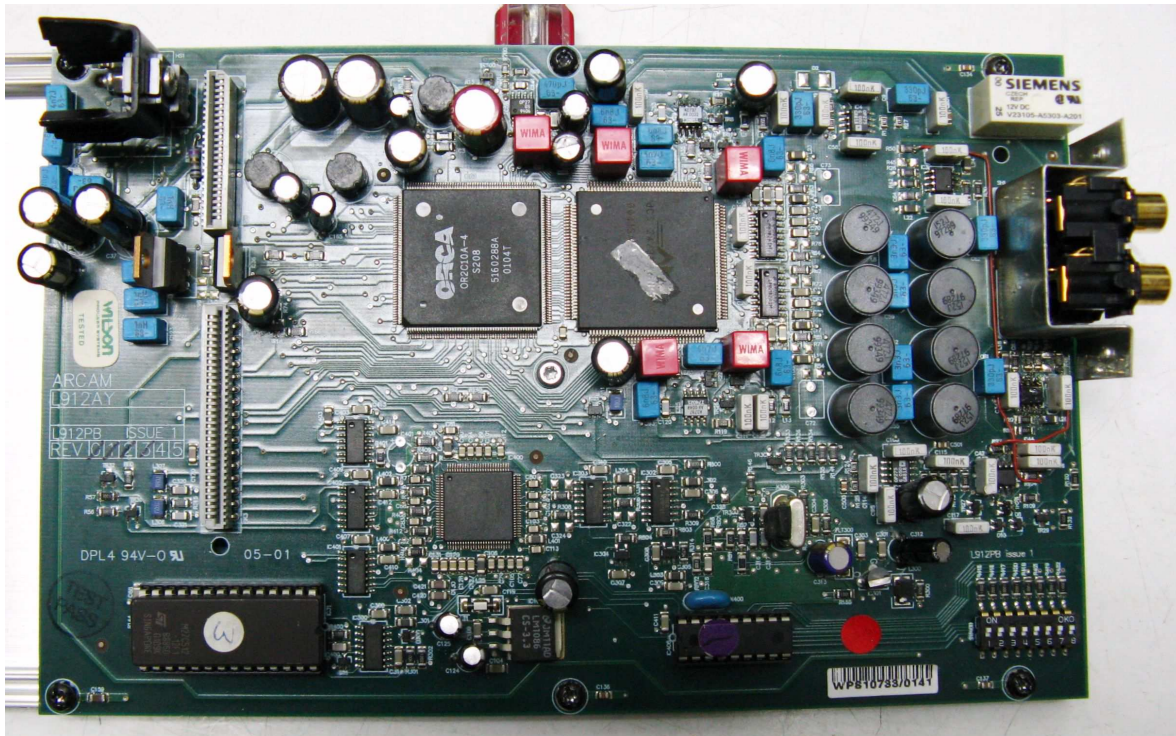
Here is the dCS Ring DAC daughter-board after restoration.

The Sanyo OsCon 22uF now measured 16uF, causing a degradation in bass response. These organic capacitors have an undesirable characteristic of losing capacitance with time. So I replaced it with a 33uF OsCon, which will take a long time to degrade to the original design spec of 22uF.

Once again, with such a high degradation ratio on this PCB, it was an easy decision to replace all the electrolytics, except for the 3 Elna Cerafine/Silmic units. As expected (these are in the signal path, so subject to very little stress), these still tested exceptionally good, even after about 10 years.

I replaced the 5 BiPolar 10uF 63V units (C27, C30, C38, C97, C98) with red Wima MKS2 10uF film capacitors. Substitution with these film capacitors also contributes greatly to improved sound quality, especially in this part of the DAC circuit.

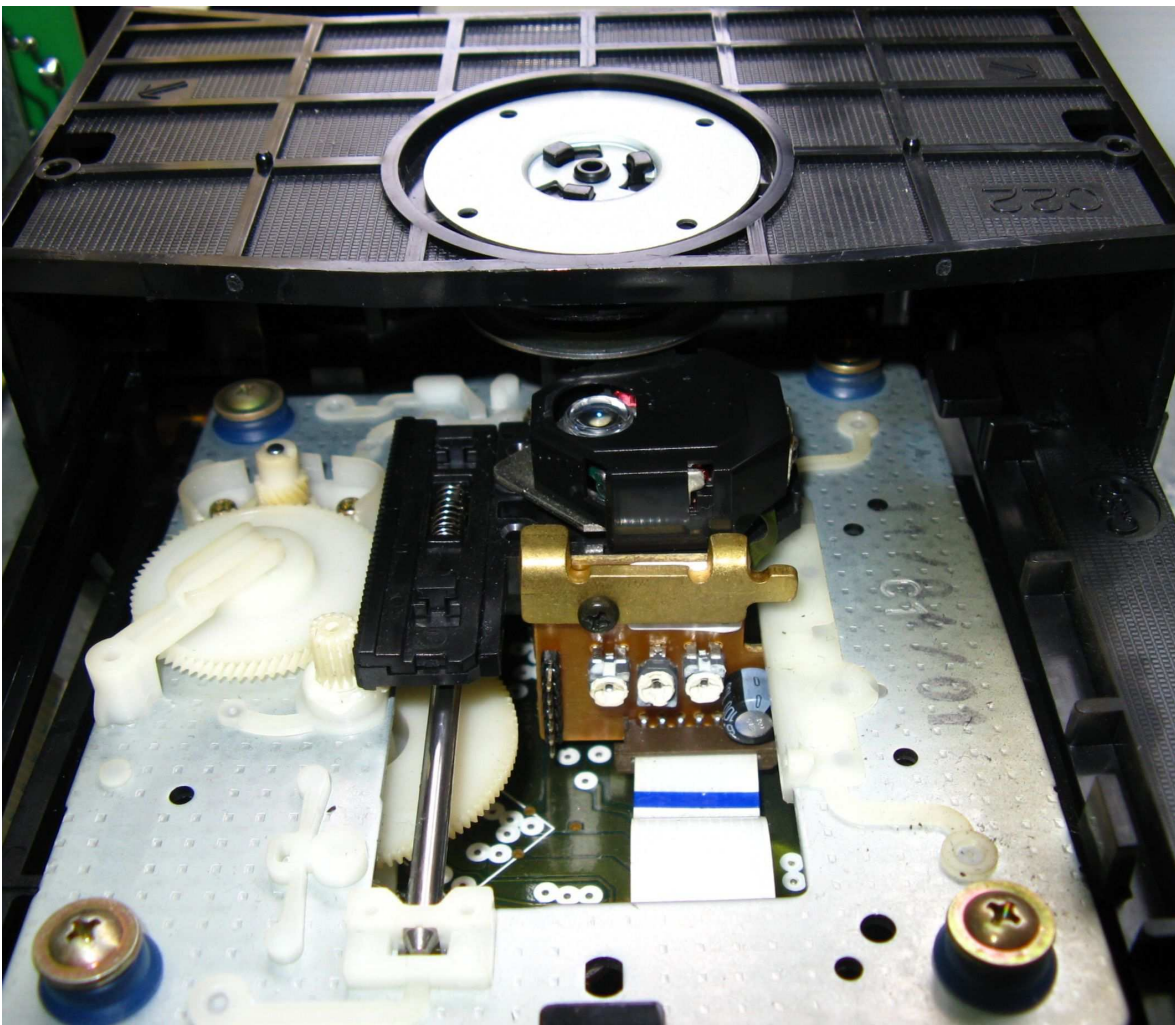
I am quite familiar with this laser transport, and I was very surprised to see the aged, yellowed plastic gears in their entirety. Generally, when I replace a KSS213C laser, I replace it with its entire transport, including new gears. So why, if the Engineer's Report specified that the laser was replaced, was the entire transport not changed?

Here is the CDM14 / KSS240A unit showing the aged, yellowing plastic gears. They should have been replaced.

The original Arcam spec is a high-quality KSS213C laser. During the repair it was replaced with a lower-quality run-of-the-mill KSS240A laser. The 213 is a longer-lasting unit and reads poor-condition CD's easily, so the replacement is a definite downgrade.

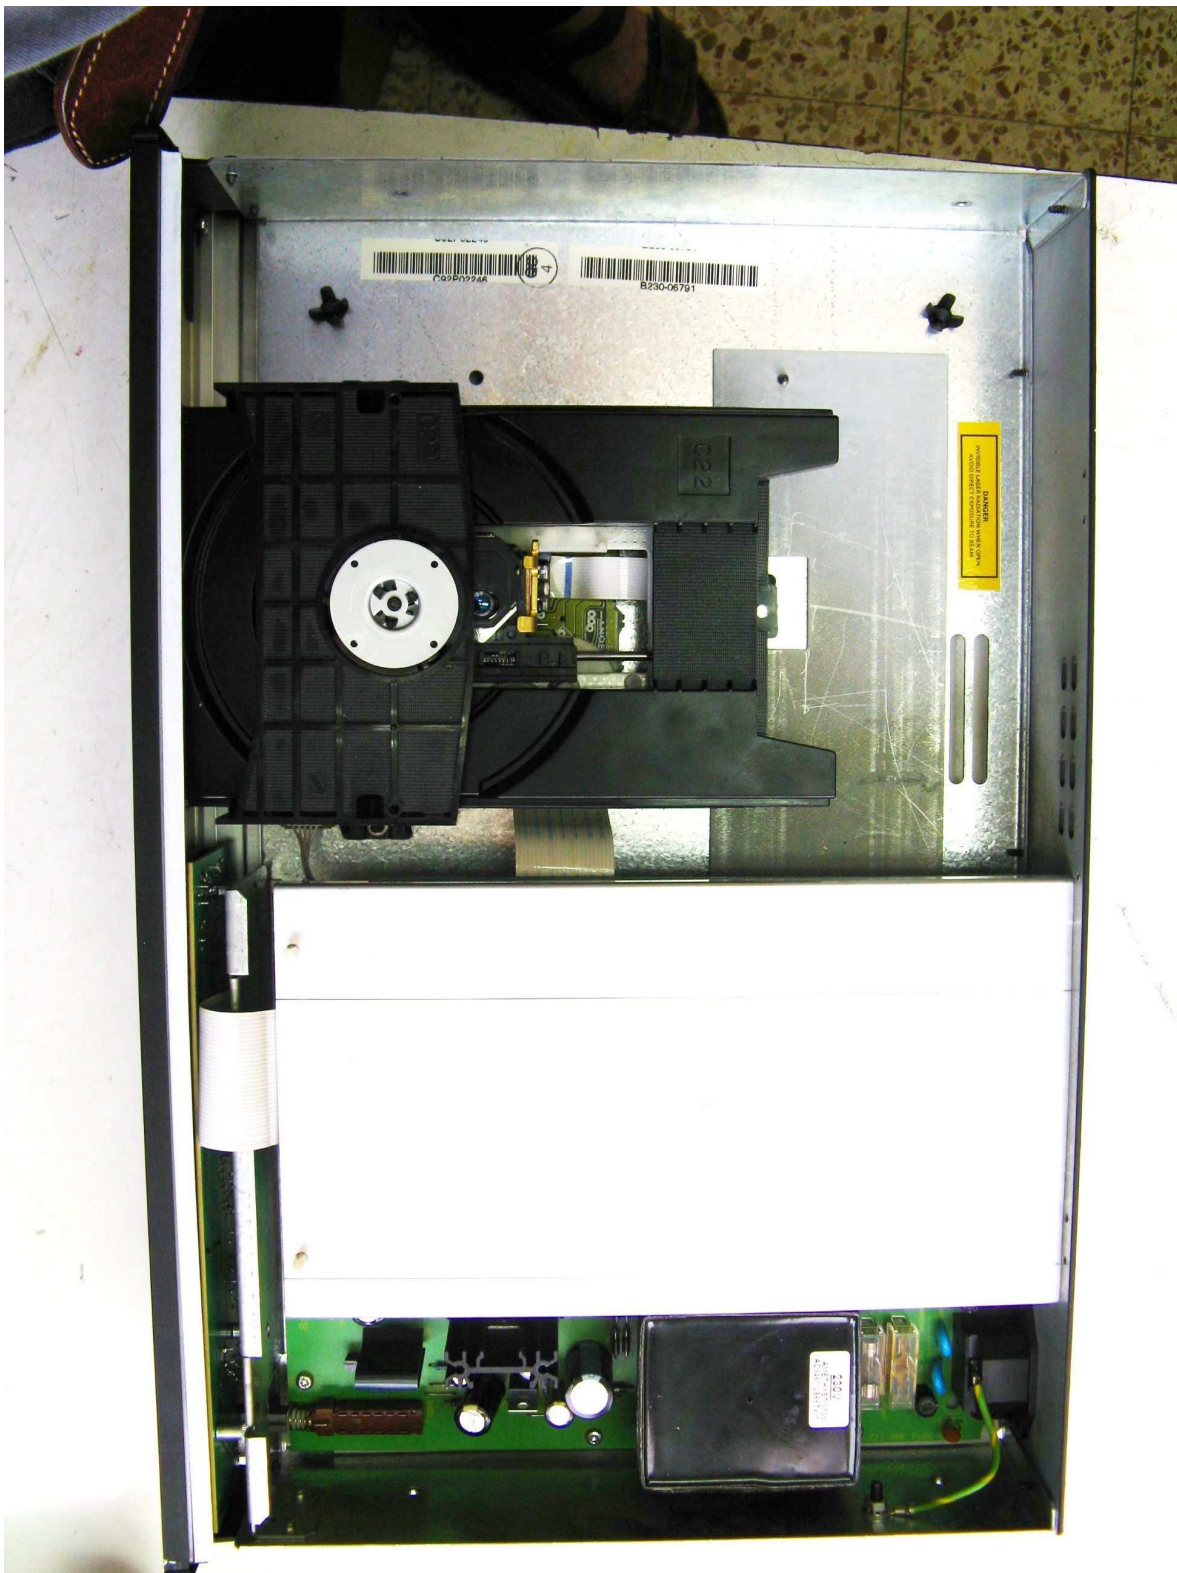
Here is the unit after complete restoration and reassembly – the DAC daughter-board is clearly visible mounted above the PSU board. Lots of free space for adding extra modifications (like an ECC81 tube output-stage ;-)
