Report on the investigation of  
***Emerald Star***  
making contact with ChevronTexaco Number 6 berth  
at Milford Haven  
on the evening of 18 January 2006

Marine Accident Investigation Branch  
Carlton House  
Carlton Place  
Southampton  
United Kingdom  
SO15 2DZ

**Report No 23/2006**  
**August 2006**

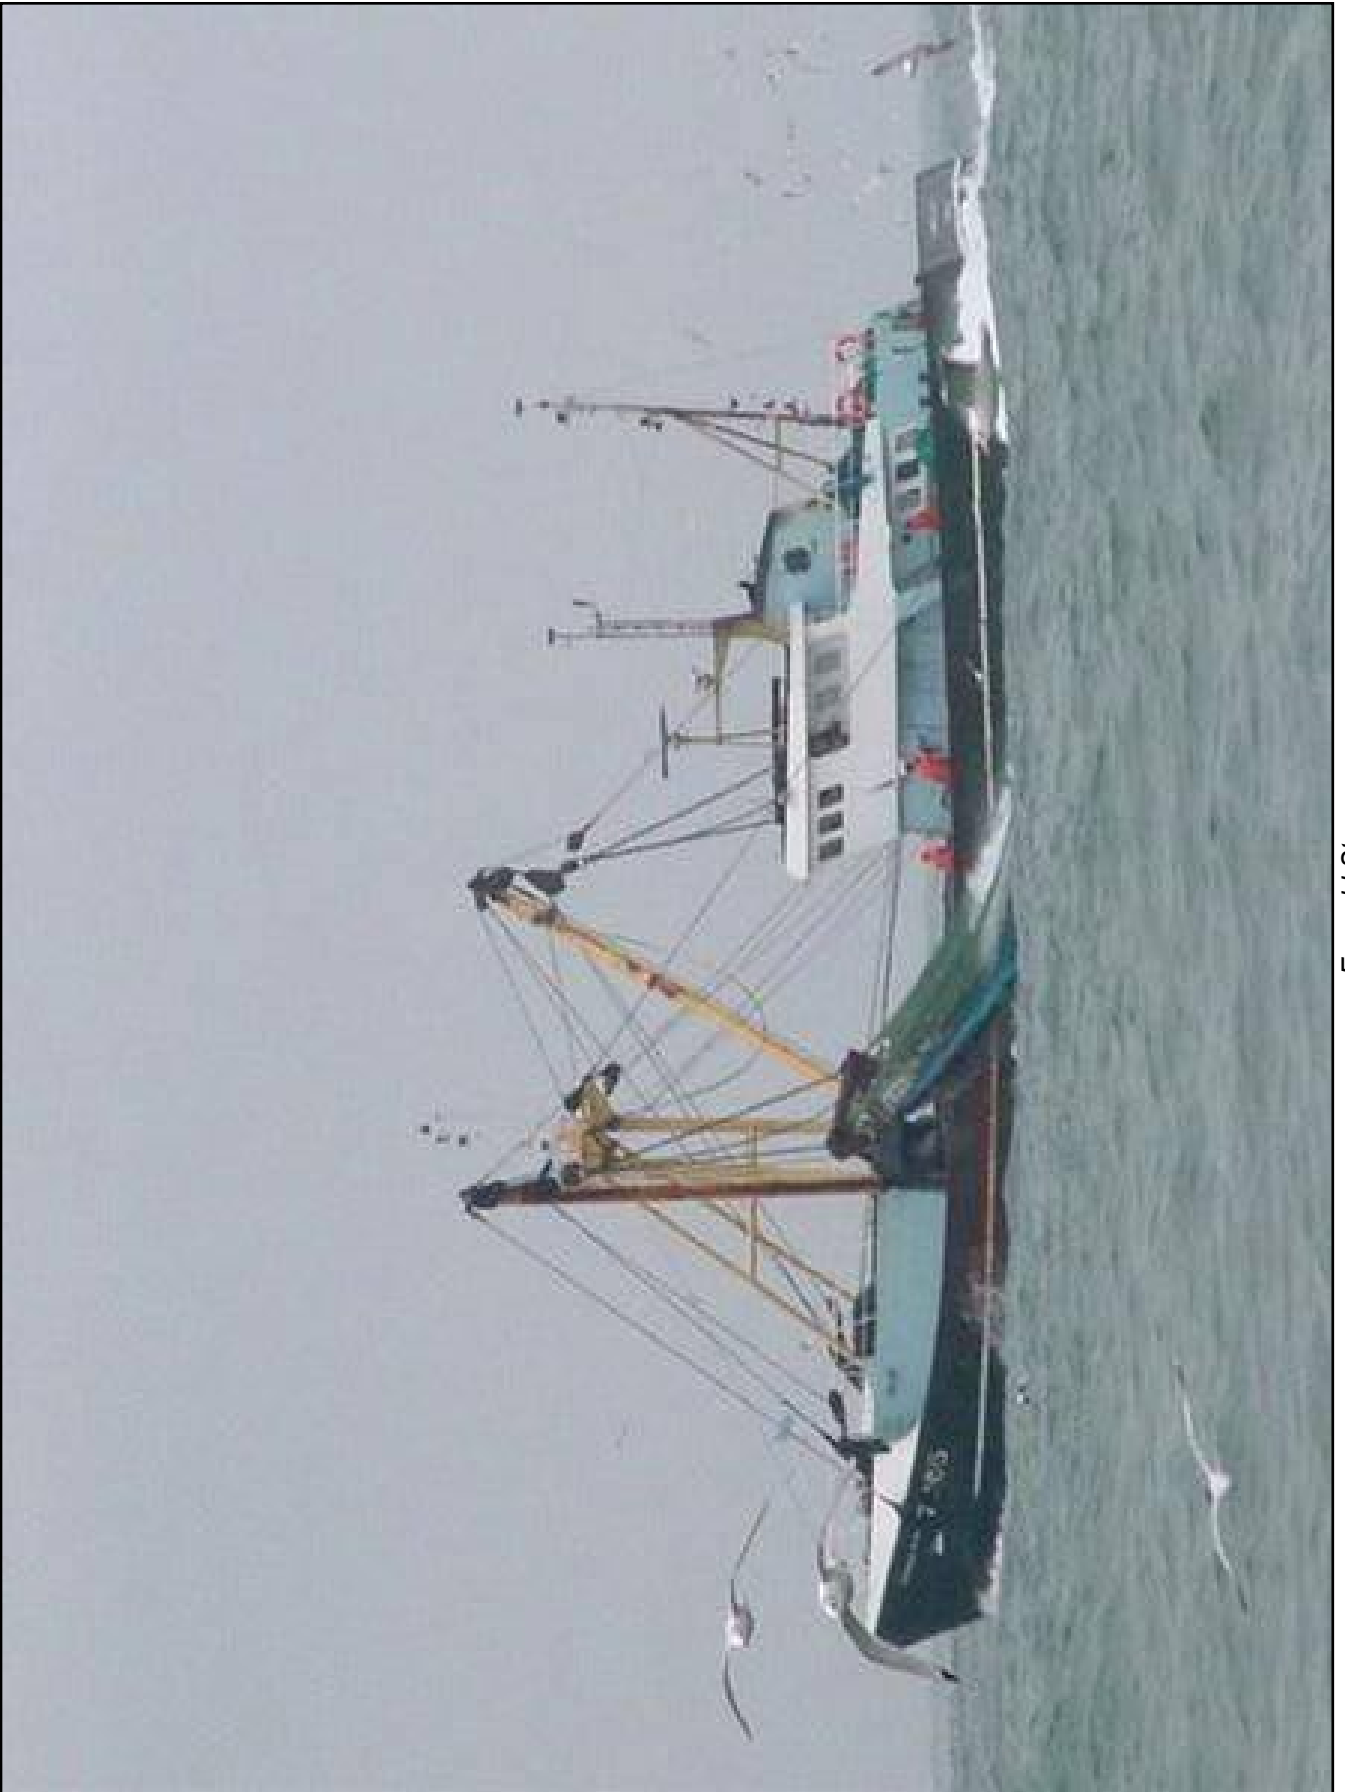
Figure 1

*Emerald Star* (**Figure 1**) was privately owned and managed by a Belgian family and skippered by the owner's son. The vessel was a regular visitor to the port of Milford Haven where her catch was landed and sent overland to European markets.

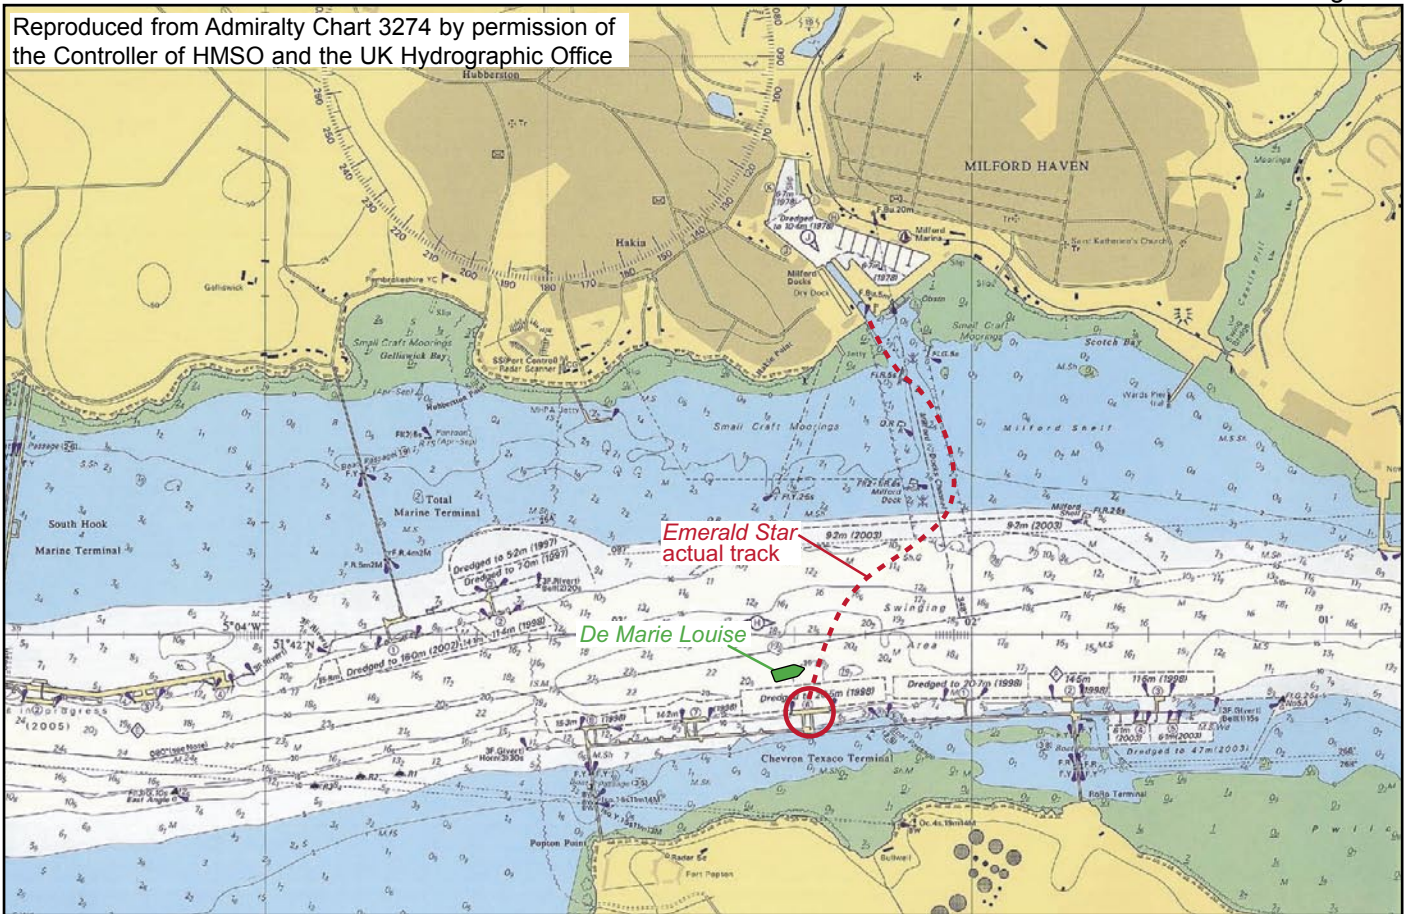
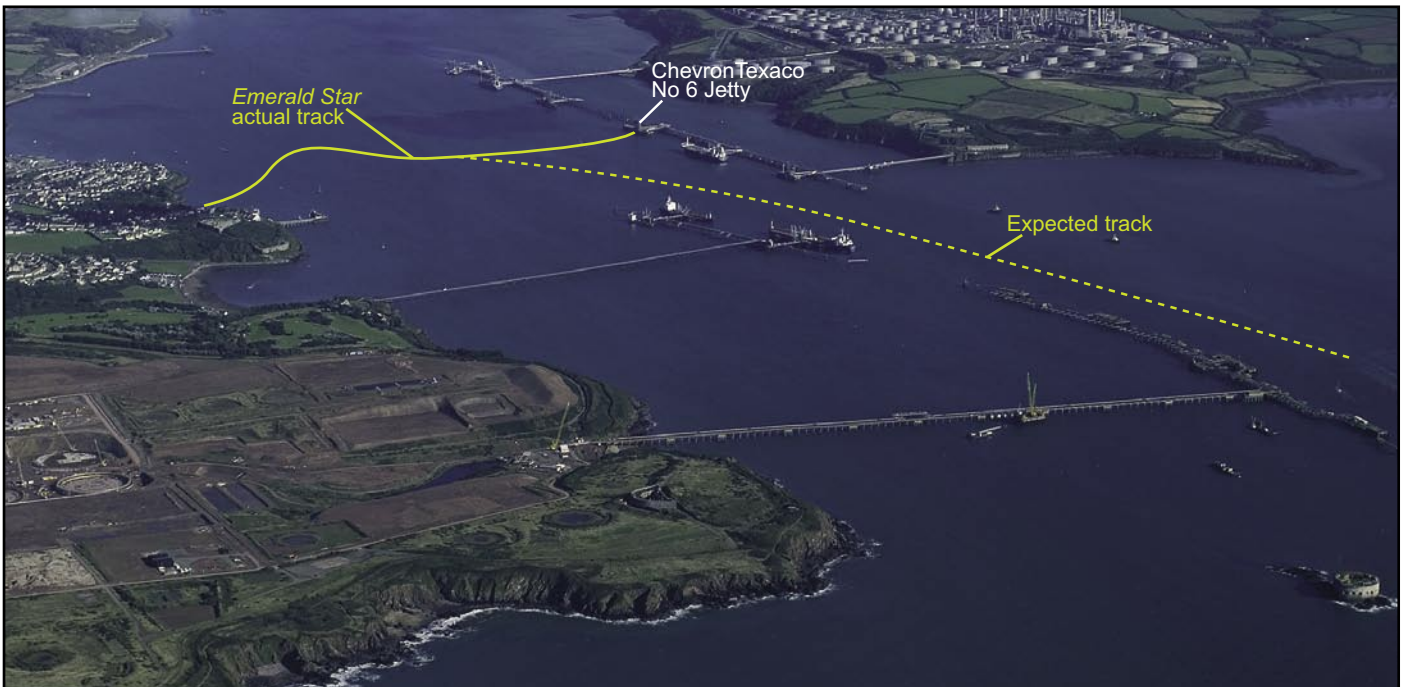
Figure 2

The skipper of *Emerald Star* continued his port swing, thereby crossing ahead of *De Marie Louise* at some 15m distance, with the intention of turning between *De Marie Louise* and the ChevronTexaco jetty; at this time *Emerald Star's* speed was approximately 12 knots. Once across the bows of *De Marie Louise*, *Emerald Star's* skipper realised there was not enough room to turn and, despite going astern, hit the jetty. The noise of the contact was heard through the open window of the VTS control room, which was approximately 0.75 mile away. A chart of the area and the vessel's track is shown on **Figure 2**.

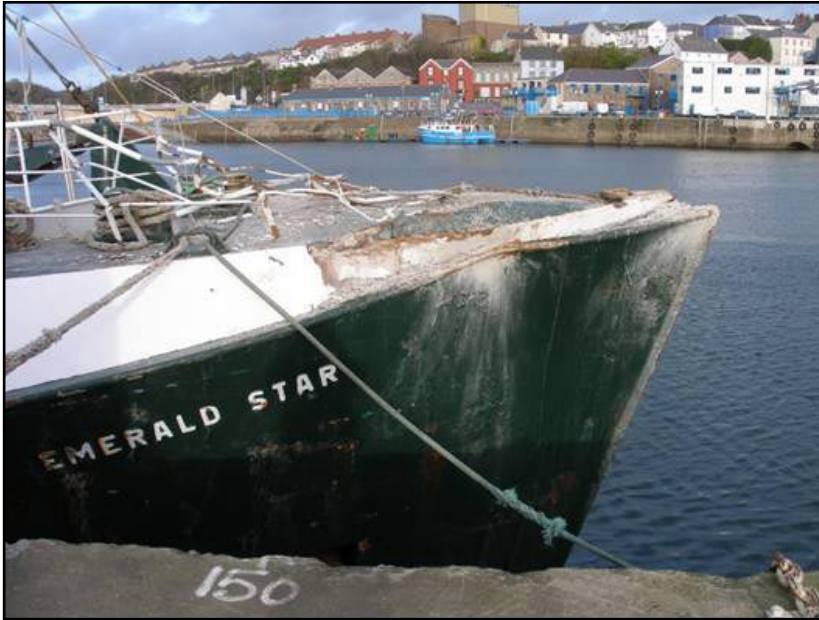
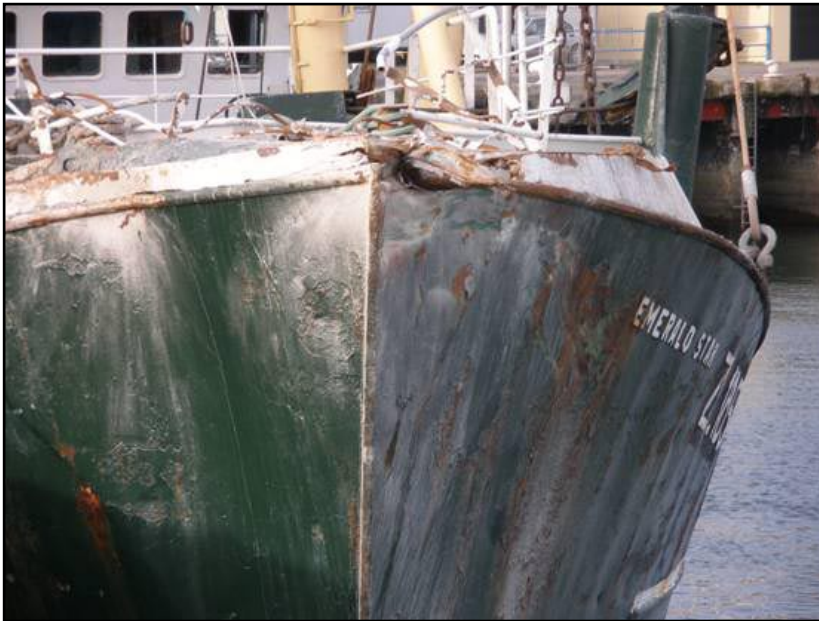
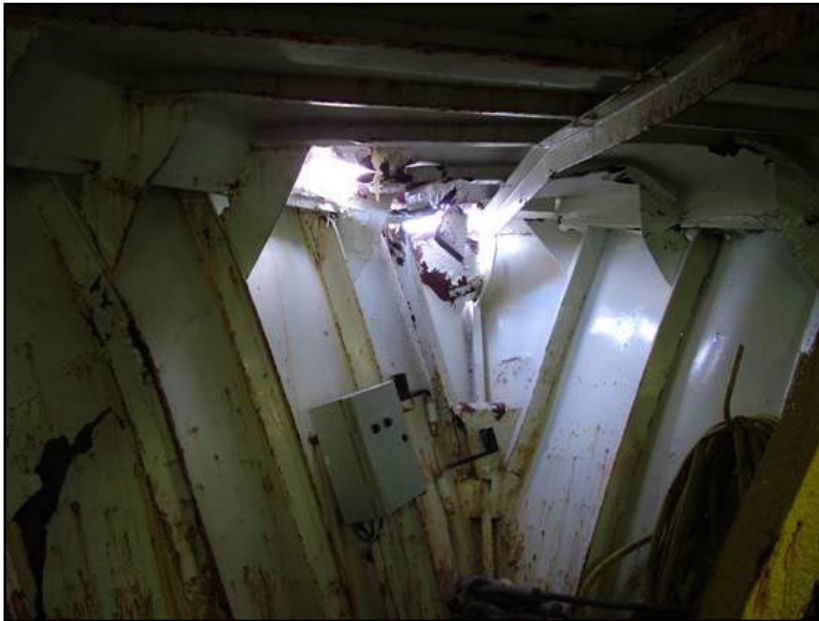
Damage to vessel

*Emerald Star* collided with ChevronTexaco Number 6 berth at Milford Haven on the evening of 18 January 2006 at approximately 1915. The damage to the vessel (**Figures 3a, b, and c**), and the berth (**Figures 4a and b**), was not particularly serious. However, had an oil tanker been lying alongside Number 6 berth, the consequences might have been very different.

The damage to the vessel was restricted to minor distortion of her bulwark bow plating and whaleback rails. There was no breach of the hull below deck level (**Figures 3a, b and c**). The damage to *Emerald Star* was minimised by the configuration of the berth platform, which allowed her to become wedged between the supports and under the platform, thus absorbing the impact. Damage to the jetty is shown in **Figures 4a and b**.

Following the impact, no inspection of damage to the vessel took place until she had returned to Milford dock. Following an impact, such as in this case, a condition inspection, to establish the extent and effects of any damage, is crucial. Although the vessel was not damaged below deck level, the watertight integrity above deck level was breached; if the vessel had continued out to sea this could have permitted water to enter the whaleback space and allow downflooding to the fo'c'sle, or entrap a substantial weight of water within the whaleback, thus potentially compromising the vessel's stability.

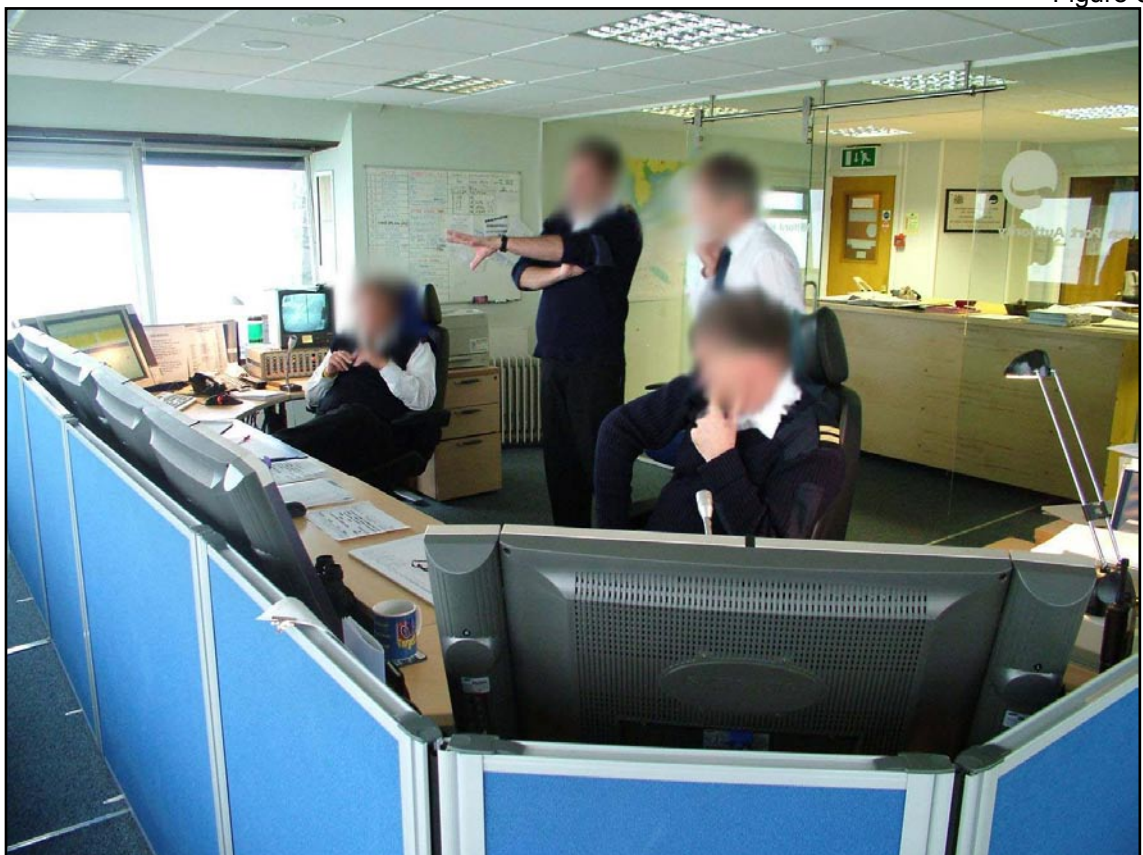
Figure 5

Milford Haven's VTS (**Figure 5**) consists of 4 radar screens, 2 database screens, 4 VHF radios, 2 telephones, a fax machine and a selection of CCTV cameras placed at various strategic positions throughout the Haven, including the dock entrance. The right-hand side of the room is a duplicate of the left, with all equipment divided

equally. However, it is not possible for operators to speak on the same VHF channel on separate sets due to their close proximity resulting in feedback and interference between the sets. VHF transmitting aerials are currently sited on a mast above Port Control. Receiving aerials are located on a separate mast some 400 metres to the North.

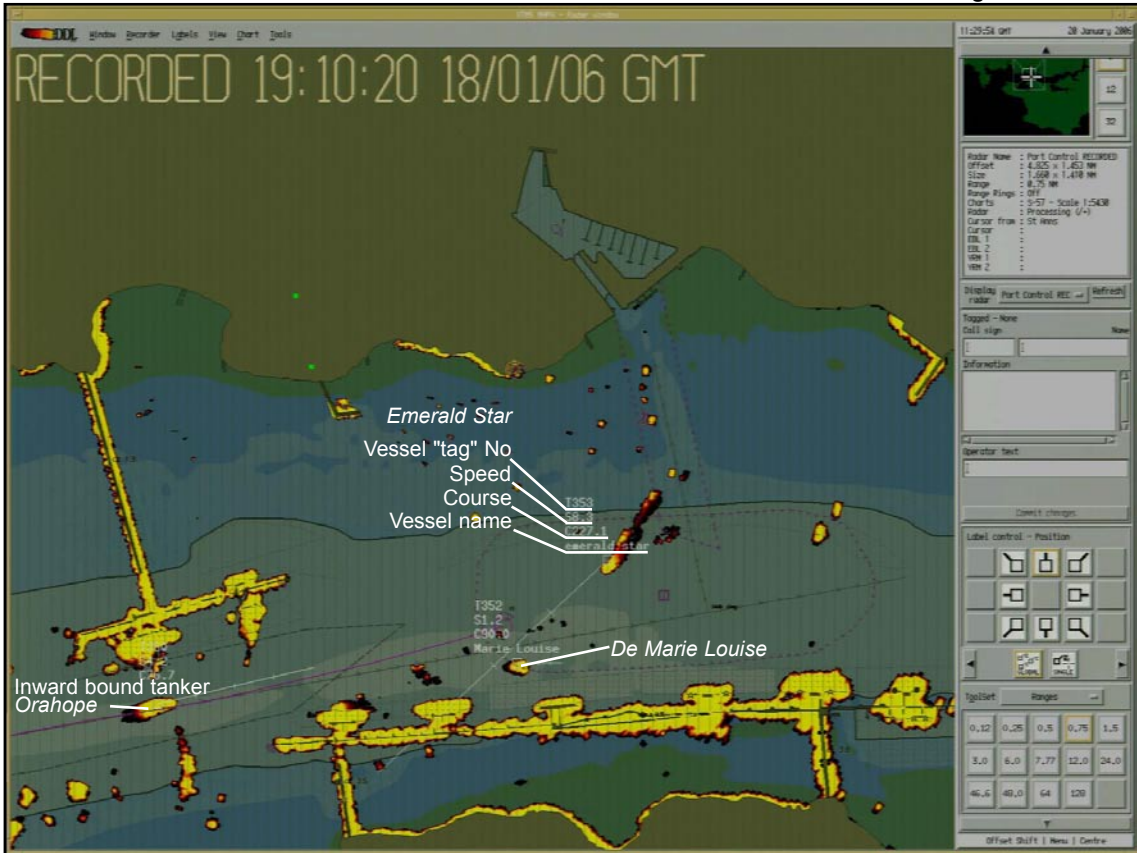
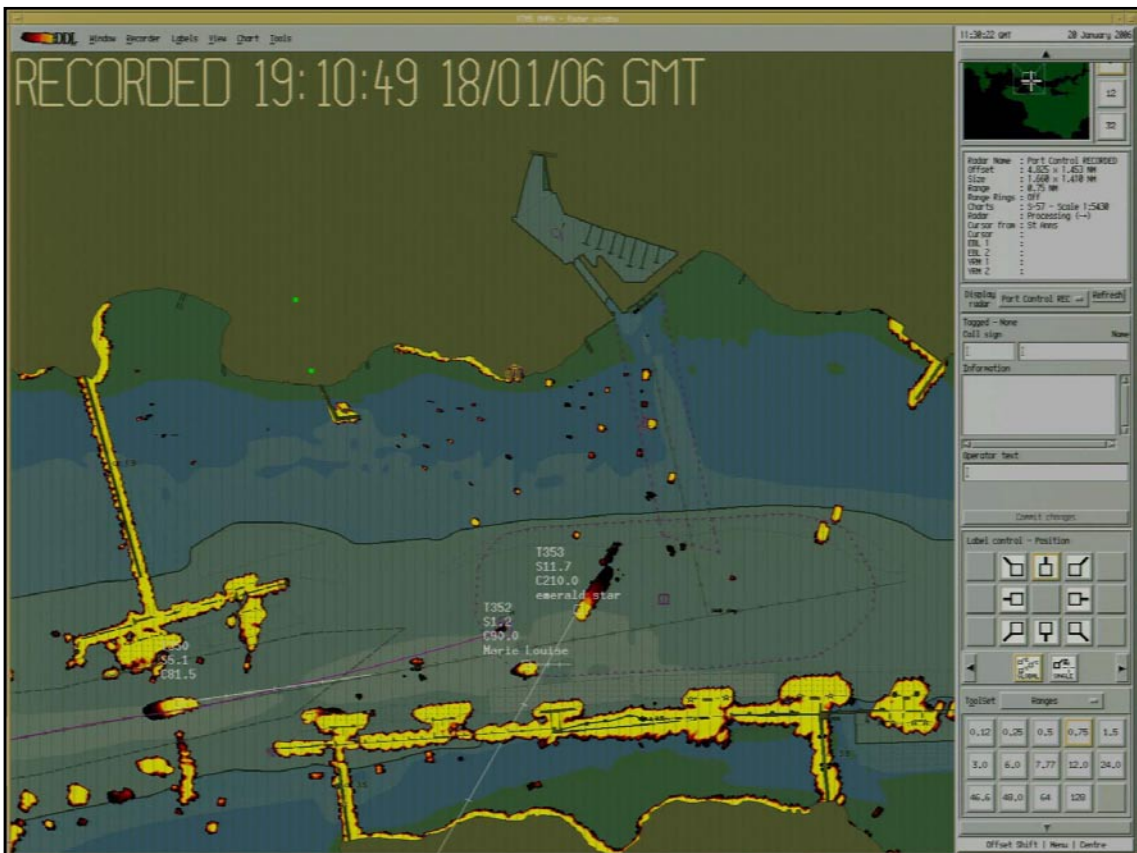
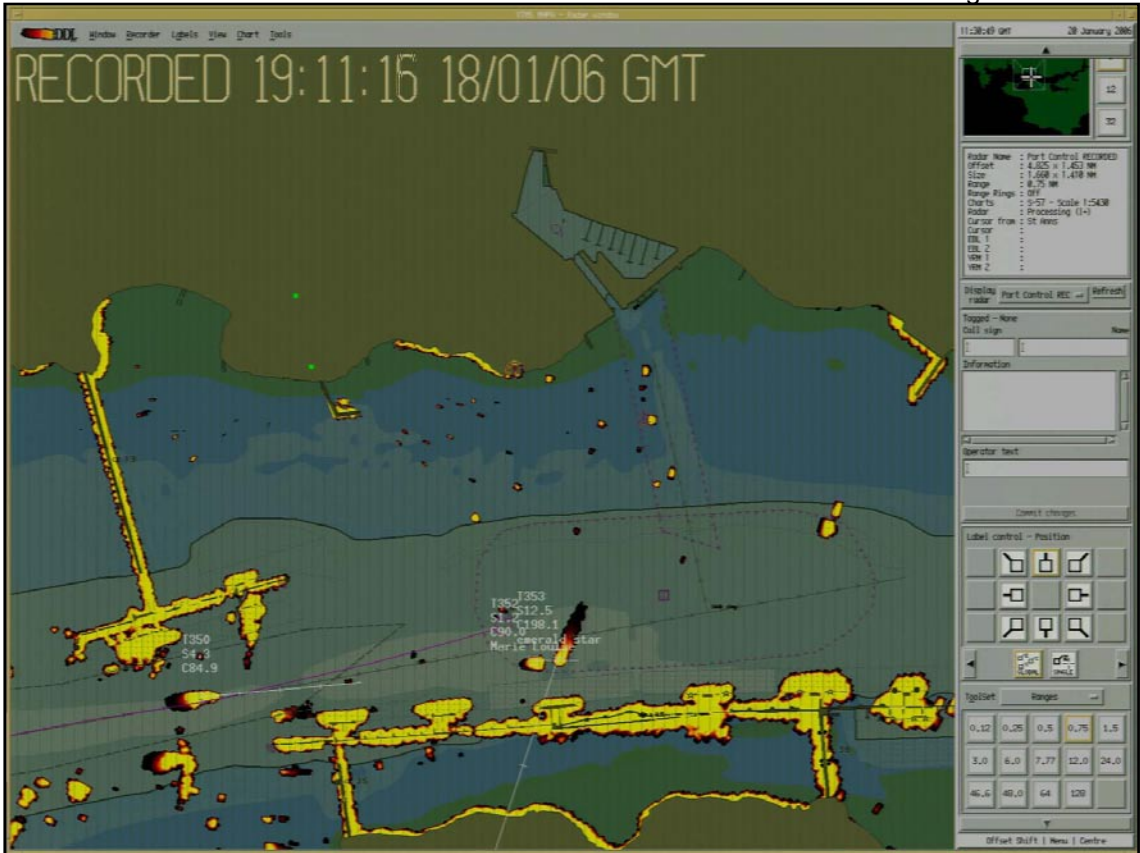
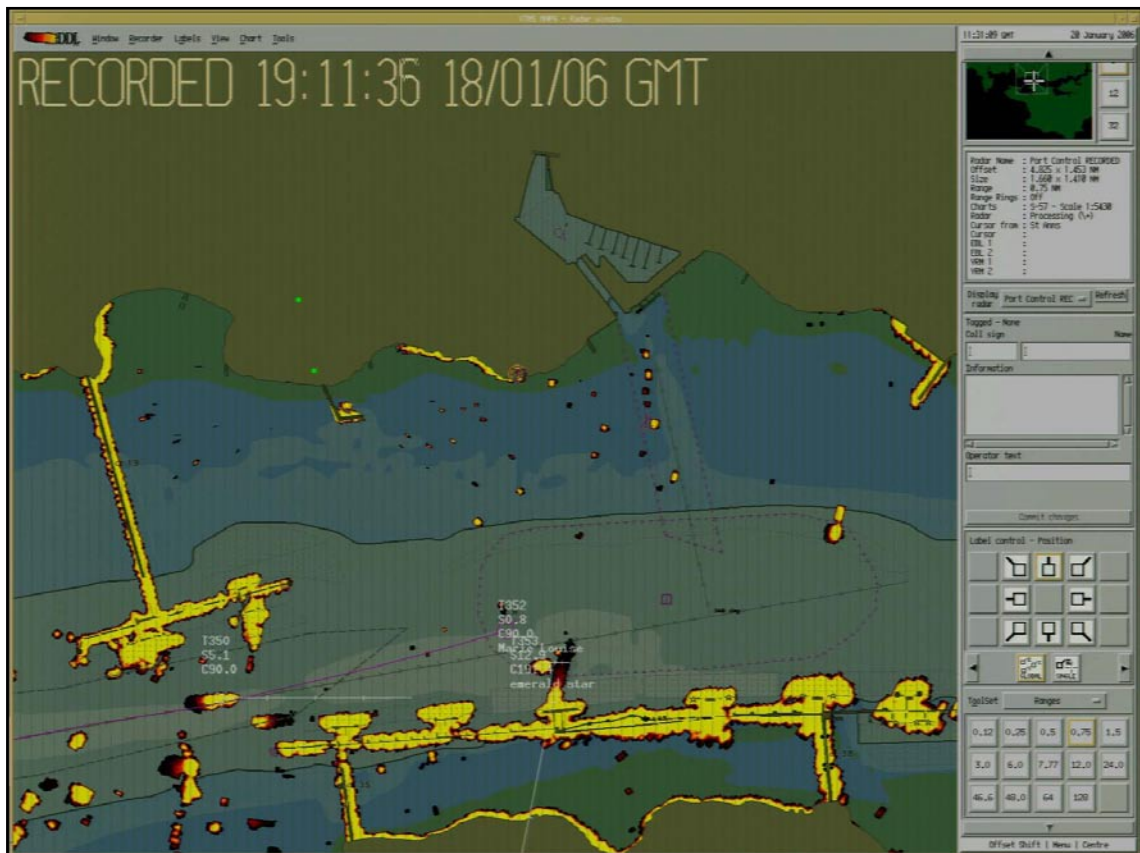
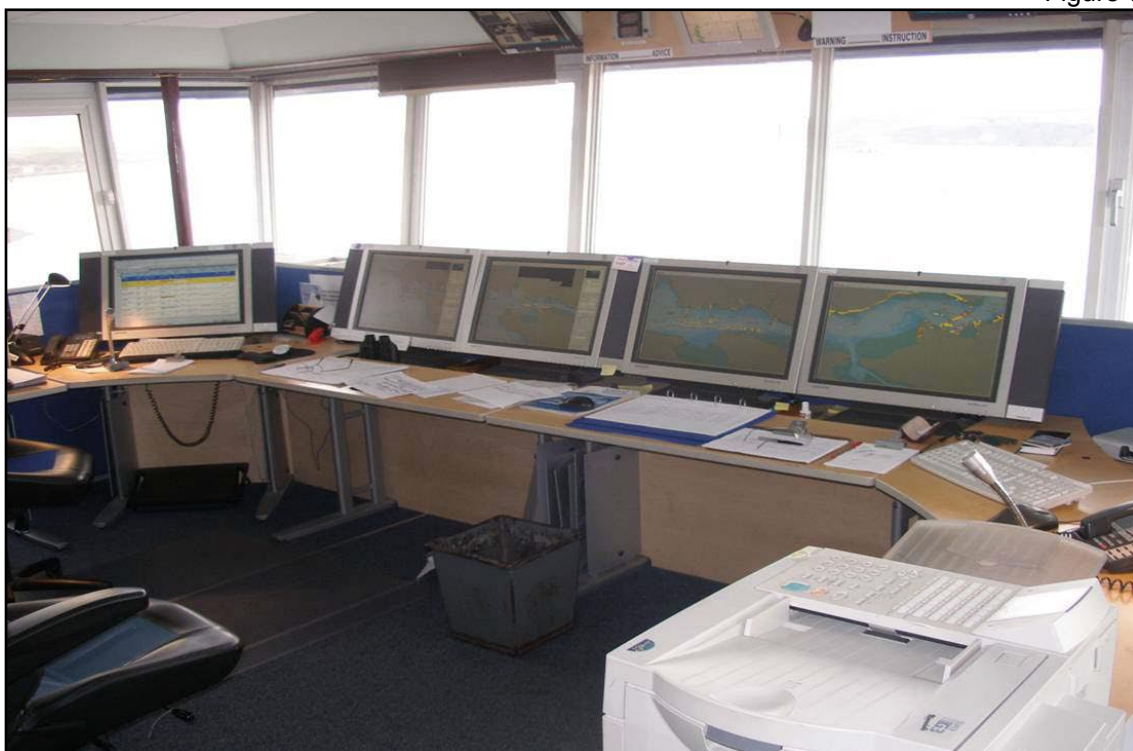
Figure 6a and 6b

Milford Haven's VTS - photograph showing the 4 screens displaying radar pictures
