Published by:
Service Department Portable Audio

LINE OF BUSINESS PORTABLE AUDIO

SERVICE NEWSLETTER

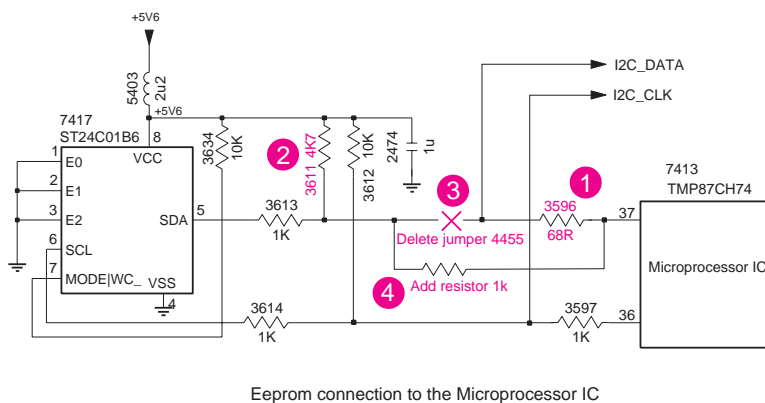
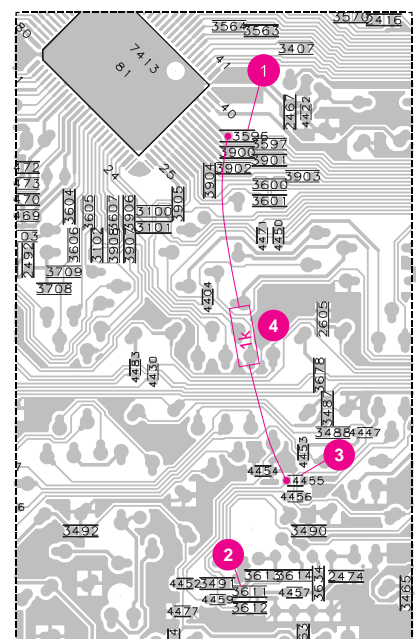
Portion of the Front board (copper side view)

- Loss of Tuner preset stations or tuning grid returns to 9kHz condition
- When changing source to Tuner the set stalls for a few seconds and may or may not switch to Tuner mode
- CD carousel rotates or the CD tray moves outwards
- Tape deck motors start to run or relay starts activation and the deck starts engaging and disengaging
- During this strange behaviour condition the set does not go into demo mode

CURE : The problem is caused by corrupted data being written into the EEPROM IC 7417 via the I2C_DATA line. The data corruption can be verified and cleared by performing an “EEPROM Format Test” in the Service Test Program.

The problem can be solved by the following hardware modification on the front board:

1. Ensure (change if necessary) that resistor 3596 is 68Ω (4822 117 12521)
2. Change resistor 3611 to 4.7kΩ (4822 051 20472)
3. Remove SMD jumper 4455
4. Add resistor 1kΩ (4822 050 11002) with insulated leads between pin 37 of microprocessor IC 7413 and junction of resistors 3611 and 3613 (left solder pad of jumper 4455)
5. Clear the corrupted data in the EEPROM as follows:
 - a) Enter the Service Test Program by holding the **PLAY ►** and **AUX** button depressed while switching on the mains supply
 - b) Perform an “EEPROM Format Test” by pressing the **SEARCH ◀◀** button to reset the EEPROM to default data
 - c) Exit the Service Test Program by disconnecting the mains supply

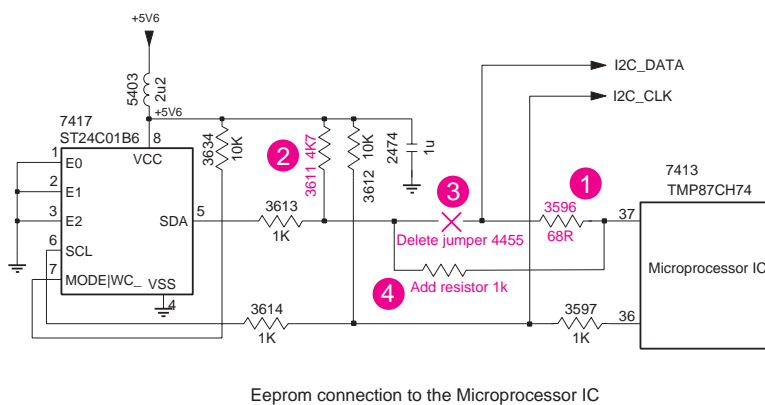
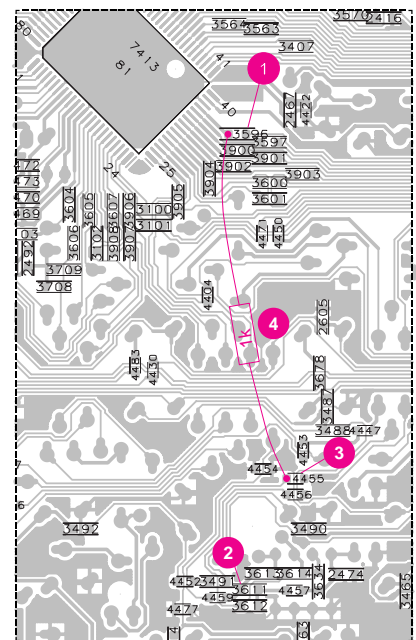
Portion of the Front board (copper side view)

- The set behaves strangely after switching it on via Standby button or mains supply re-connection. Strange behaviour includes:
- Loss of Tuner preset stations or tuning grid returns to 9kHz condition
 - When changing source to Tuner the set stalls for a few seconds and may or may not switch to Tuner mode
 - CD carousel rotates or the CD tray moves outwards
 - Tape deck motors start to run or relay starts activation and the deck starts engaging and disengaging
 - During this strange behaviour condition the set does not go into demo mode

CURE : The problem is caused by corrupted data being written into the EEPROM IC 7417 via the I2C_DATA line. The data corruption can be verified and cleared by performing an “EEPROM Format Test” in the Service Test Program.

The problem can be solved by the following hardware modification on the front board:

1. Ensure (change if necessary) that resistor 3596 is 68Ω (4822 117 12521)
2. Change resistor 3611 to 4.7kΩ (4822 051 20472)
3. Remove SMD jumper 4455
4. Add resistor 1kΩ (4822 050 11002) with insulated leads between pin 37 of microprocessor IC 7413 and junction of resistors 3611 and 3613 (left solder pad of jumper 4455)

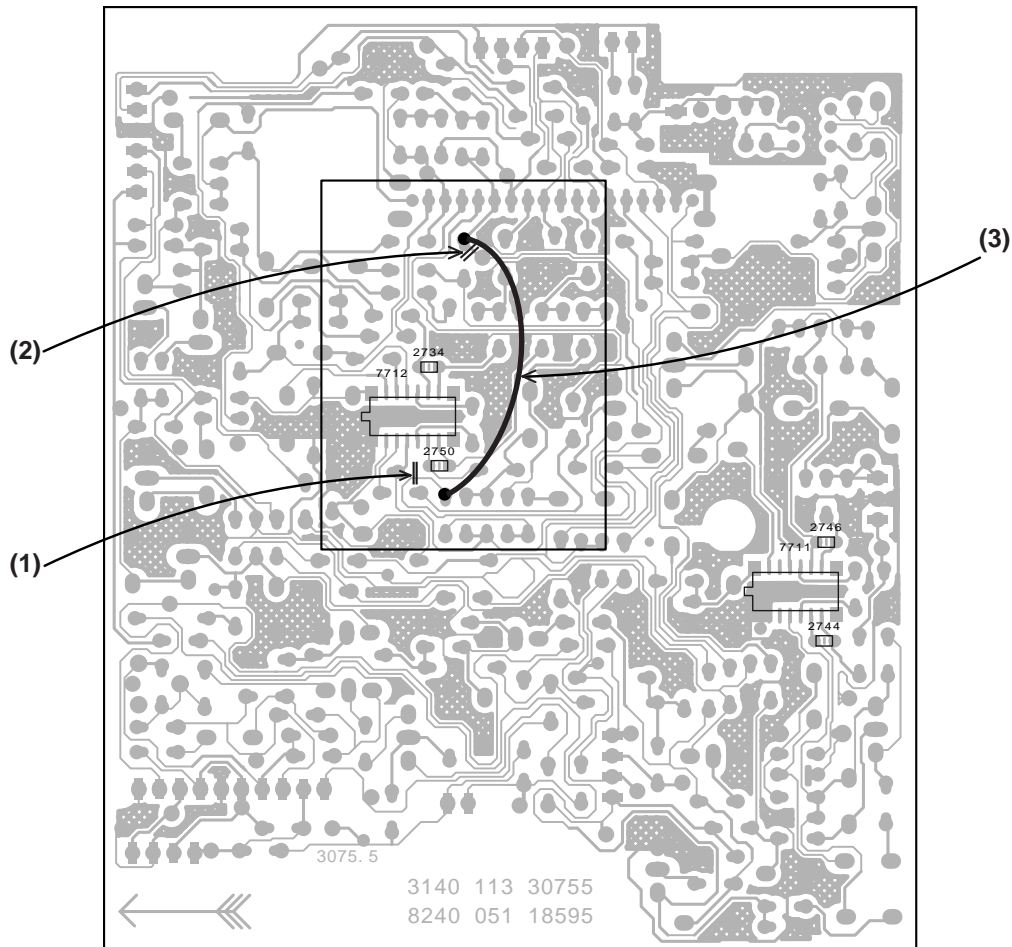
Recorder Board - Layout Diagram
(PCB code : 3140 113 30755)

SYMPTOM : **IRIS CODE C 1 4 X**
Abnormal noise is audible in TAPE mode.

CURE : The signal paths on the Recorder board are too close.
Solution is to cut 2 copper tracks on the printed board and to connect resistor 3729 and capacitor 2736 with a wire (for details see diagram below).

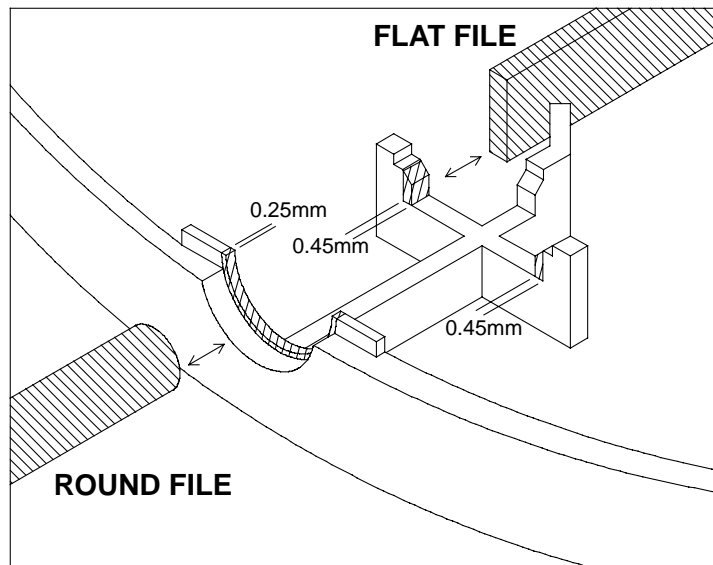
INFORMATION : In course of production, the PCB Assembly was changed to PB2 (for details please refer to Service Manual 4822 725 26021).
In the PB2 assembly a smaller headphone jack was used and thus the hole for h/p jack on the cabinet was also made smaller.
The cabinet (4822 449 80201) of the sets produced in earlier stage is no longer available and the new cabinet (4822 449 80266) with smaller jack hole will be delivered as substitute.

As a service solution, for repairing sets with bigger headphone jack, we suggest to enlarge the hole by use of files (see drawing below).

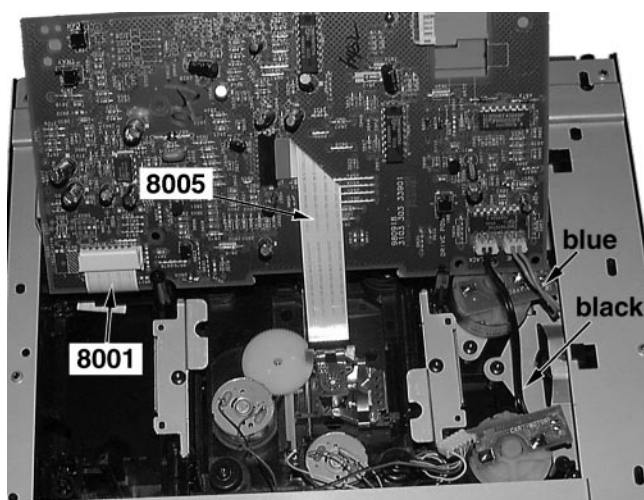
fig.1 – location of flex-foils

INFORMATION : Correction to the Service Manual, Partslist
The following flex-foils and flex-foil-connector were missing and have been added to the partlist of the 3CDC-99 Module (chapter 10).

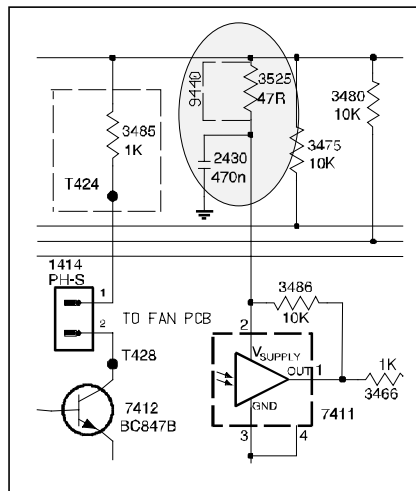
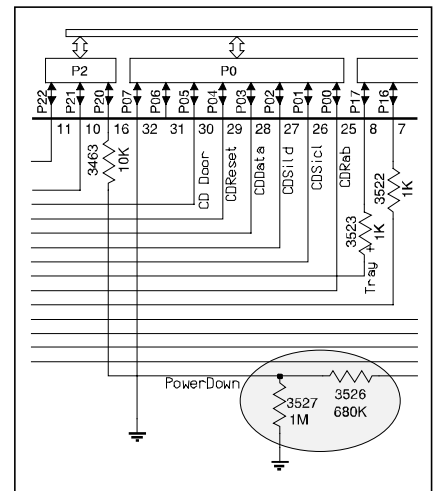
INFORMATION : Correction to the Service Manual, Frontboard:
 Following parts have been added/changed from production start onwards:

- Capacitor 2430 changed from 100pF to 470nF (4822 126 13482)
- Jumper 9440 replaced by resistor 3525, 47Ω (4822 116 52195)
- Resistor 3526, 680kΩ (4822 051 20684) added
- Resistor 3527, 1MΩ (4822 051 20105) added

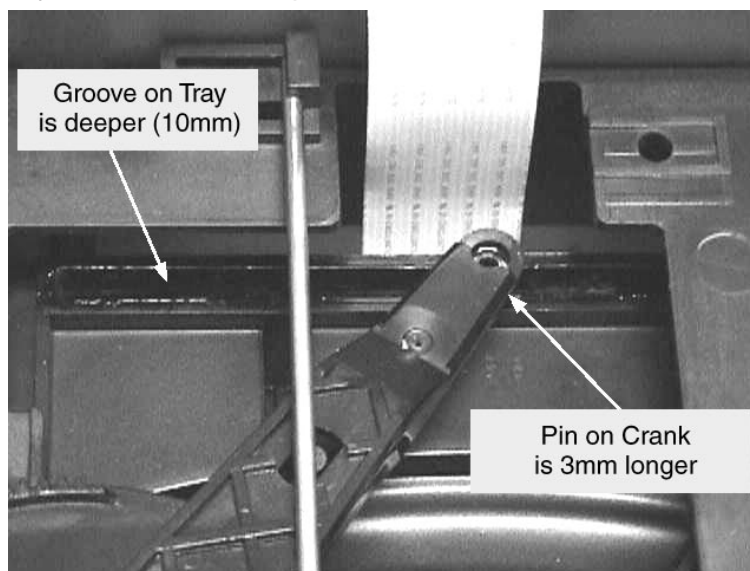
From production wk9835 onwards, the Tray and Crank have been modified. The groove on the tray is now deeper and likewise the pin on the Crank is 3mm longer.

Due to this change the new Crank does not fit into the old Tray anymore. But it is still possible to use the old Crank on the new Tray.

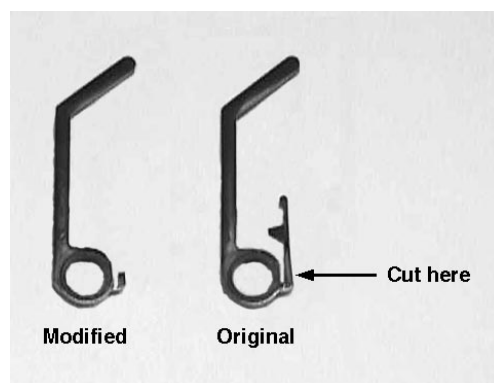
SYMPTOM : **IRIS CODE 1 6 7 X**
When CD tray was activated to open, the tray would move out and immediately go in again or stop at half way.
When the CD tray is in motion the inside arm of the switch bracket (pos 123) hits the micro switch earlier than the main lever.

CURE : The problem can be solved by cutting a section of the inside arm of the switch bracket as indicated below:
