**INTERNAL RESISTANCE TO CORROSION
IN STEEL HOLLOW SECTIONS**

Notice 1059

**CIDECT
Final Report 10B-78/3**

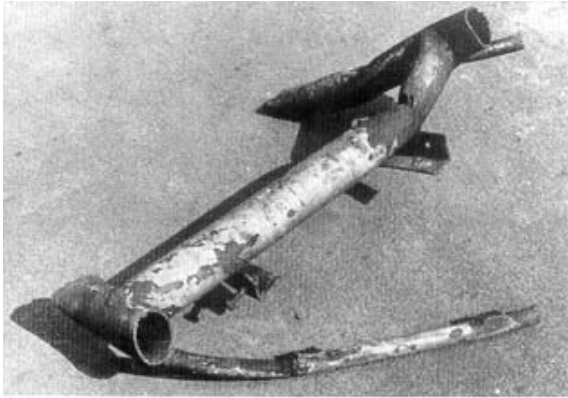
Ten years later, the steamship "Baalbek" collided with one of these catwalks in foggy weather. The ship suffered substantial damage and the catwalk was completely destroyed, as can be seen from the photographs. It must however be observed that, in spite of the extent of the damage, there were comparatively few broken hollow sections; the whole structure was deformed in a ductile manner. Subsequent inspection showed that, even where the hollow sections were broken, the rupture was not of a brittle nature.(Figs. 1-6).

Figure 1: Joint unit with parts of the chords showing severe deformation and rupture at the point of impact.

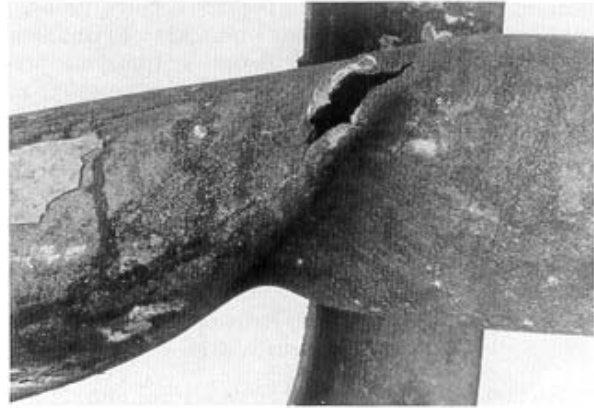
Figure 2: Detail of the rupture at the point of impact showing the ductile fracture.

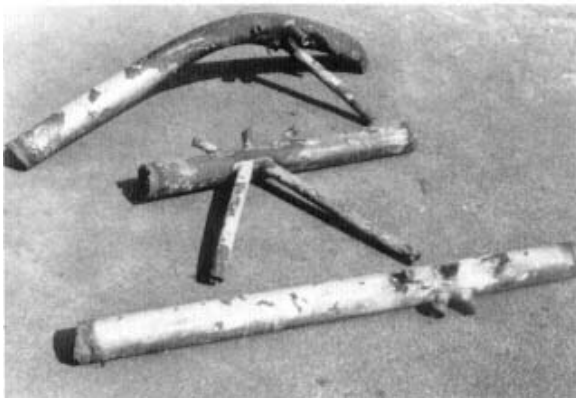
Figure 3: Various parts of the twisted and damaged side chords.

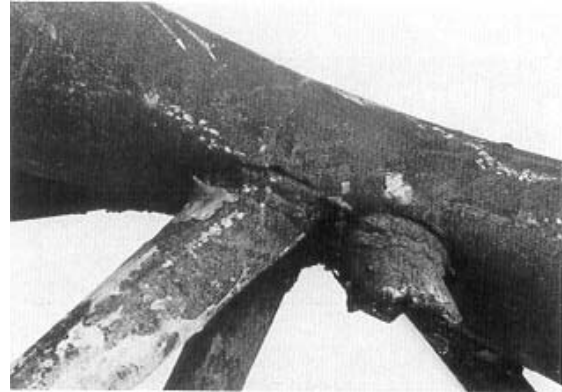
Figure 4: Detail of the upper chord from Fig. 3

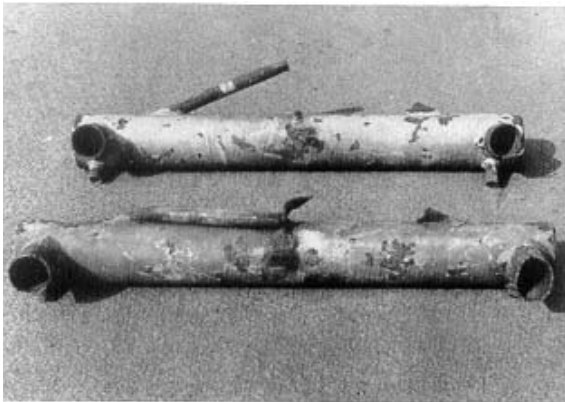
Figure 5: Compressed members with ends still sealed, the ductile bending of the lattice members should be noted.

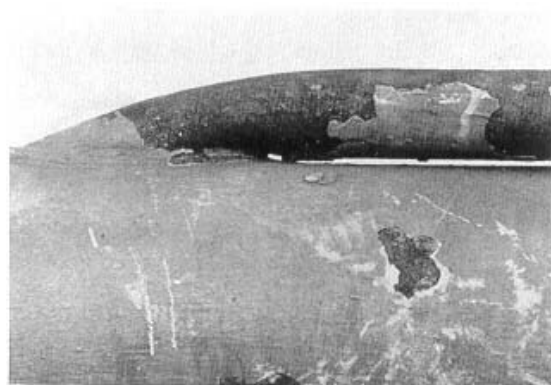
Figure 6: Web member at the bottom of Fig. 5 indicating that the weld has not parted in spite of the large bending force.

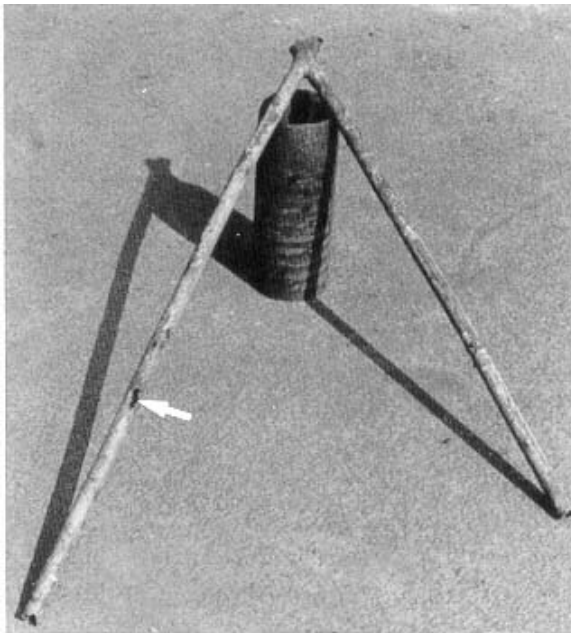
One major case of external corrosion was however observed. This can be seen on the photos, Figs. 7 and 8, where a hole has developed in one of the lattice members. It appears that another component of the framework or even possibly a rope had been in contact with this member causing abrasion which assisted the penetration of moisture, thus intensifying the corrosion. A proper inspection would have made it possible to detect damage of this type.

Figure 7: Perforated member, probably the result of rubbing against another part during its working life.

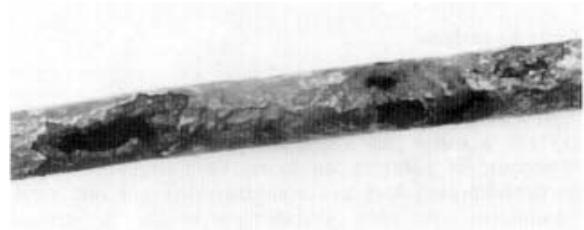
Figure 8: Detail of the corroded openings of the members in fig. 7.

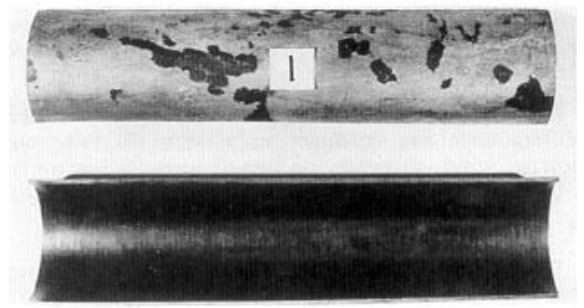
Figure 9: Hollow sections 114.3 mm dia. internal surface: perfectly preserved. External surface paint chipped during handling.

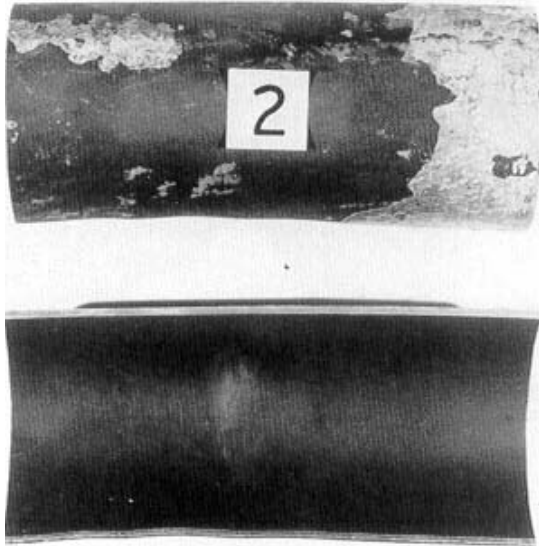
Figure 10: The same part. The traces of pre-welding heating can still be seen intact after 10 years.

It is interesting to note, on Figure 10, the indication of the area heated during the welding operation, visible on the internal wall. Nevertheless no deterioration occurred in this region.

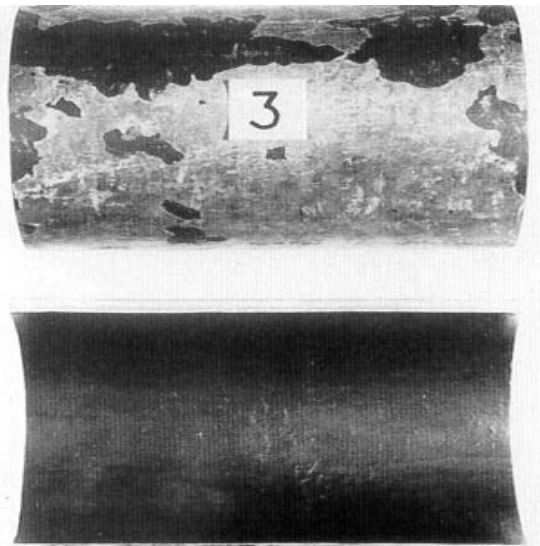
Figure 11: Hollow section 168.3.mm dia internal and external faces

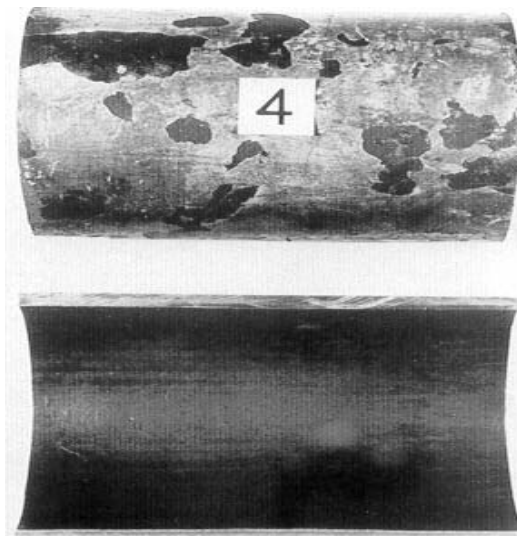
Figure 12: Same component as Fig. 11, the bright appearance of the internal surface should be noted. Some of the original mill-scale adheres to the wall.

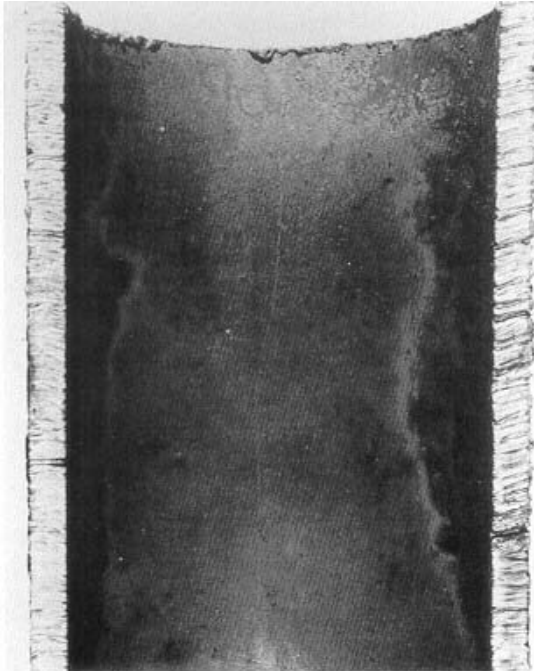
It can be stated in conclusion that, as one would expect no internal corrosion occurred in these davits in spite of their 40 years' service at sea.

Figure 14: Internal surface of the central section of the davit

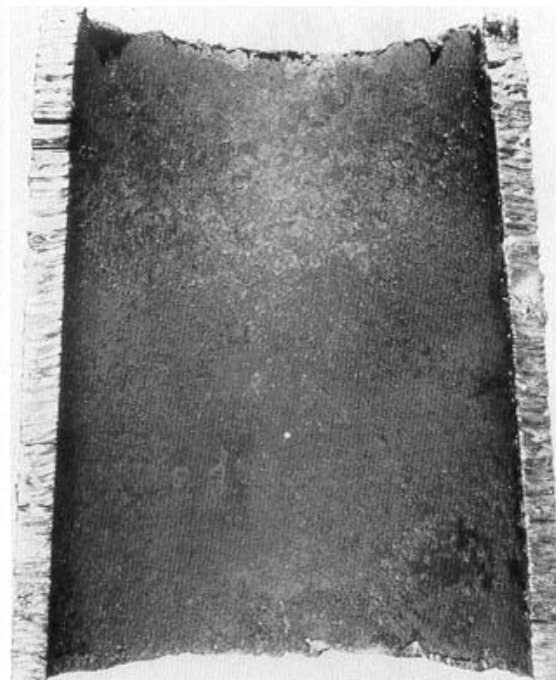
Figure 15: Upper part of the davit post cut open. (note the white spaces and the small spots due to oxyacetylene cutting)

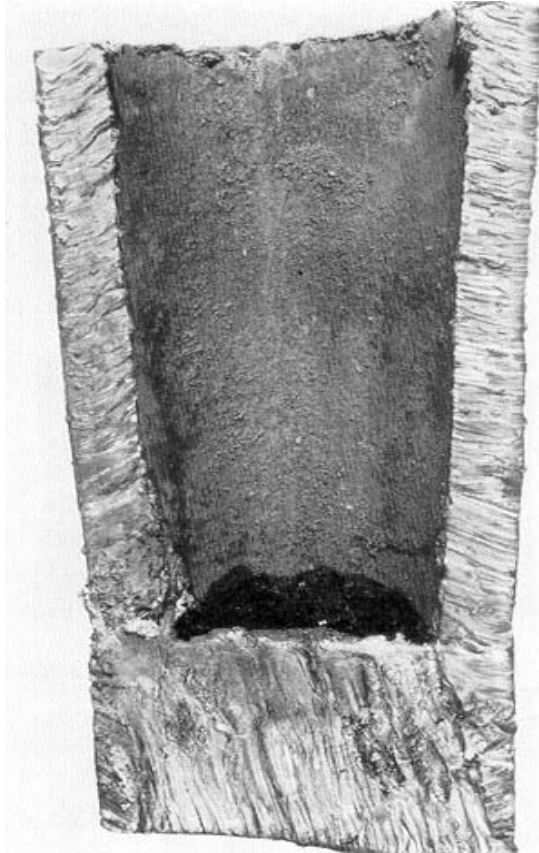
Figure 16: Lower part of the davit post as cut open.
(The white spots are again due to oxyacetylene cutting)

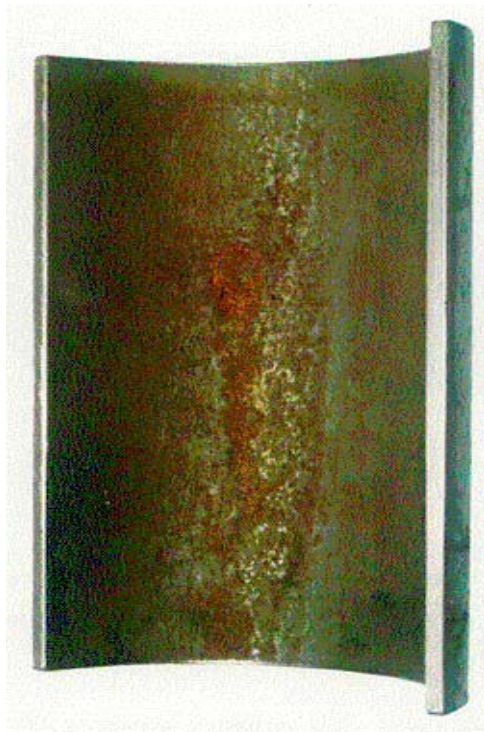
Very slight signs of internal corrosion were observed, other than surface discolouration, due to the oxygen and the humidity in the imprisoned air. Much of the original mill scale was also visible. The slight rusting which was found at the centre of the sample was recent, having appeared after the tube had been cut open for examination.

Figure 17: Circular hollow section 139.7 mm showing one of the half cylinders cut longitudinally. The slight amount of rust in the middle the tube is recent and has appeared since the tube was cut for inspection.

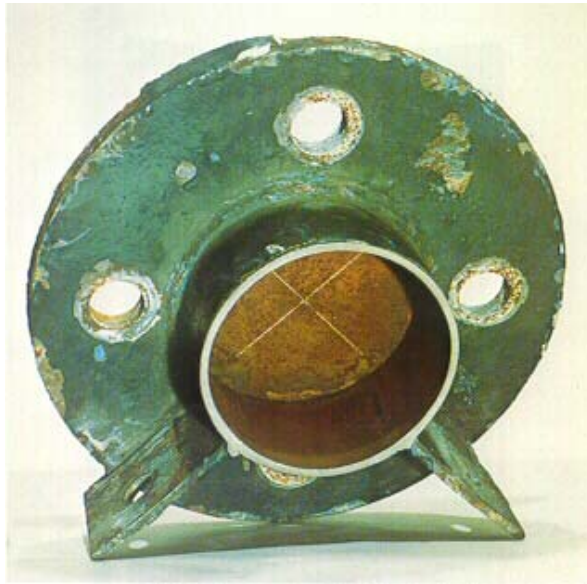
Sample no. 2: Also 159.7 mm dia. included an intermediate flange assembly (Figure 18). The conditions of the internal face of the flange, which had been enclosed and hermetically sealed by being welded to the CHS, was still relatively bright, the original marking-off lines being clearly visible. The intermediate flange assembly was dismantled in order to examine the contact faces of the flanges (Figure 19)

Figure 18: Circular hollow section 139.7 dia. welded to a solid flange showing clean conditions of the internal of faces. The original marking off lines on the flange are still perfectly visible.

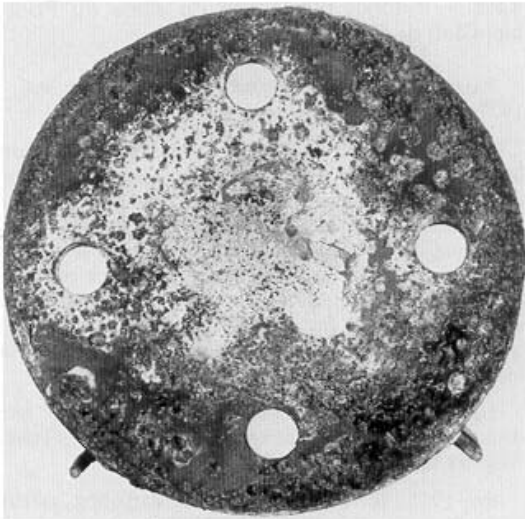
On the outside of the flanges a certain amount of corrosion was discovered, but this was, in fact limited to the area which was outside the pitch circle diameter of the bolts and was obviously due to the progressive ingress of rainwater between the flanges over many years of service (Figure 19).

Figure 19: Contact faces of the solid flange after dismantling.

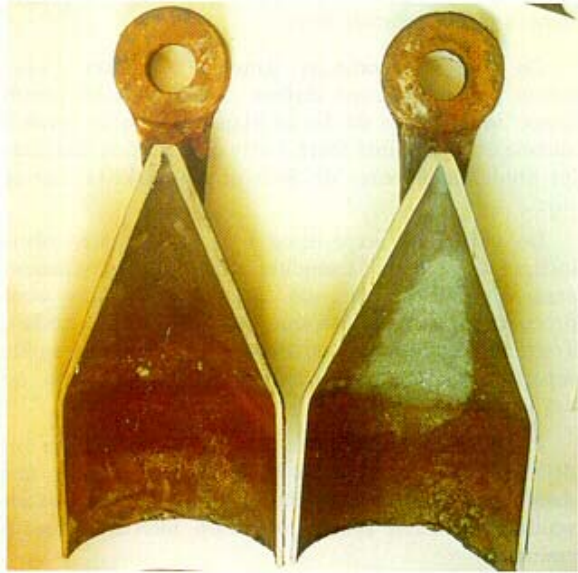
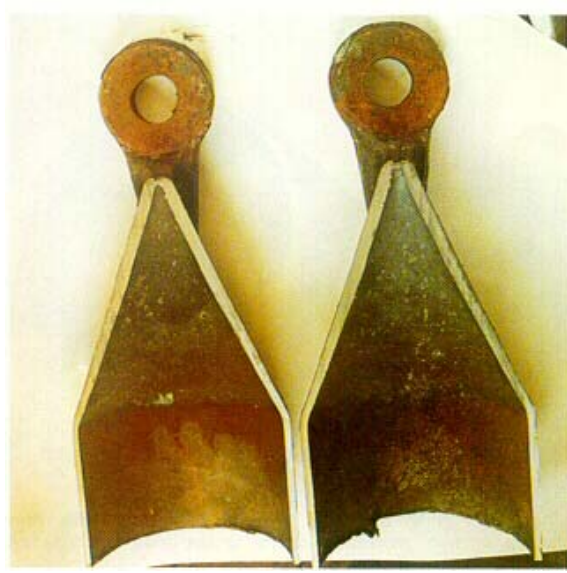
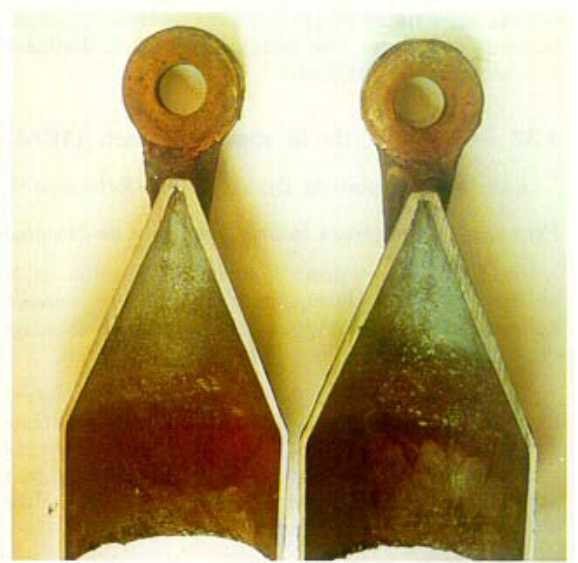
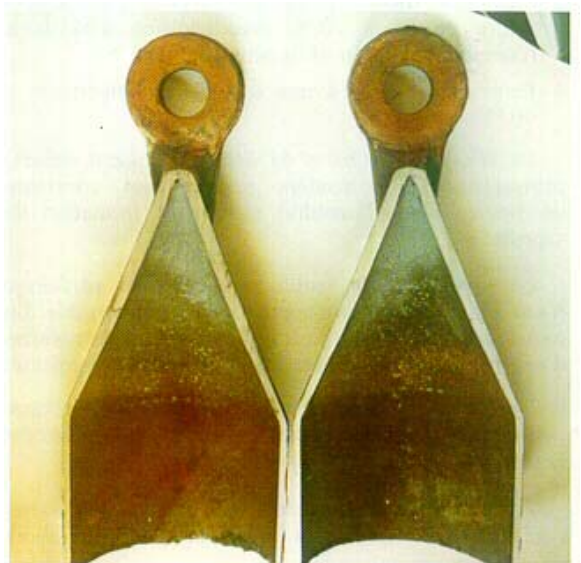
Figure 21: View of the internal faces of the brace component No. 1.

Figure 22: View of the internal faces of the brace component no. 2.

Figure 23: View of the internal faces of the brace component no. 3.

Figure 24: View of the internal faces of the brace component no. 4.

It was thus possible to verify that, under particularly severe conditions of use no internal corrosion takes place in hollow sections providing the sections have been sealed properly. This confirms the previous investigations of Seils and Kranitzky [17] on this subject.

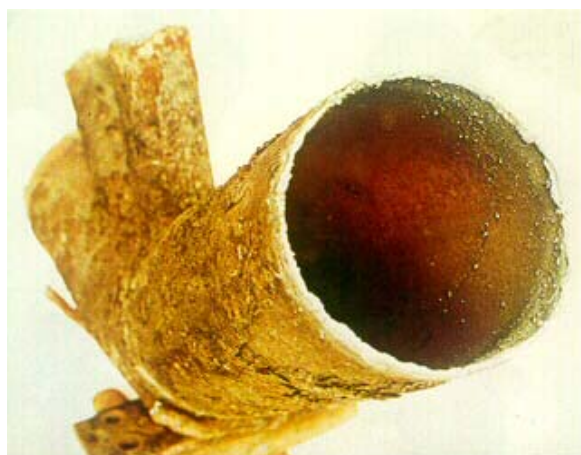
Figure 25: Truss component located over a pickling bath. The external surface shows an advanced state of corrosion, due to the ambient atmosphere, whereas the inside is well preserved, the traces of damage are entirely due to the oxyacetylene cutting operation.

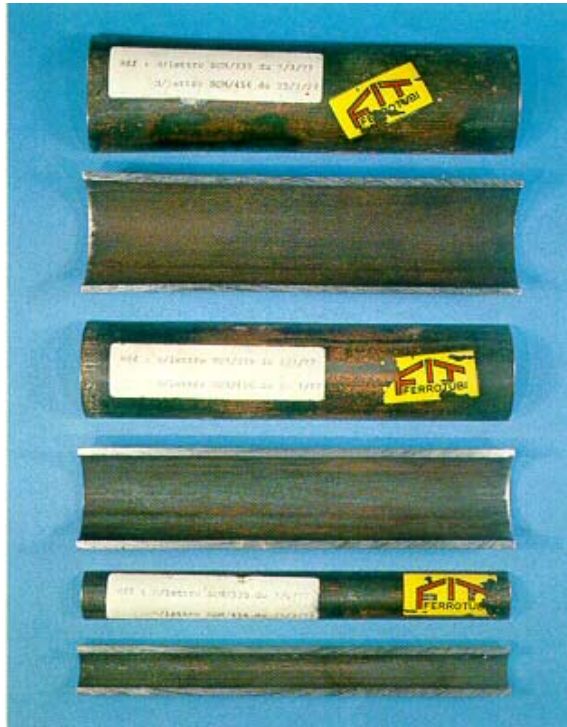
The 3 samples taken from an industrial building had been cut longitudinally and examined (see figure 30). There is no trace of internal corrosion in spite of the age of the structures (more than 10 years) and the conditions of exposure (industrial atmosphere).

Figure 30 - Internal and external appearance of three samples cut from the tubular framework of an industrial building.

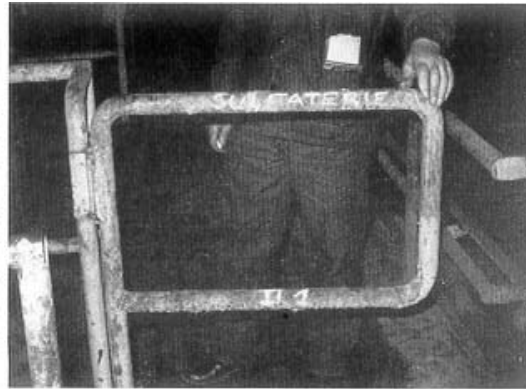
Figure 34: A sample of the railing which had been removed from the sulphate works. Particularly badly corroded externally.

The railing sample from the vicinity of an acid bath showed an external surface which was excessively corroded. On the other hand, this member, sealed by welding at both ends, had kept its original internal condition with remains of the mill-scale. The contrast between the two faces of this sample was particularly significant; the sealed interior is protected whatever the external atmosphere.

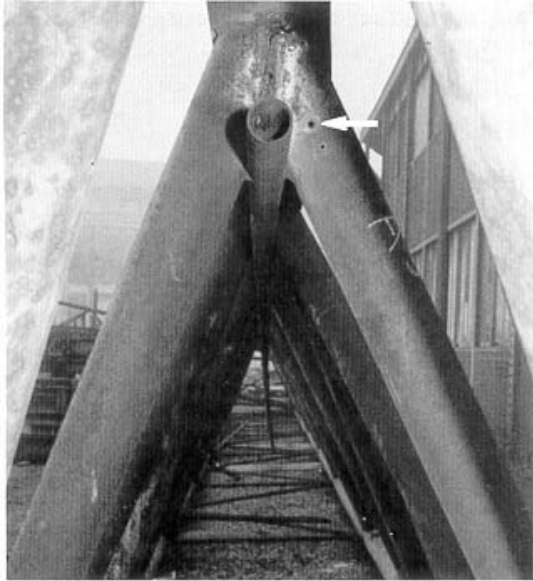
LNE detected a substantial quantity of rust at the bottom of this member and the two undamaged chords retained their original mill scale over a very large area.

Figure 37: Lower part of the A3 diagonal member showing the two attachment holes (note that the triangular girder is resting upside down)

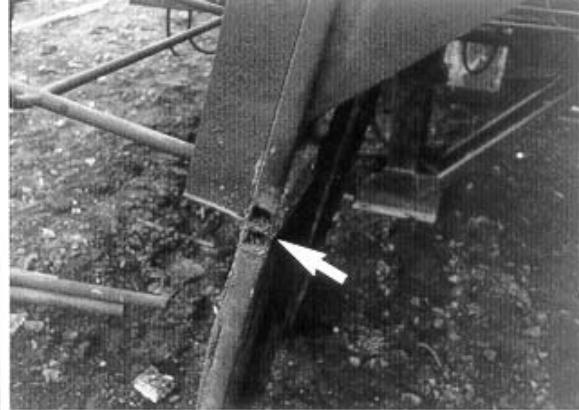
Figure 38: Platform with RHS stiffening. Only the longitudinal members with sealed ends have kept a corrosion-free internal surface.

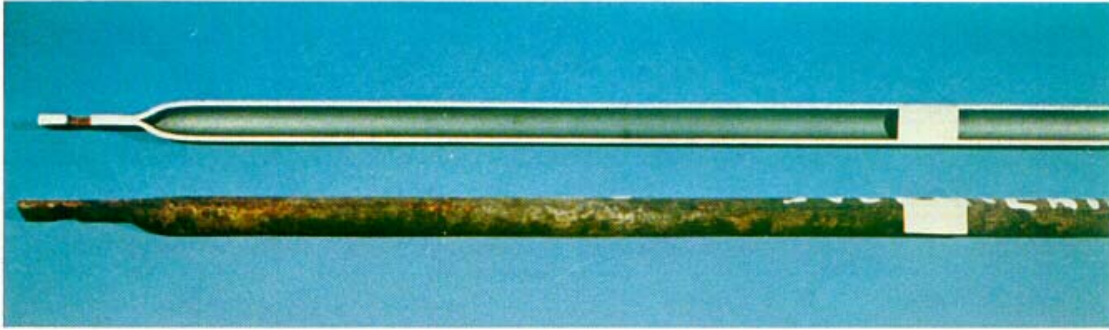
Figure 57 shows a circular tube sealed by flattening at the ends; its internal surface has remained in a satisfactory state in spite of the corrosion on the external surface.

Figure 57: Flattened end tube (First inspection programme)

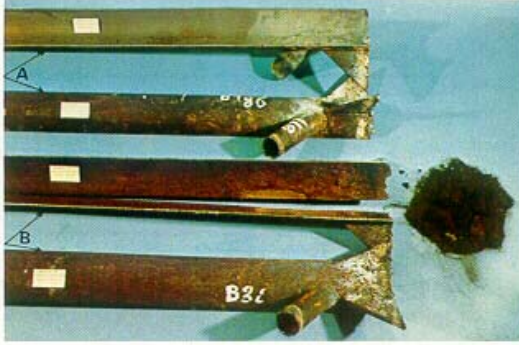
Figure 61: Tube(A) sealed and Tube(B) showing damage going back to original fabrication (First inspection programme)

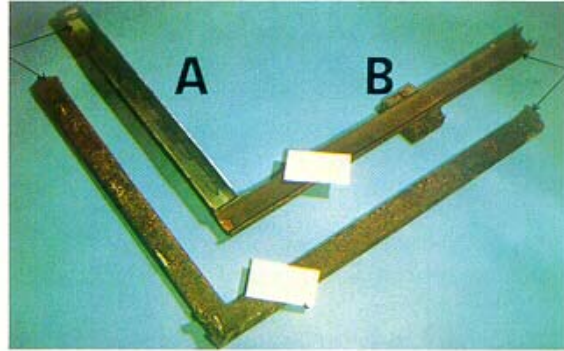
Figures 62 and 63 show the welded junction of open ended tubes (RHS in one case and CHS in the other) and one or two tubes sealed at the ends. The deterioration of the internal surface of the open ended tubes only is due to the ingress of aggressive agents (or simply moisture), which lead to corrosion. This is only possible in the case of tubes which have not been sealed, or where openings have occurred, such as cracks or holes. These conclusions remain valid whatever the location and type of assembly of the hollow sections within the structure, whatever the geometrical properties or the method of manufacture.

Figure 62: Joint between open Tube (A) and closed Tube(B)
