MANDATORY SERVICE BULLETIN

No. 2182
ATA Code 27-40
Recurring Inspection

SUBJECT: FLIGHT CONTROLS - INSPECTION OF STABILATOR HINGE
BRACKETS FOR WORKING RIVETS

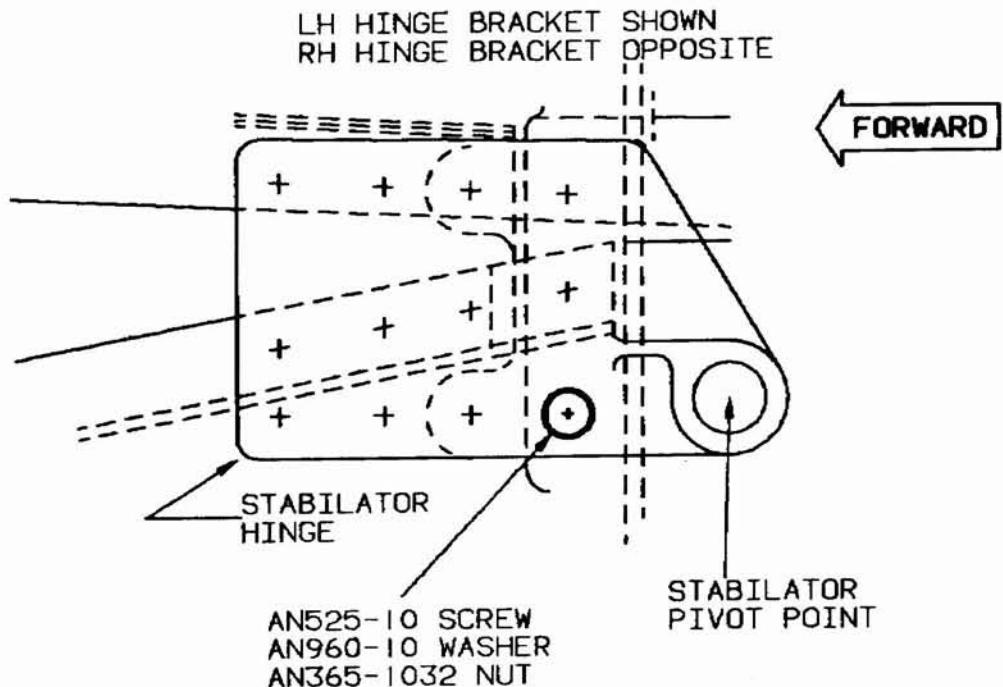
1. Refer to Figure 1 and visually inspect both the LH and RH stabilator hinges, at the fuselage attach point, for broken, loose or working rivets as follows:
 - a. Inspect for cracks in paint around the circumference of a rivet head.
 - b. Inspect for black discoloration which appears as residue working out from beneath the rivet head.
 - c. Inspect for any gap between the rivet head and airplane skin.
2. If none of the above conditions exist and the LH and RH stabilator hinges appear to be in a normal and secure configuration, no further action is necessary at this time.
3. If any rivet on either the LH or RH stabilator hinges is found to be working, all rivets on both hinges must be replaced with P/N MS20470AD-5 or -4 (as appropriate) rivets of the appropriate length for material thickness.

INSPECT ALL STABILATOR HINGE RIVETS FOR CONDITION AND SECURITY
Figure 1

4. Refer to the Shop Manual and remove the stabilator.

Replace the rivets in horizontal rows (one row at a time) to maintain stabilator hinge/fuselage alignment. See illustration.

5. If an oversize fastener is required, enlarge the hole as required to accept a P/N CR2249-5 or -4 (as appropriate) Cherrylock rivet (NAS1738-5) of the appropriate length for material thickness.
6. If rivet replacement has been accomplished, replace the existing screws, washers and nuts on both the LH and RH stabilator hinges with new P/N AN525-10 screws, new P/N AN960-10 washers and new P/N AN365-1032 nuts.
7. If problems are encountered during the rivet replacement procedure, contact: Beech Aircraft Corporation Commercial Service Department, Phone (316) 681-7265, International TELEX No. 203603.
8. Refer to the Maintenance Manual and reinstall the stabilator.
9. Reinspect the LH and RH stabilator hinges as described in a, b and c above at each 100 service hour interval (normal category) or each 25 service hour interval (acrobatic category) until further notice.
