AD COMPLIANCE

Aircraft Make *SGS* Model *1-26 F* Reg. No. *N33917* Serial No. *637*

PUBLICATION INDEX

SCHWEIZER SAILPLANES

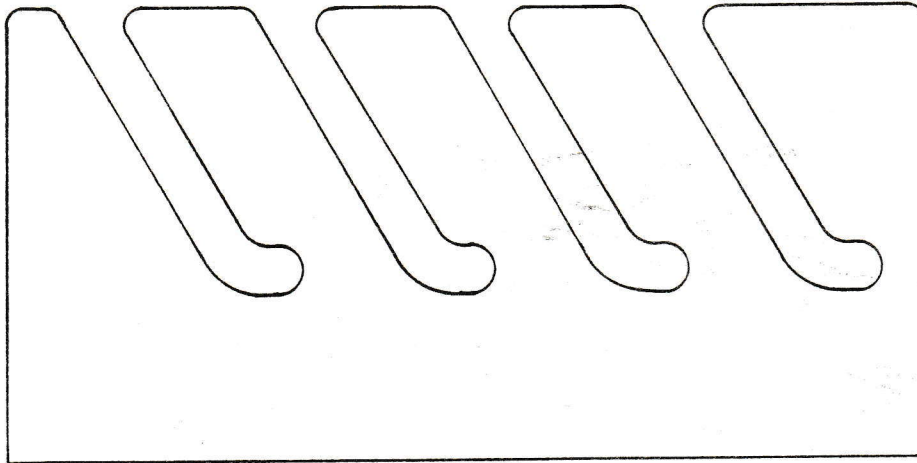
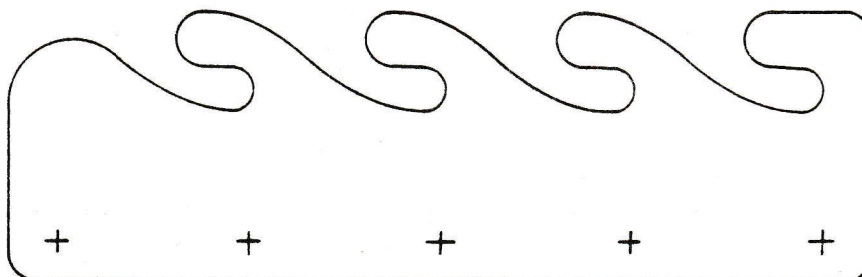
SEAT ADJUSTMENT BRACKET

PREFACE: Reports indicate that on the affected aircraft, the pilot's seat back could inadvertently slide back during tow, when experiencing turbulence or during certain flight attitudes where a negative g condition may exist.

- Drill out rivets securing existing seat adjustment brackets. Remove brackets.
- Clean up bracket mount area removing any burrs and sharp edges.
- Paint bracket mount areas with a thin coat of Zinc Chromate or equivalent primer to prevent corrosion.
- Place the spacer between the inside fuselage wall and the lower edge of bracket.
- Mark the mount area and drill holes as per old bracket using a #30 drill bit and secure with Cleco.
- Install rivets (MS20426AD4) (5) places on each bracket and spacer kit.
- Paint exterior of rivet heads.
- Record compliance with this service bulletin in the aircraft log book.

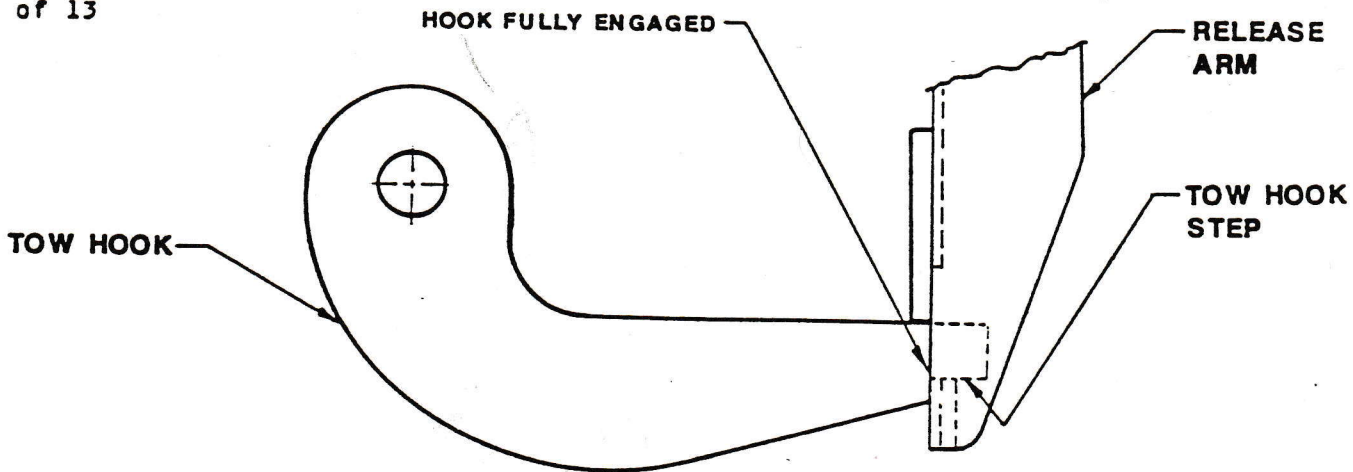
VIEW A. PROPER ENGAGEMENT

- Proper engagement of the tow hook into the release arm is shown in Figure 1, View A and Figure 4. Excessive wear of the tow hook step could result in improper engagement. Figure 2 of this bulletin provides inspection data and wear limits for the tow hook. Tow hooks which do not meet the specified limits must either be reworked to obtain dimensions (as specified in Figure 2) or replaced.
- If tow hook is able to slide into the release arm, beyond the tow hook step, as shown by Figure 1, View C, the release arm must either be reworked with a slug as specified in Figure 3, or replaced.

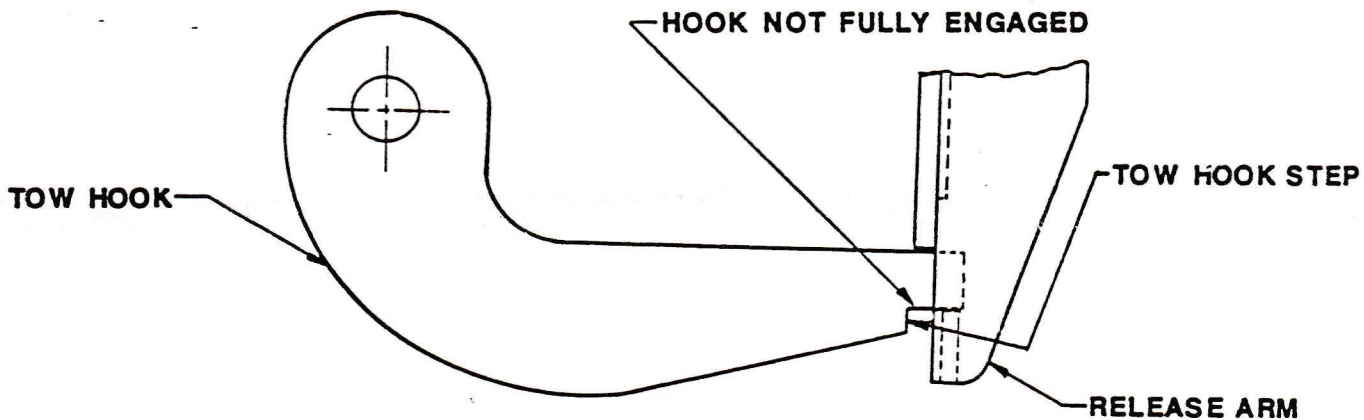
VIEW B. IMPROPER ENGAGEMENT

IF TOW HOOK IS ABLE TO SLIDE THROUGH RELEASE ARM, BEYOND THE TOW HOOK STEP, THE RELEASE ARM MUST EITHER BE REWORKED IN ACCORDANCE WITH FIGURE 3, OR REPLACED.

- d. If tow hook dimensions are not within limits specified in Figure 2, either rework the tow hook to obtain dimensions (as specified in Figure 2) or replace it with a new or serviceable, used tow hook.
- e. Engage tow hook into release arm. Ensure that the tow hook engages properly as shown in Figure 1, View A.
- f. If tow hook is unable to completely engage (shown by Figure 1, View B), shorten the rubber bumper stop between the release knob and the instrument panel to allow the release assembly to close further.

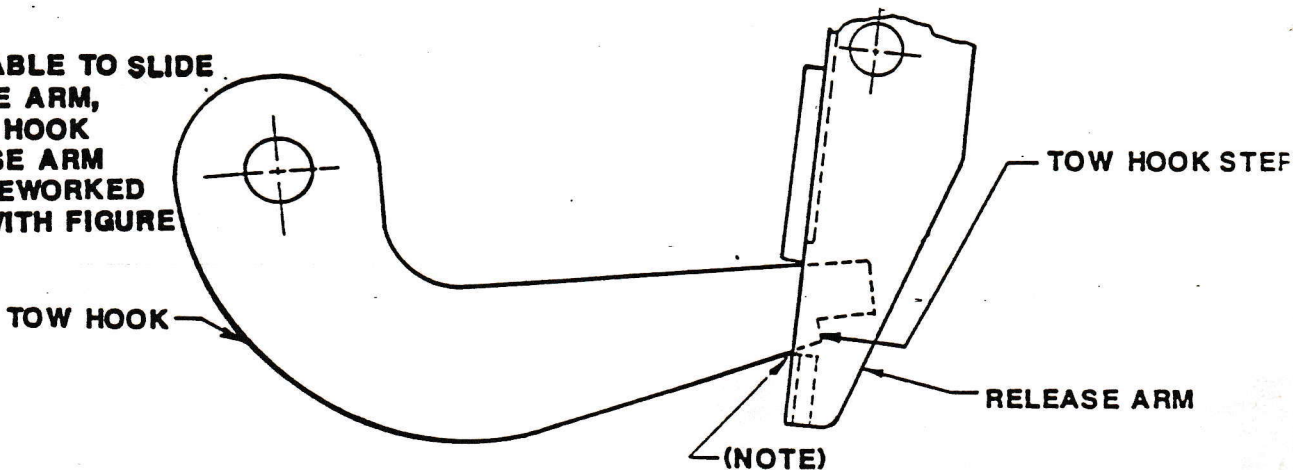
VIEW C. IMPROPER ENGAGEMENT

- g. If tow hook is able to travel too far inboard as shown in Figure 1, View C, disengage tow hook from release arm and measure the length of the release arm slot.
- h. If dimension is less than 0.66 inch, rework release arm by welding on 1B-217-19 slug at location shown in Figure 3. (Release arm may be replaced as an alternate to welding on slug.)
- i. If length of release arm slot is greater than 0.66 inch, replace release arm.
- j. Perform a thorough inspection of the tow hook installation in accordance with the 100 hour inspection requirements listed in Table 2 of this bulletin.
- k. Repair or replace unserviceable component(s), as required.
- l. Record compliance with Part I of this Service Bulletin in Aircraft Log Book.

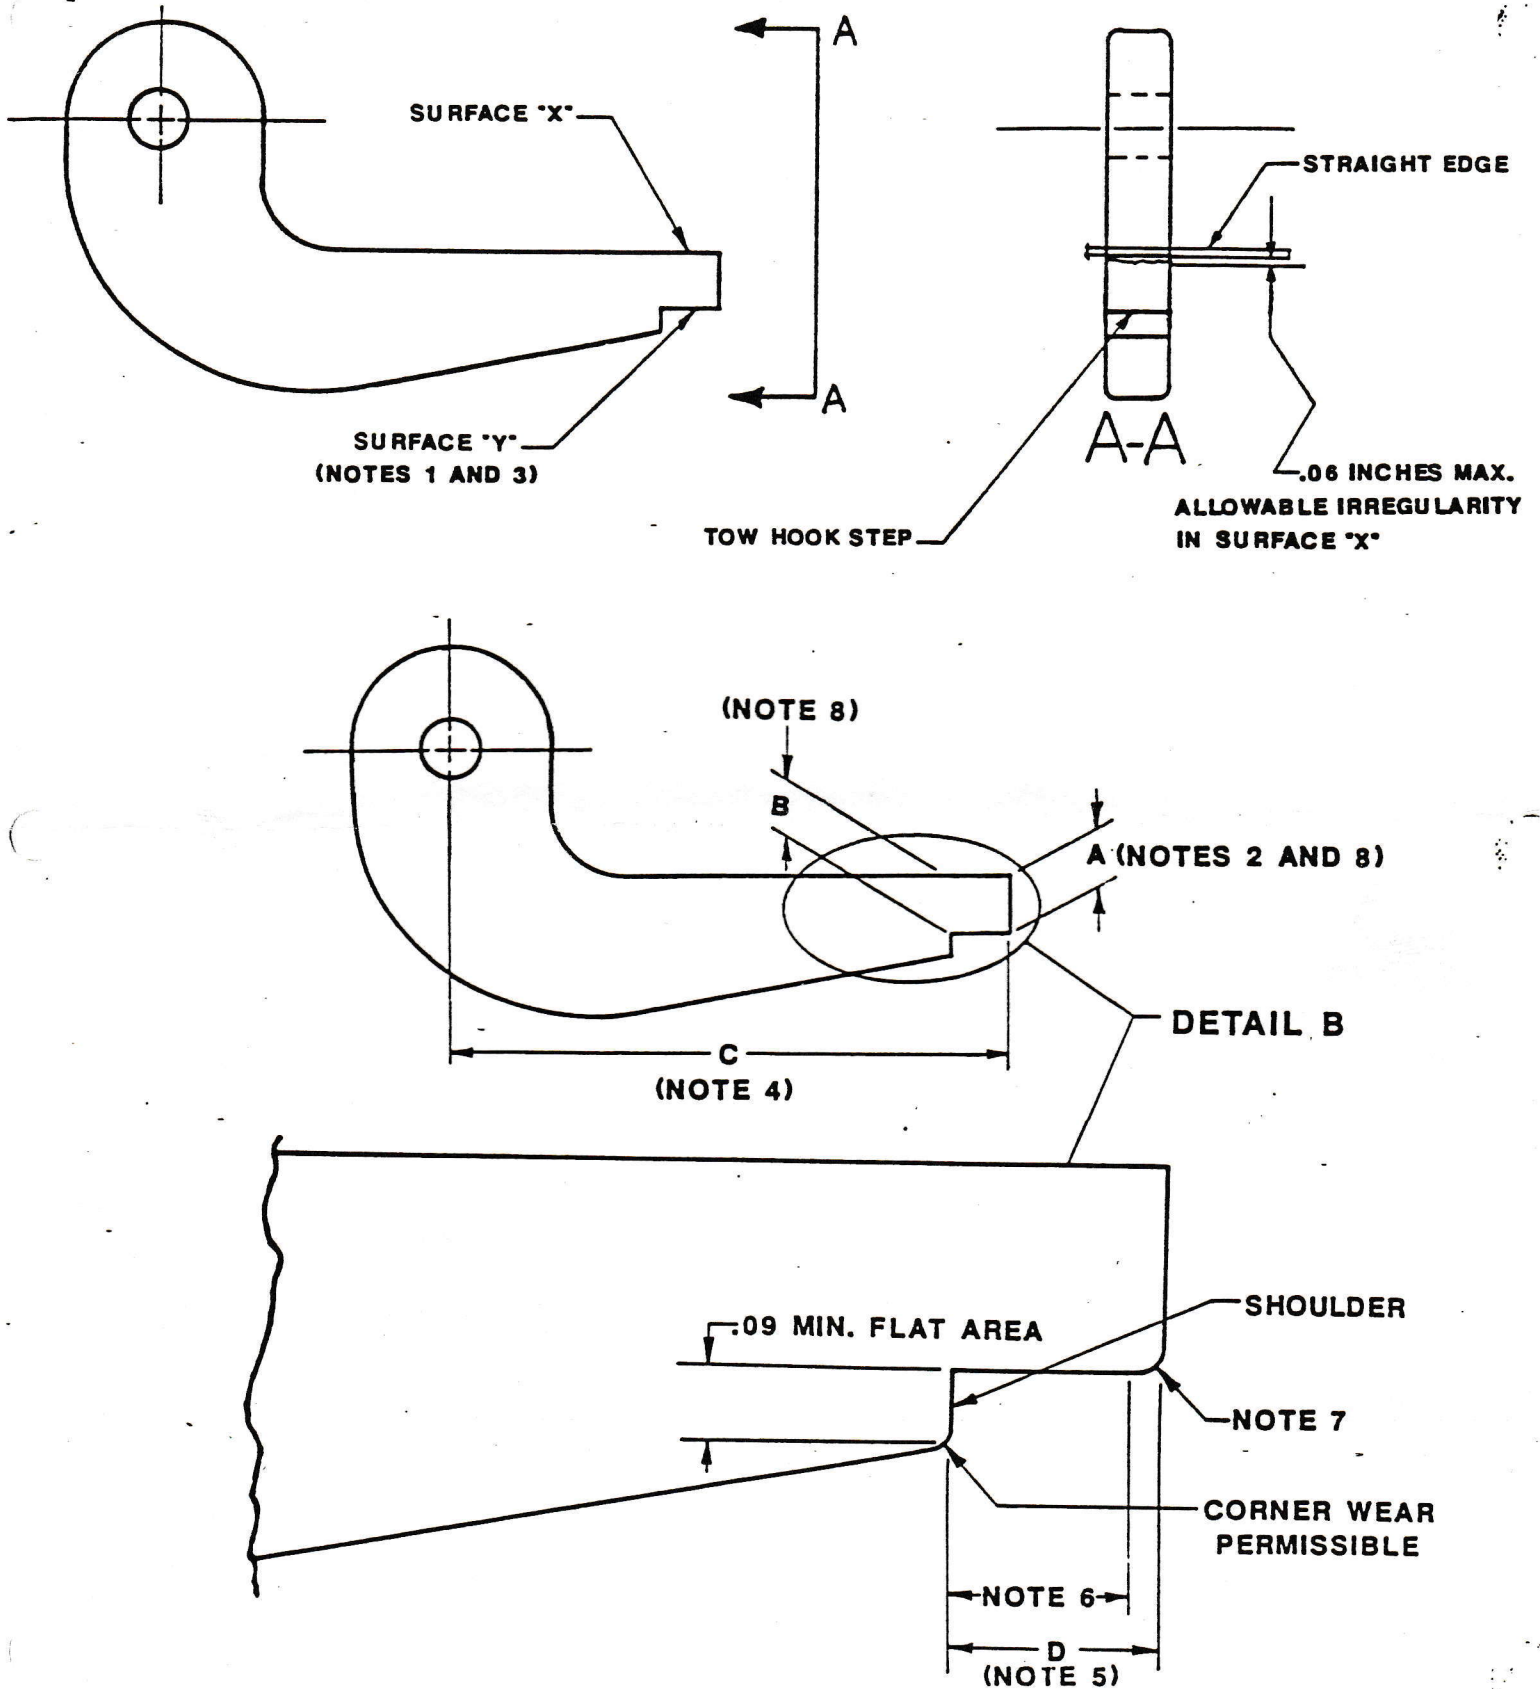
FIGURE 2. TOW HOOK INSPECTION AND REWORK (SHEET 1 OF 2)

1. IF WEAR OCCURS ON SURFACE "Y" IT MUST BE POLISHED FLAT WITHIN TOLERANCES PROVIDED IN FIGURE 2 (SHEET 1). IF THE HOOK CANNOT MEET THESE REQUIRED DIMENSIONS IT MUST BE REPLACED. UNDER NO CONDITIONS SHOULD SURFACE "X" BE POLISHED OR MACHINED TO CHANGE ITS ANGLE.

5. DIMENSION "D" SHALL BE $.31 \pm .03$ INCHES.
6. HOOK MUST REMAIN FLAT IN THIS AREA FOR A MIN. OF .21 INCHES FROM SHOULDER OF HOOK.
7. WEAR OUTSIDE OF THE .21 MIN. FLAT AREA IS PERMISSIBLE.

8. DIMENSION "B" MUST BE EQUAL TO DIMENSION "A", OR LESS THAN DIMENSION "A" BY NO MORE THAN .015 INCHES AND CANNOT BE GREATER THAN DIMENSION "A".
9. ALL SURFACES EXCEPT SURFACE 'X' MAY BE FILED TO OBTAIN REQUIRED DIMENSIONS.

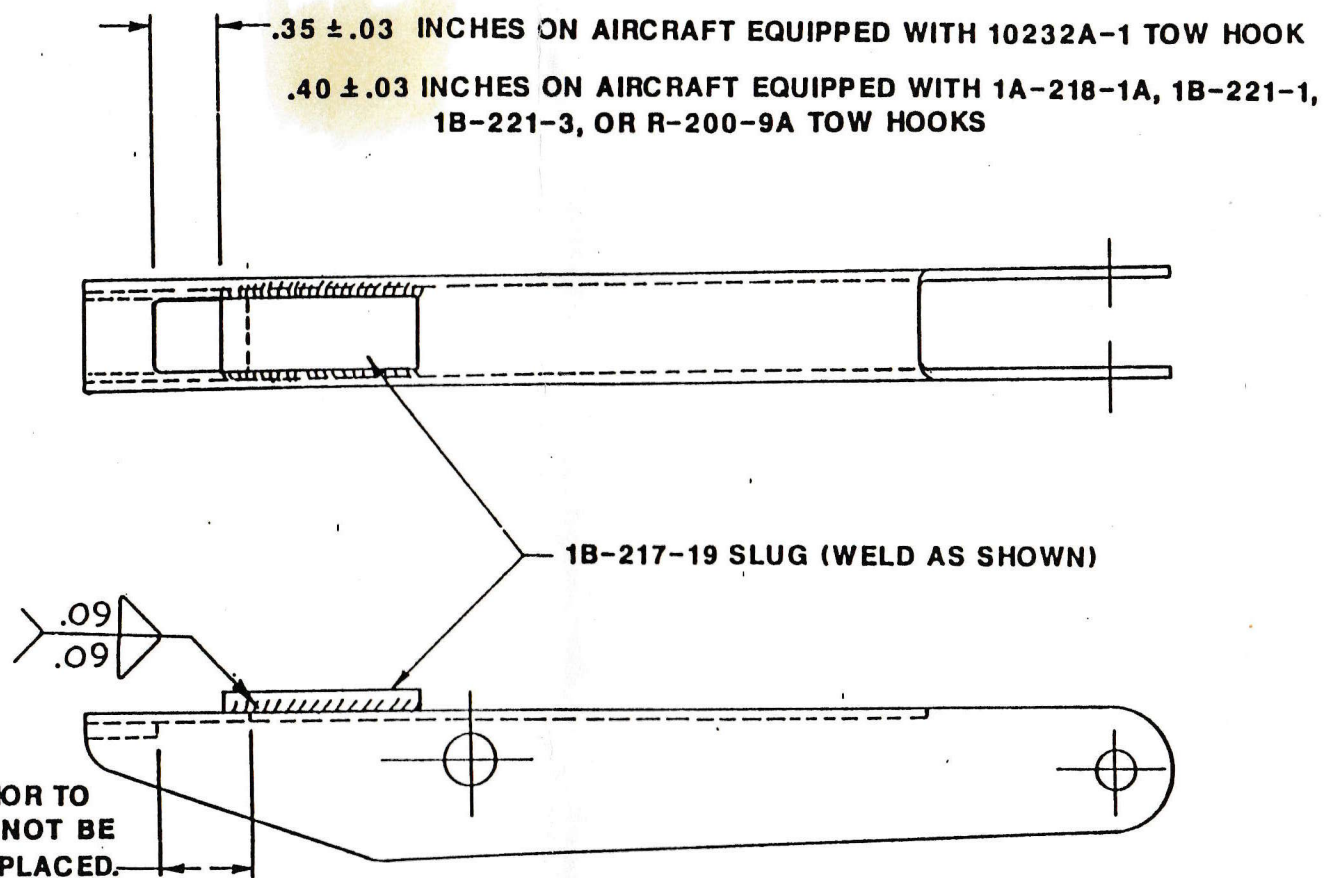
FIGURE 3. REWORK OF RELEASE ARM

NOTE: ALL TOW RELEASE ARMS MUST BE REWORKED AS SHOWN
ABOVE OR REPLACED WITH THE PROPER SUPERSEDING ARM
AS SPECIFIED IN TABLE 1.

NOTE: 1B-217-19 SLUG IS AVAILABLE FROM SCHWEIZER AIRCRAFT CORP.
0.125 X 0.5 X 1.0 4130N STEEL

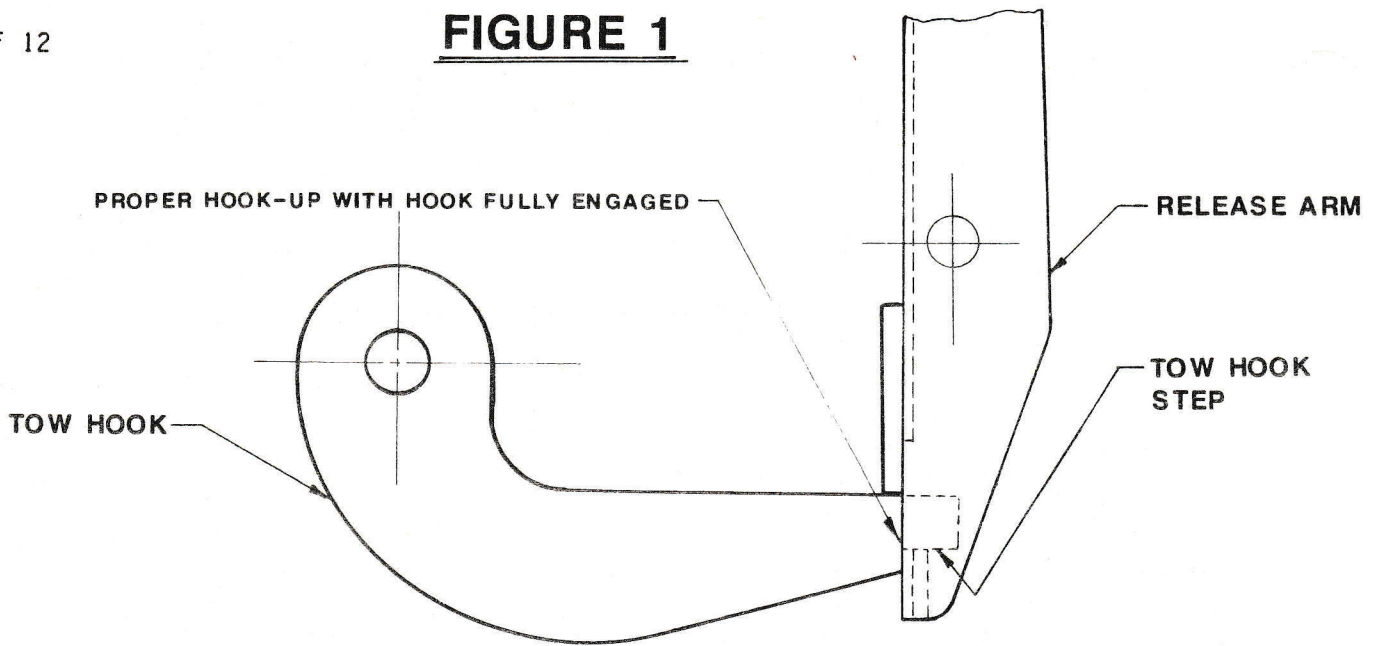
A. CORRECT HOOK-UP

Figure 1 shows the positions for the tow hook and release arm when correctly hooked-up. Note that the step of the tow hook should be tight against the release arm assembly. The tow hook step must fully engage the release arm to allow the release assembly to work properly. The tow hook must not be allowed to extend through the release arm beyond the step on the hook since this creates a condition which defeats the design of the release and increases the possibility of an inadvertent release.

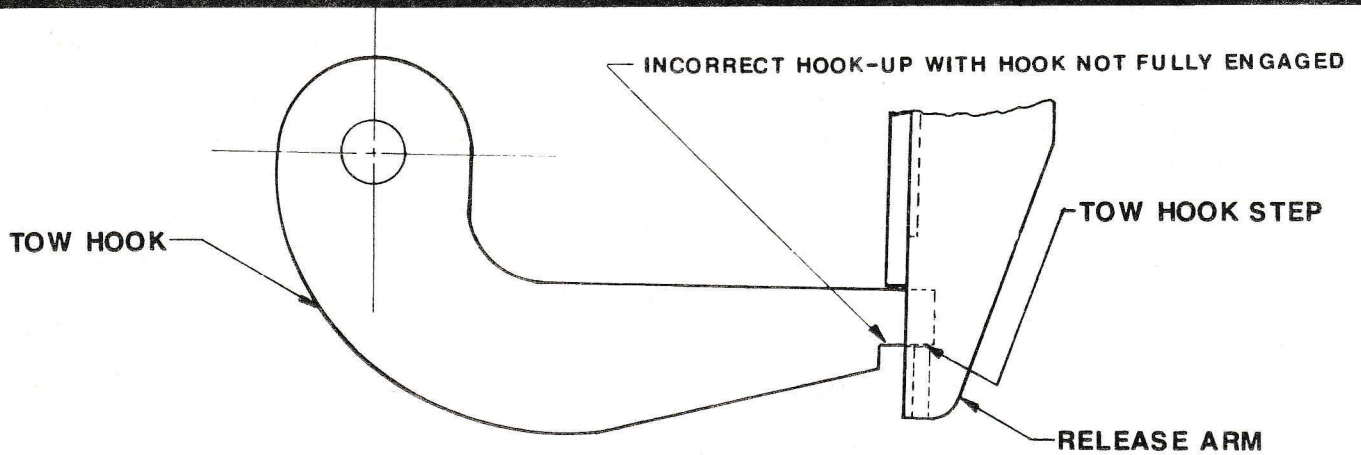
B. INCORRECT HOOK-UP

If tow hook fails to engage completely as shown in Figure 1B, check release control rigging. Shortening the rubber bumper stop between the release knob and instrument panel will allow the release assembly to close further.

IF TOW HOOK CAN EXTEND THROUGH THE TOW RELEASE ARM AS SHOWN, RELEASE ARM AND POSSIBLY TOW HOOK MUST BE REPLACED.

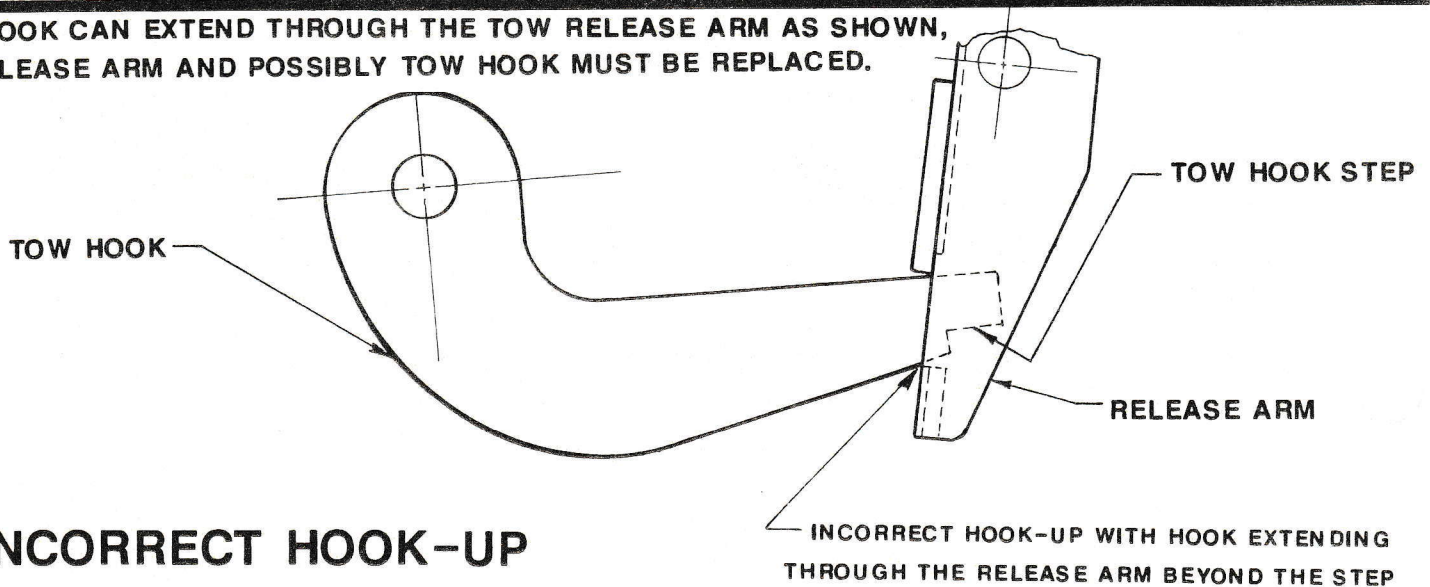
C. INCORRECT HOOK-UP

Tow hook must engage release arm in accordance with Figure 1A & Figure 4. If hook is able to pass through release arm beyond step as shown in Figure 1C, release arm and/or hook must be reworked with slug or replaced.

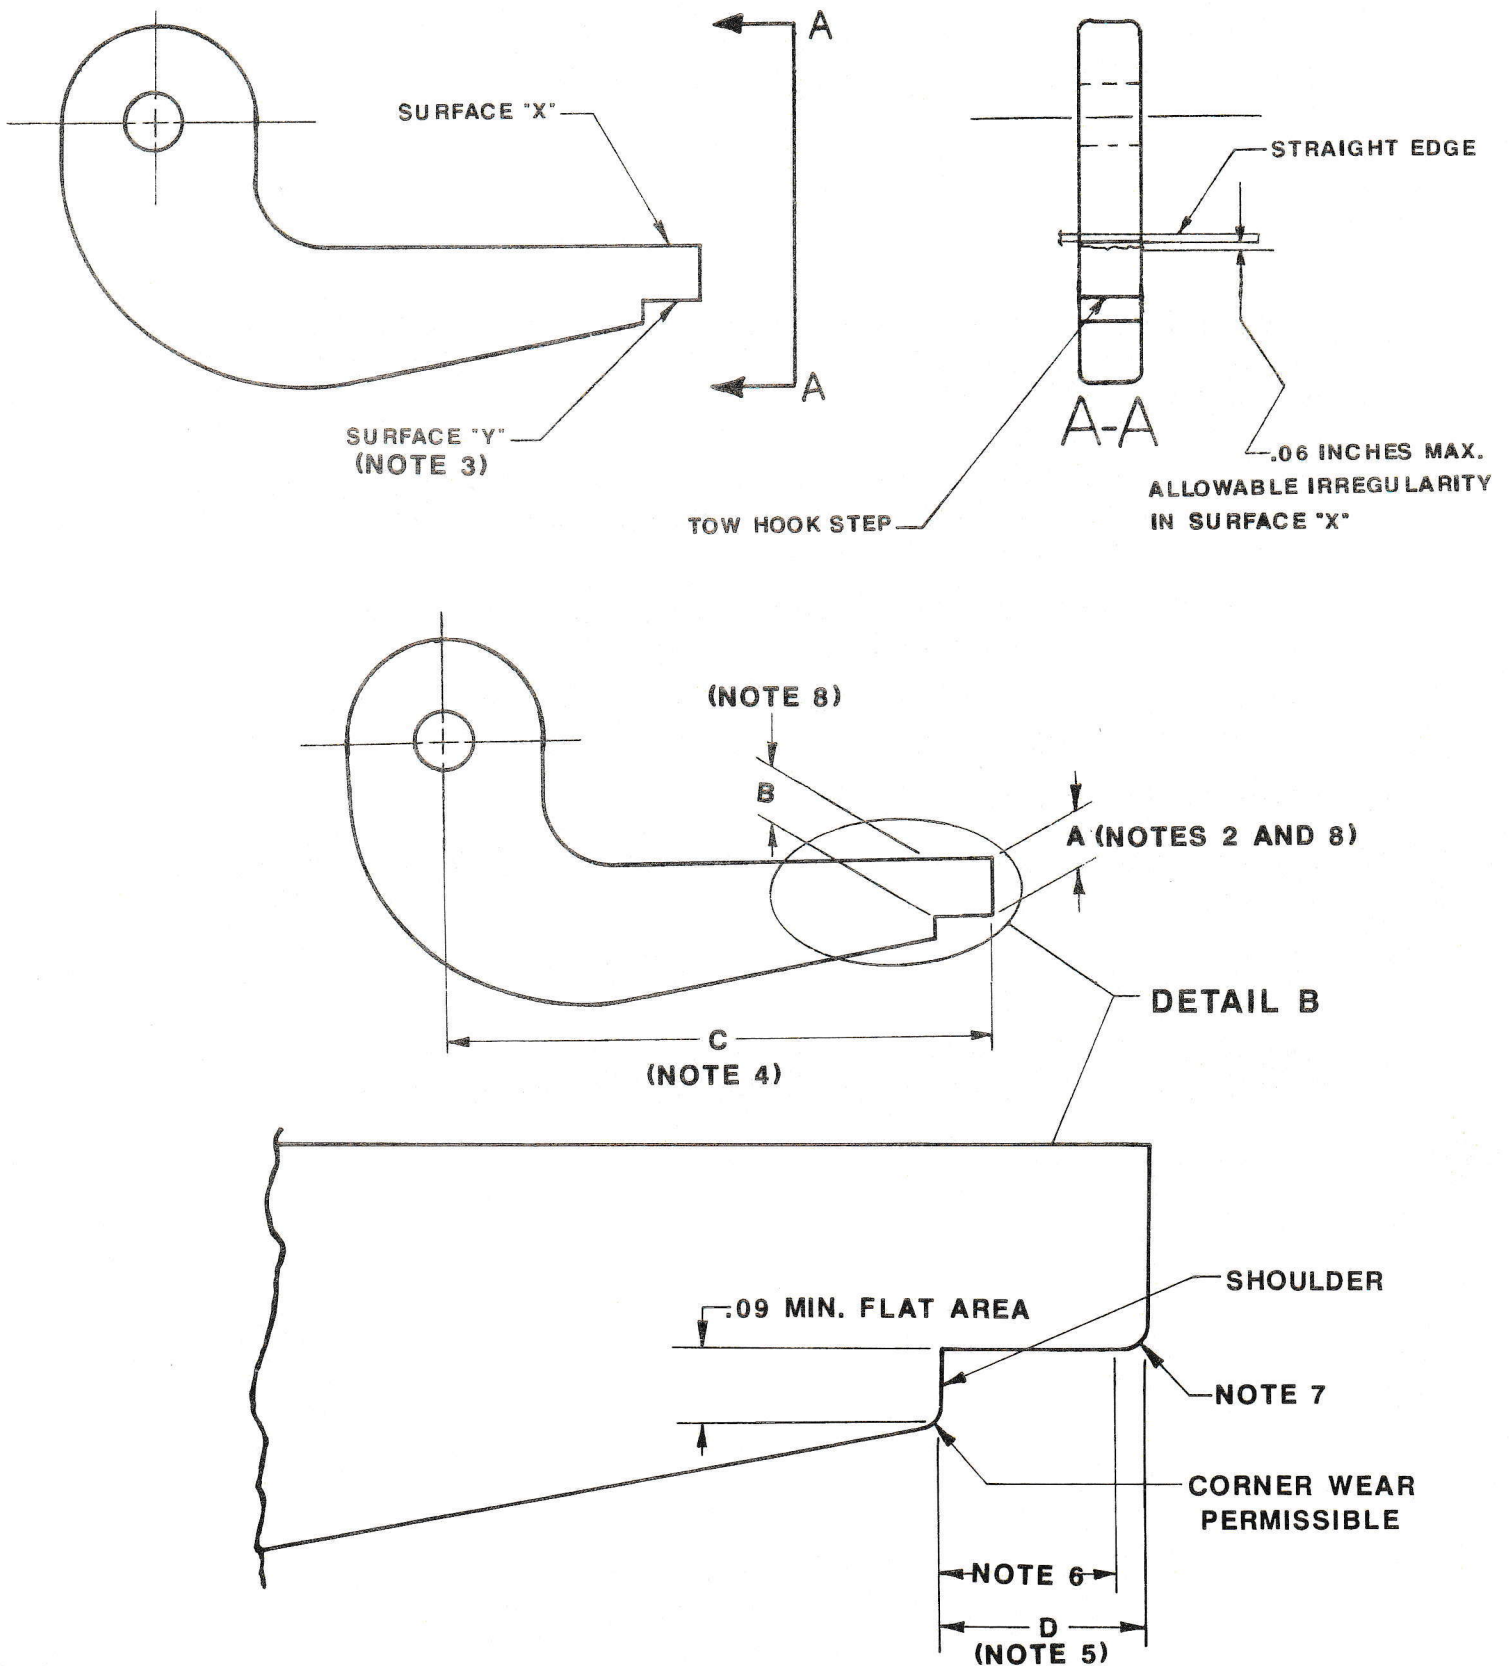
FIGURE 2. TOW HOOK INSPECTION AND REWORK (SHEET 1 OF 2)

- B. Wear of the tow hook step will cause improper engagement of the hook and release. The tow hook must be inspected in accordance with Figure 2. Any tow hook which does not meet the minimum specified dimensions, after inspection and/or rework, as listed in Figure 2 must be replaced.

1. IF WEAR OCCURS ON SURFACE "Y" IT MUST BE POLISHED FLAT WITHIN TOLERANCES PROVIDED IN FIGURE 2 (SHEET 1). IF THE HOOK CANNOT MEET THESE REQUIRED DIMENSIONS IT MUST BE REPLACED. UNDER NO CONDITIONS SHOULD SURFACE "X" BE POLISHED OR MACHINED TO CHANGE ITS ANGLE.

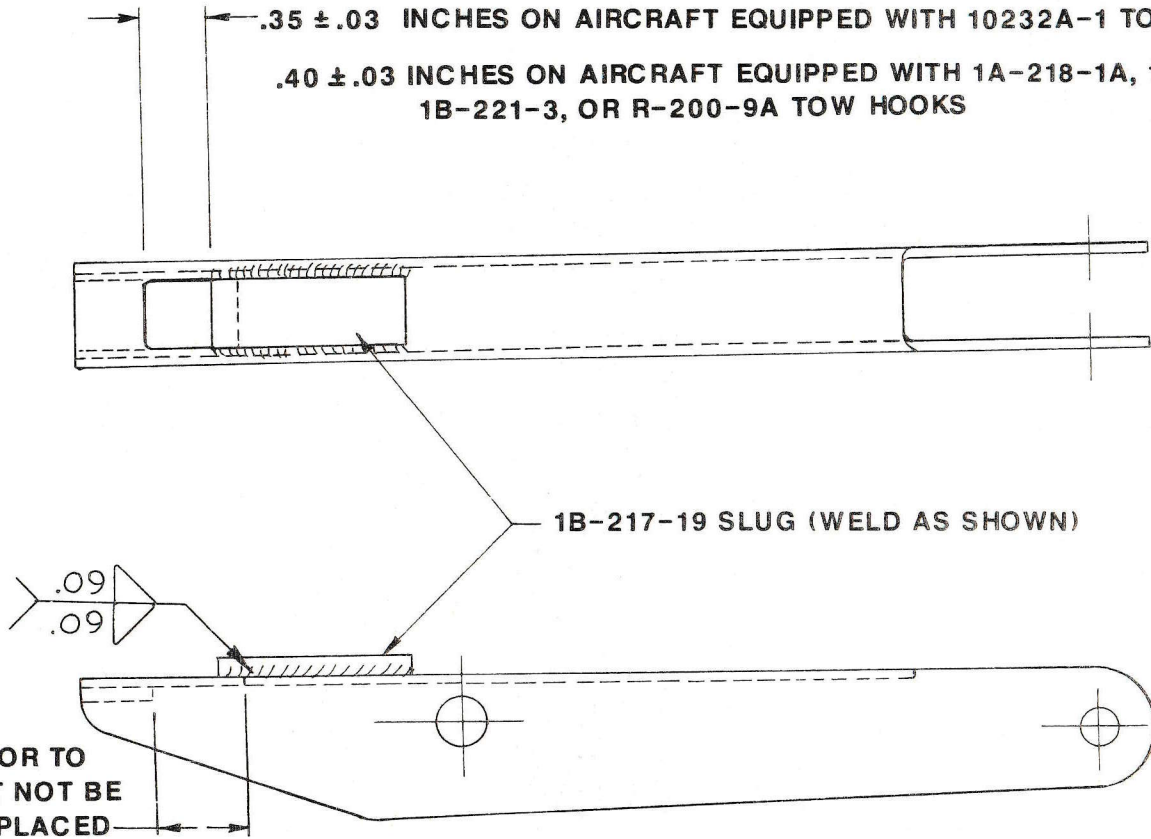
FIGURE 3
REWORK OF RELEASE ARM

IF THIS DIMENSION IS
.66 INCHES OR GREATER PRIOR TO
REWORK THE RELEASE MUST NOT BE
REWORKED AND MUST BE REPLACED

- C. All tow release arms must be reworked in accordance with Figure 3 or replaced with a new superseding Schweizer release arm as listed in Table 1. If the release arm wear exceeds the dimensions given in Figure 3, rework is NOT allowed and replacement is MANDATORY.
- D. Perform complete inspection in accordance with Item 4 of this bulletin.

NOTICE...ALL TOW RELEASE ARMS MUST BE REWORKED AS SHOWN
ABOVE OR REPLACED WITH THE PROPER SUPERSEDING
UNIT PER TABLE 1

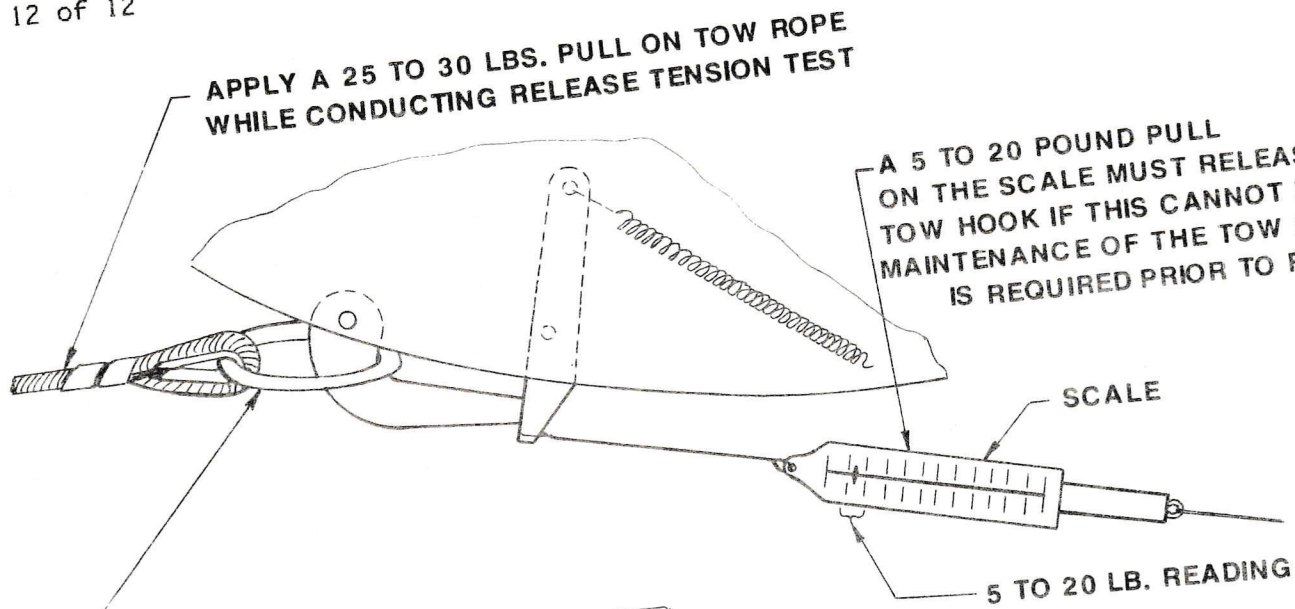
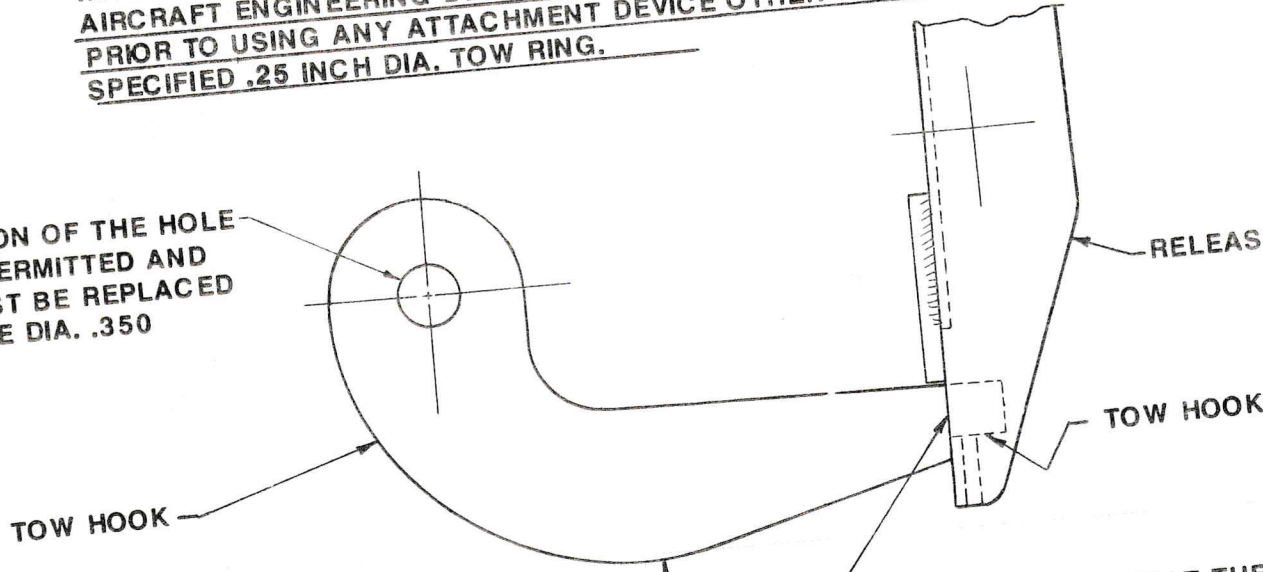
SCHWEIZER TOW RELEASES ARE DESIGNED TO OPERATE WITH A .25 INCH DIA. TOW RING. CHECK WITH SCHWEIZER AIRCRAFT ENGINEERING DEPARTMENT FOR WRITTEN APPROVAL PRIOR TO USING ANY ATTACHMENT DEVICE OTHER THAN THE SPECIFIED .25 INCH DIA. TOW RING.

ELONGATION OF THE HOLE IS NOT PERMITTED AND HOOK MUST BE REPLACED MAX. HOLE DIA. .350

ANY ROUGH EDGES MUST BE POLISHED SMOOTH AND BLENDED WITH EXISTING CONTOUR

CHECK TO INSURE THAT THE CANNOT PASS THROUGH THE RELEASE ARM BEYOND THE ON THE HOOK

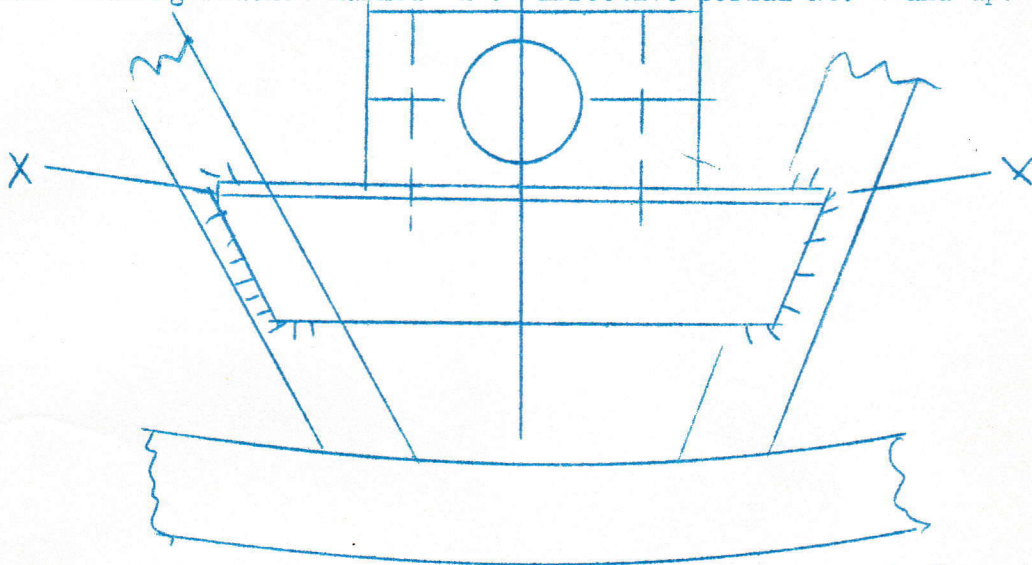
We have a field report of a weld failure at the forward Control Torque Tube Bearing Bracket marked "X". Effective Serial No. 2 and up.

While we believe this to be an isolated case, we feel that this point should be checked before flight by all owners. It is readily accessible for inspection. If any cracks are found, please advise us.

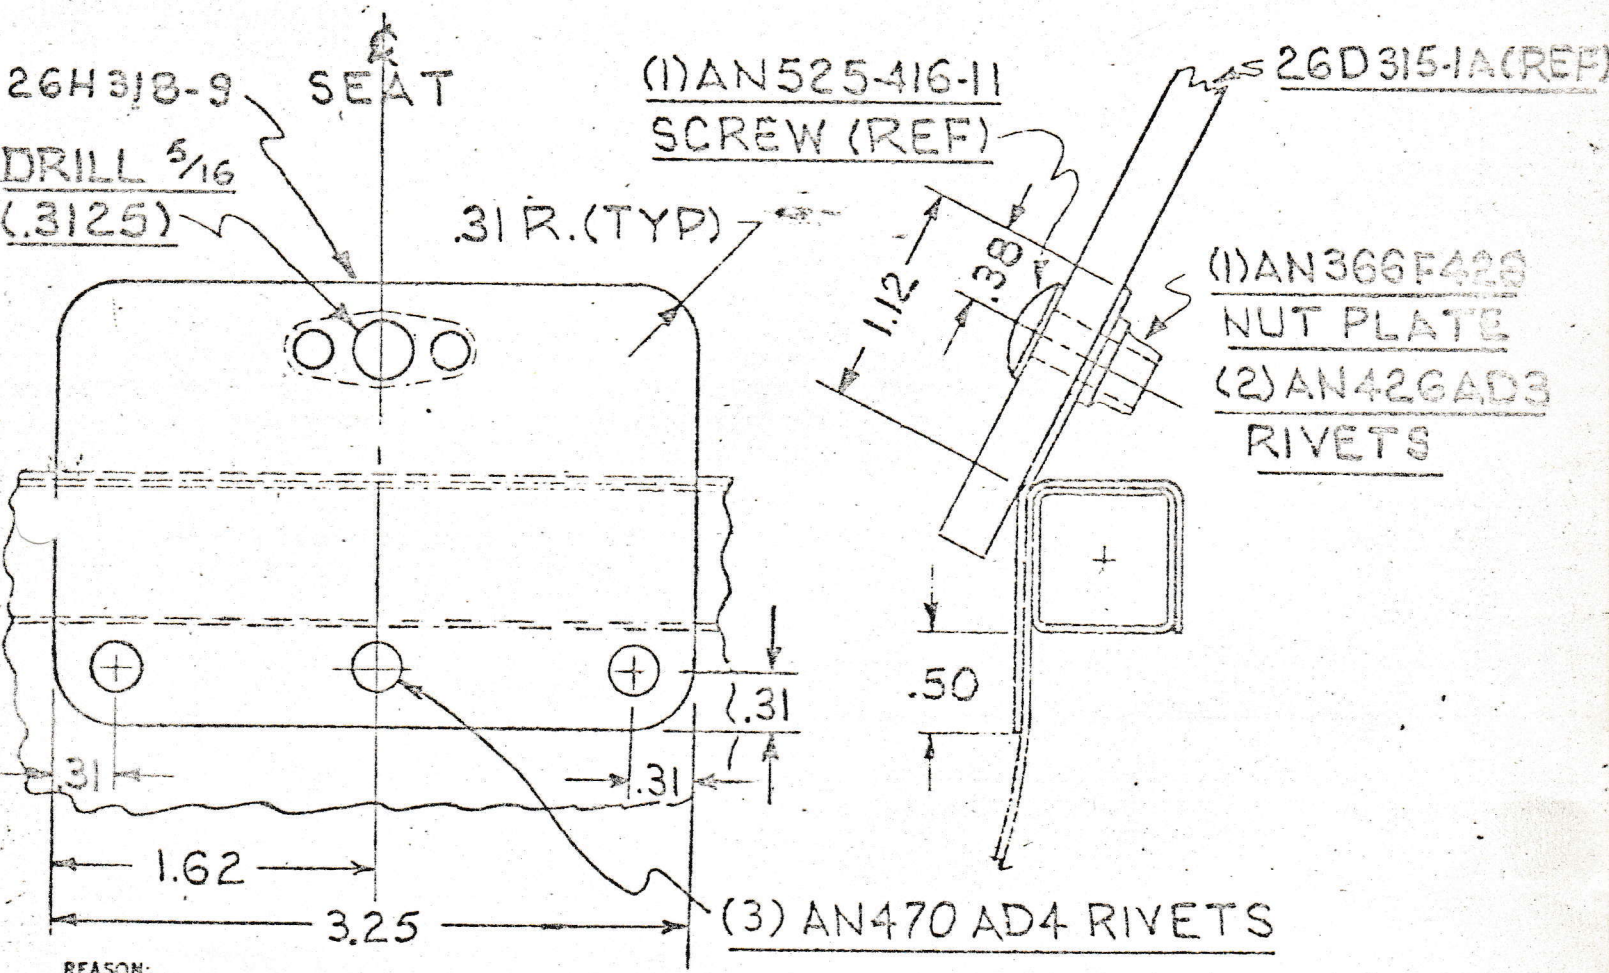
I. TO PROVIDE ADDITIONAL ATTACHMENT FOR SEAT BACK.

CHANGE: I. ADD ATTACH PLATE TO SEAT AS SHN.
 MAKE FROM .040 2024-T3 ALC

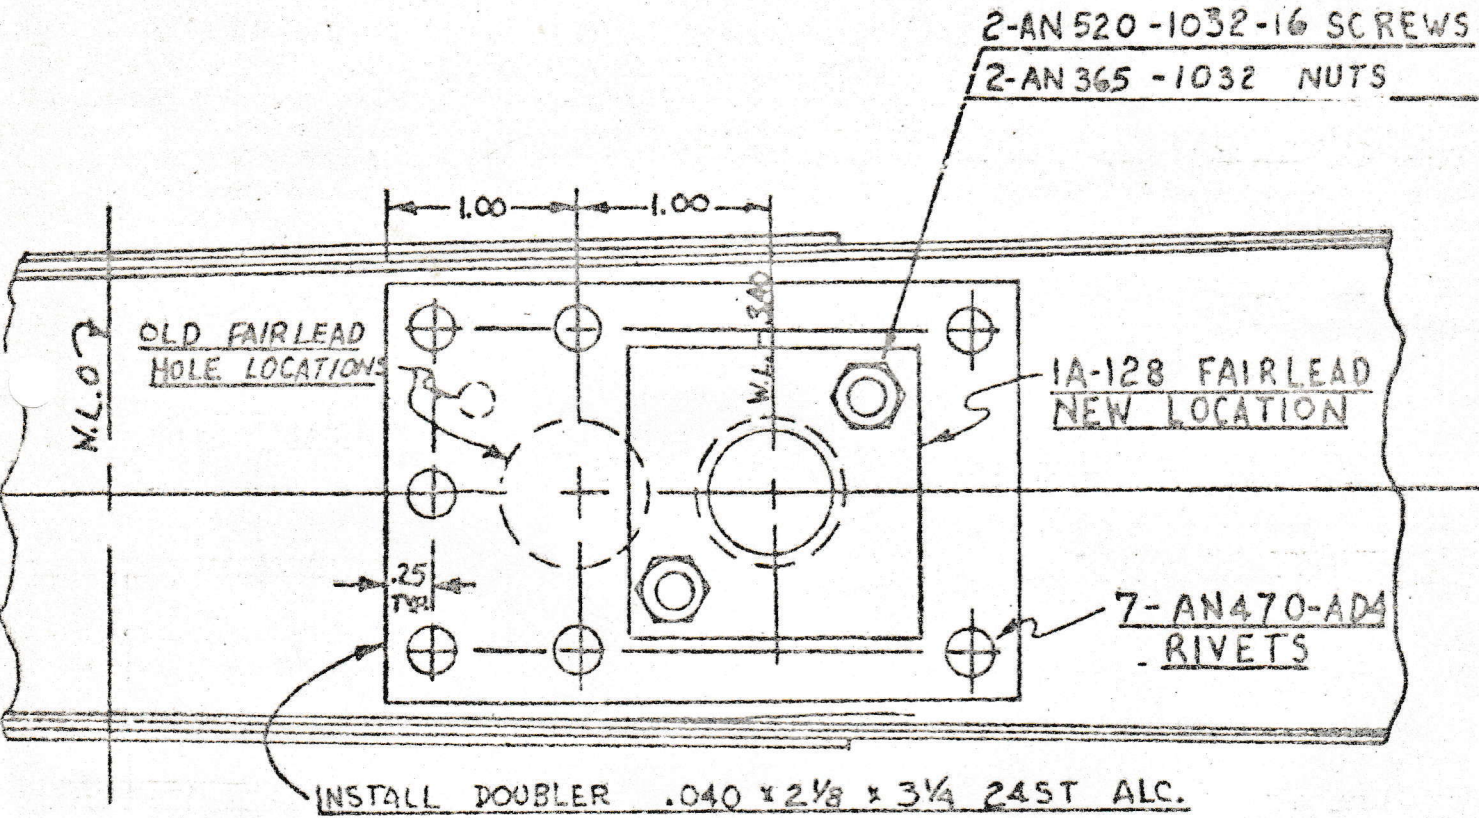
A condition has been discovered which could cause excessive wear on the 26B120-2A Elevator Control Cable at the 1A-128 Fairlead on the Fin Spar. This wear would be induced by the location of the 1A-128 Fairlead at W.L.--2.40. This condition exists on all ships to and including Ship No. 75.

The condition noted may be eliminated by relocation of the 1A-128 Fairlead to W.L. 3.40 according to the attached sketch. Material kits for this work are available upon request.

We recommend the accomplishment of this relocation at the earliest convenience and thorough inspection of the area and parts for indications of wear, each 25 hours until the relocation is made.

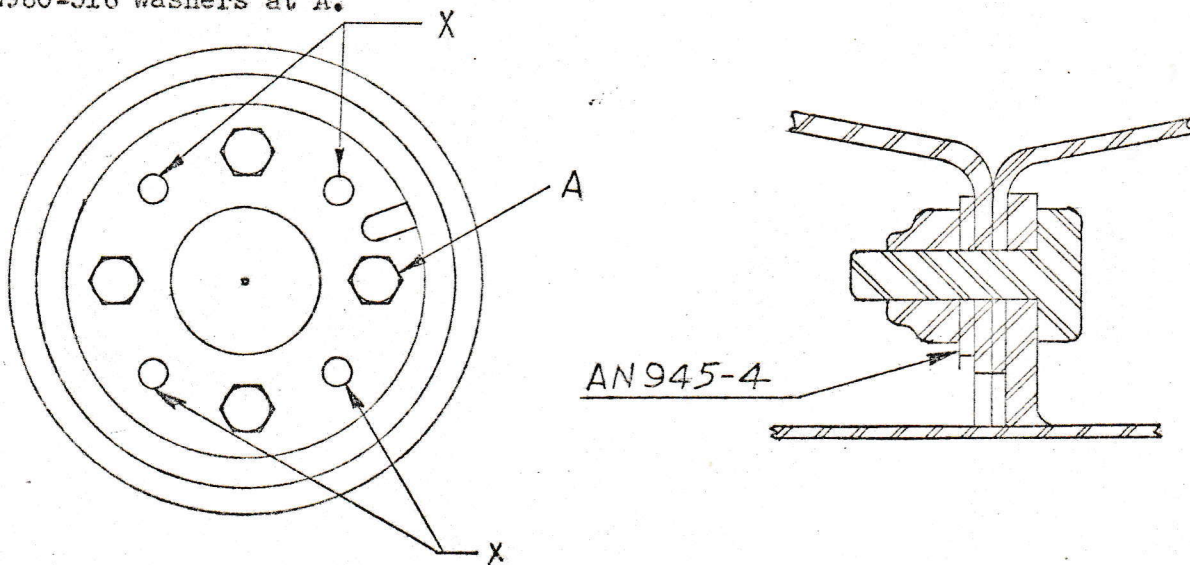
A few failures have occurred in the field to the 1-26 Wheel Assembly-- 26B201. This failure has occurred in the stamped flange at the edge of the bolt heads. To eliminate this condition, the following procedure should be used. This is not a safety of flight item, but it will eliminate the possibility of a wheel failure. The change is being incorporated in new production 1-26 sailplanes.

Procedure: Take the wheel assembly out of the ship and drill thru the four holes at X that do not have bolts with a 5/16" drill, install an AN 5-6A bolt, AN945 washer, and AN365-524 nut. Then remove the original four bolts and reinstall with AN945-4 washers. Note that all bolts will be installed with the washer between the nut and the wheel flange. (See sketch below). The one bolt next to the valve stem does not have room for the AN945 washer. On this bolt use one of the existing AN960-516 washers at A.

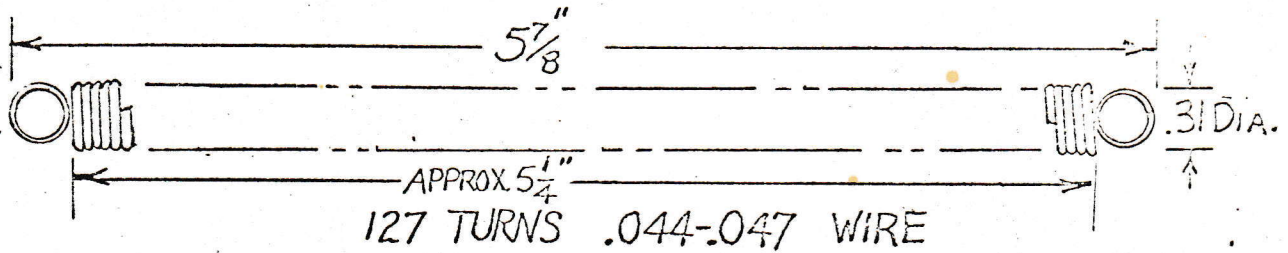
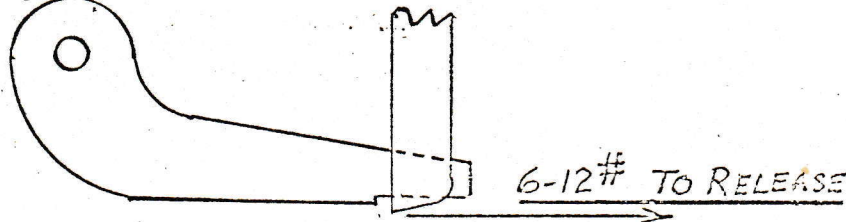
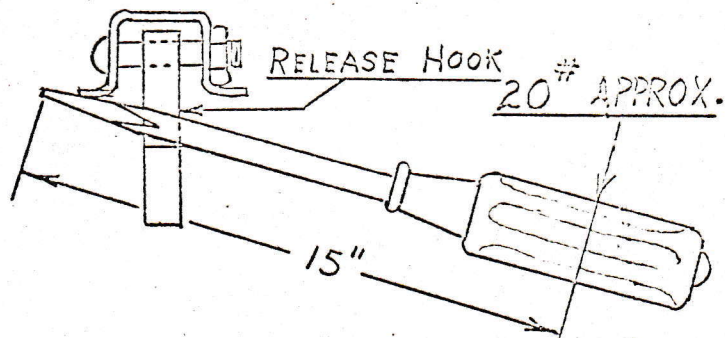
- There are three alternate springs used in the 1-26 tow release mechanism. From field reports from owners, it appears there are cases of excessively high release operating loads. We have run tests and have determined that the best spring is our No. 1A113-1 shown below.

All 1-26's should be equipped with this spring. The installation should be checked by pulling on the release arm just below the hook with a small spring scale. This should require from 6-12 lbs. pressure to release. (See note on page 2).

The force required at the release control should be moderate. Check your control system if you feel the operating force is excessive. An additional check which is used at the factory is to operate the release while load is applied at the hook. This is done by applying pressure with a large screw driver or small bar (see sketch). Pilot should be able to release under this condition--it will, however, take more force.
