SUPPORT COMMUNICATION - SERVICE ACTION ADVISORY

Document ID: c00775200

HP Color LaserJet 3000, 3600 and 3800 Printers - Cartridge Lock Replacement Procedure

HP Color LaserJet 3000, 3600, and 3800 Series Printers - Broken Cartridge Lock Emerging Issue

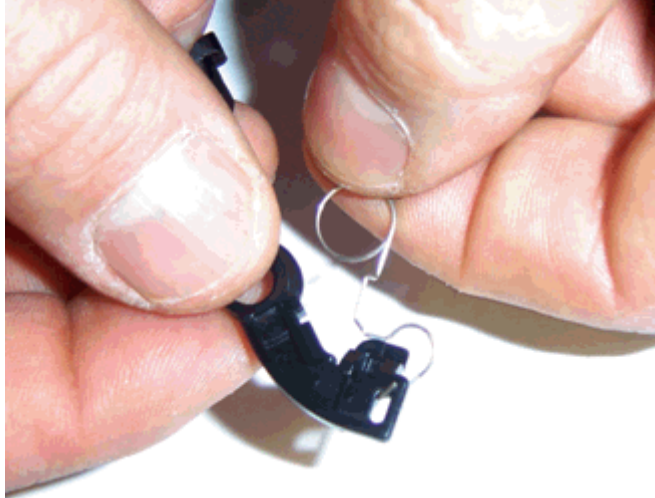
NOTE: The service kit has four new locks and four new springs in it, replace all the locks and springs, even if they are not currently broken. The new kit has white colored countermeasured locks. The picture below shows an old black non-countermeasured lock.

10. Once the sliding lever is removed, the cartridge locks can be accessed. The new grounding springs are not on the new cartridge locks and will need to be attached. Look at the current springs on the machine for guidance, and at the instructions below. Make sure to feed the hooked end through the hole at the end of the lock to begin with (See figure below.).

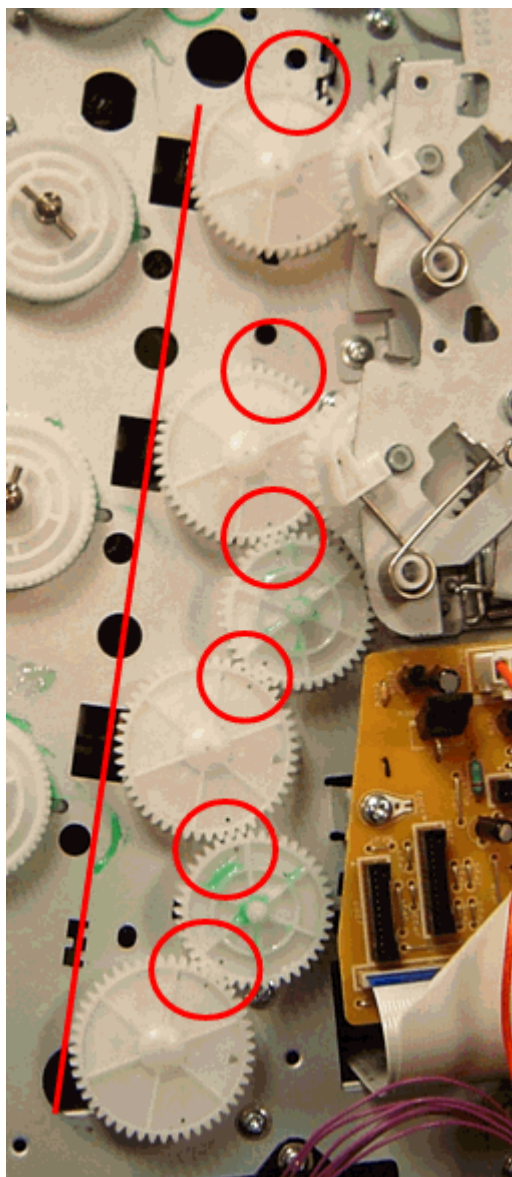
16. Make sure the gears are aligned properly before installing the main drive assembly. The four large gears should be in a approximate line (see picture). The top two large gears have an oval hole that aligns with a triangle stamped into the sheet metal. The two small gears to the right (they may fall off when removing the MDA), align with the three large bottom gears. Notice the two holes on each of the small gears align with the small holes of the large gears.

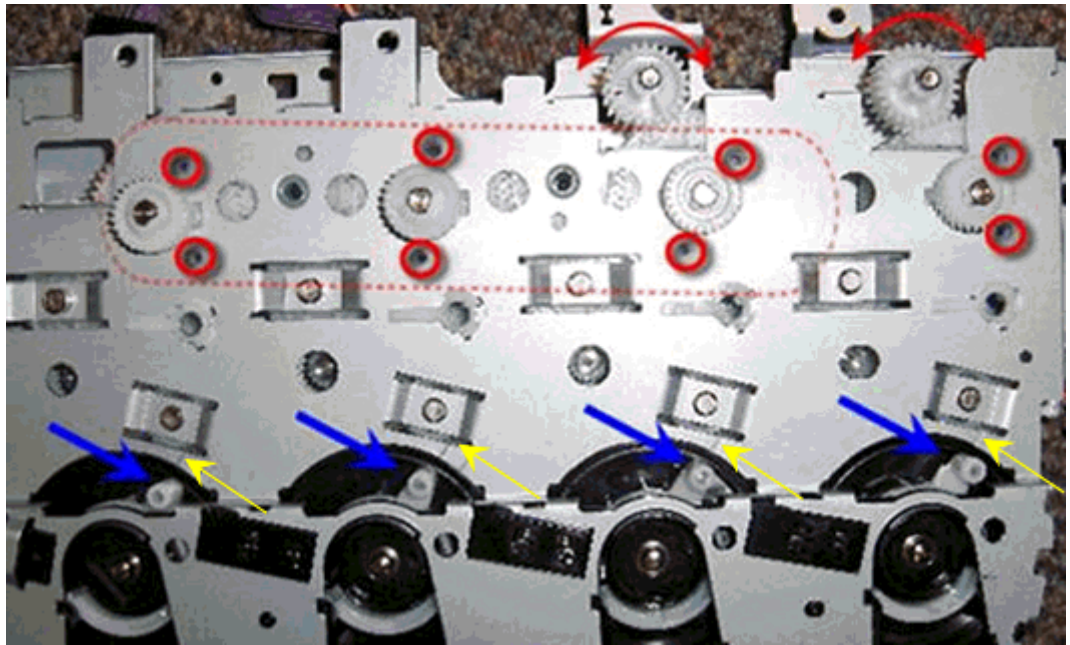
- a. Make sure that all the white shafts are pushed to the right (clockwise) when the MDA is oriented as shown below (See the blue arrows in the image below.). The shafts are aligned correctly in the picture.

Hint: Rotate the shaft all the way to the right side first (as far as possible) then push them back a little to the left they will come to a hard stop. *Leave them there. Look at the lines marks on the metal frame of the MDA (yellow arrows).*

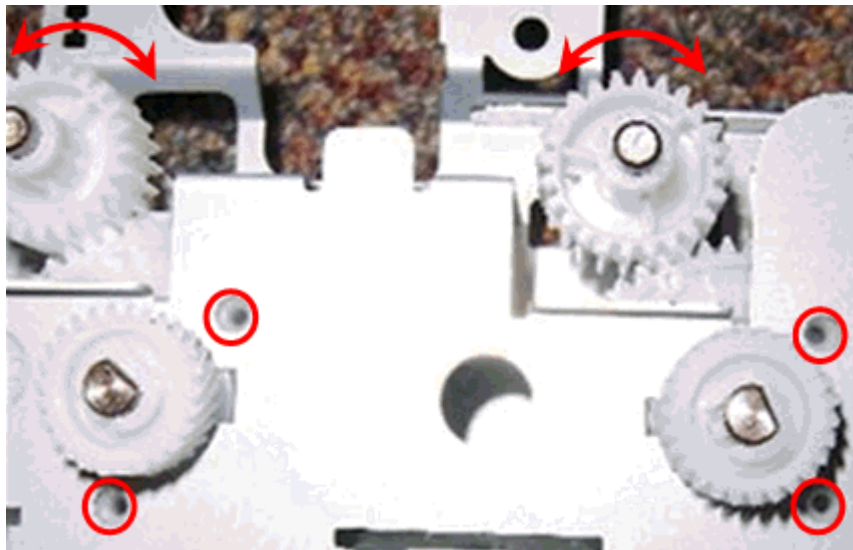
- b. Next, pay attention to the area marked with the two red arrows, enlarged in the picture below. It is possible that during the handling of the MDA one or both of these two gears can be mis-positioned by accident. If this happens, one or more of the color planes could be missed during printing.
- The gear on the right controls the black cartridge; it drives the larger gears to right below it to the right.
 - The gear on the left controls all three of the color cartridges; it drives all the remaining three larger gears, the one directly below it and the two to the left. (Indicated by the dotted oval in the picture above).

Both gears can be rotated either way to properly correct the MDA gears alignment. The images above show how to verify if the gears are correctly aligned. The two

holes from larger gears should both be showing *as illustrated by the red circles* . (The large gears are under the frame and driven by the smaller gears.)

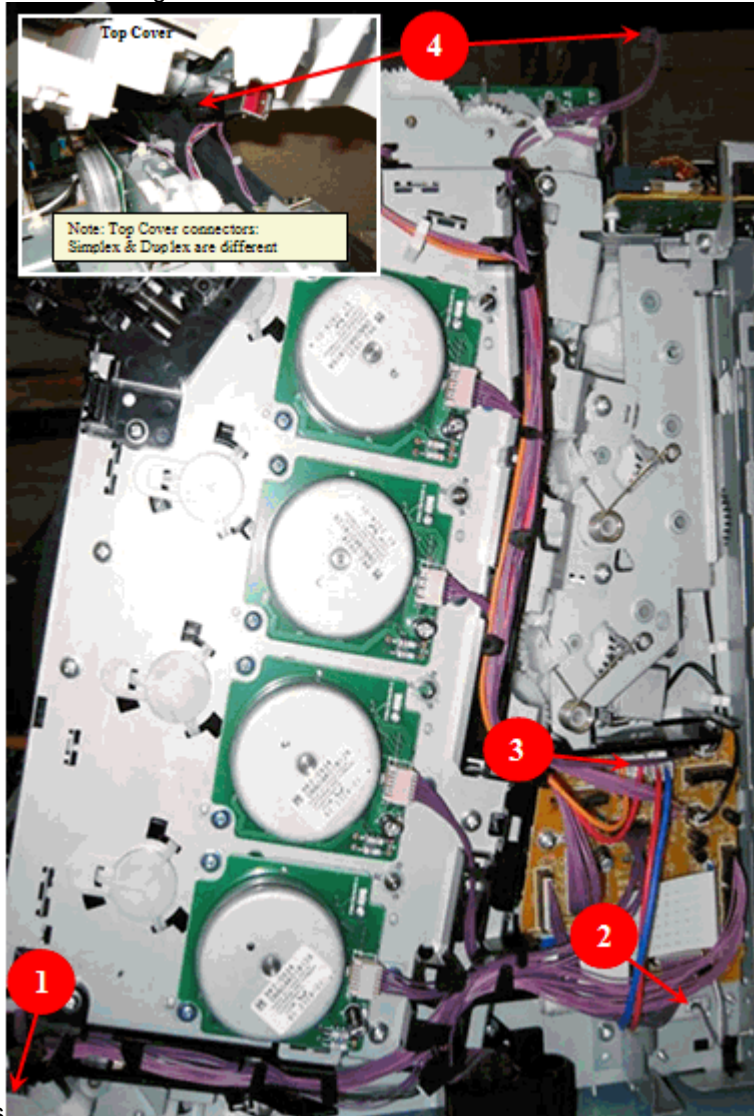
Figure 1: Troubleshooting connection

AISS Main Drive Ass'y (MDA) rework possible side-effects	
Possible Failures After Rework	Troubleshooting
13.01.00/13.02.00	Check connection 1 (see #1 in Figure 1)
Close Top Cover/ Close Front Door	<ul style="list-style-type: none"> Check connection 4 (see #4 in Figure 1) Check connection 3 (see #3 in Figure 1)
Insert or Close Tray 2	Check connection 2 (see #2 in Figure 1)
<ul style="list-style-type: none"> 10.92.XX Noise From Main Drive Assembly PQ-defect (i.e.: wrong color, Missing color pane, process CPR) 	Check the cartridge bottom lock (see #5 in Figure 2) Remove the MDA and check all the Gears Alignment and correct as instructed. (for details, see steps 16 and 17 above and re-check the MDA alignment as shown in Figure 3 below) For noise specifically, check the Cartridge Drum Sensors on the MDA (see Figure 4)

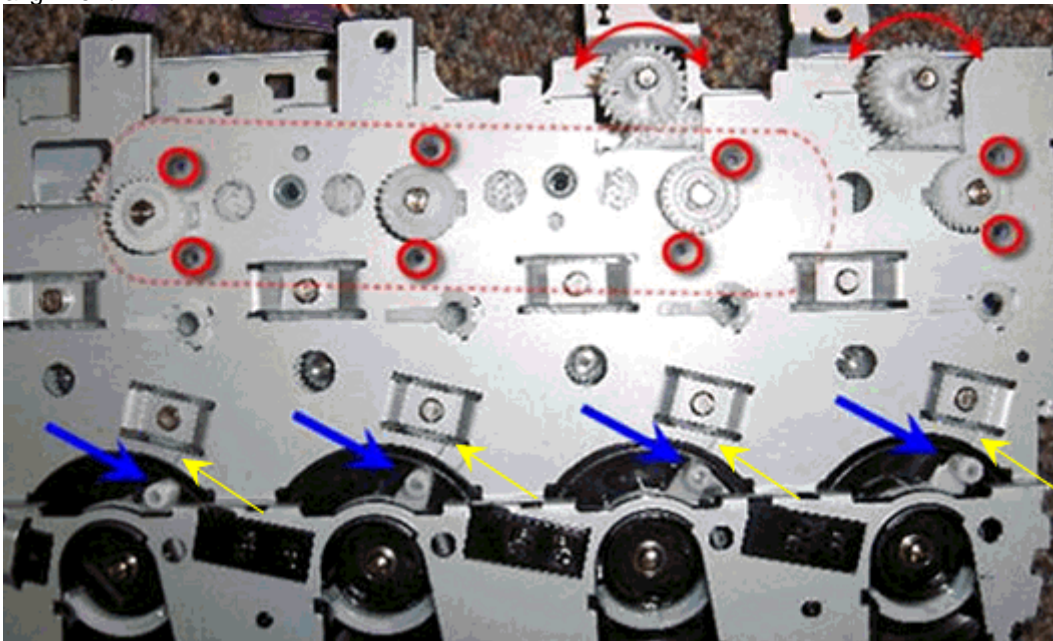
Figure 3: Troubleshooting gear alignment

AISS Main Drive Ass'y (MDA) rework possible side-effects	
Possible Failures After Rework	Troubleshooting
<ul style="list-style-type: none"> 54.XX Error 	
59.C0 Error	One of the two drive gears on the engine is NOT correctly inserted. Remove MDA and re-align gears as instructed (see step 16 above)

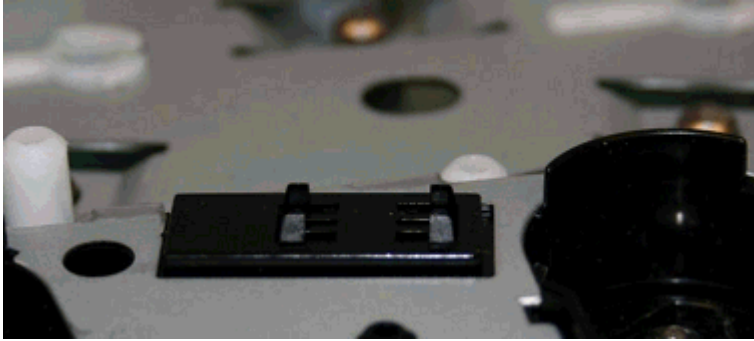
Figure 4: Troubleshooting cartridge drum sensor

Noise - Check the Main Drive Assembly to see that the cartridge drum sensor is correctly seated. See the picture below for the proper orientation of the sensor. There are 4 of these (one per drum) on the MDA.

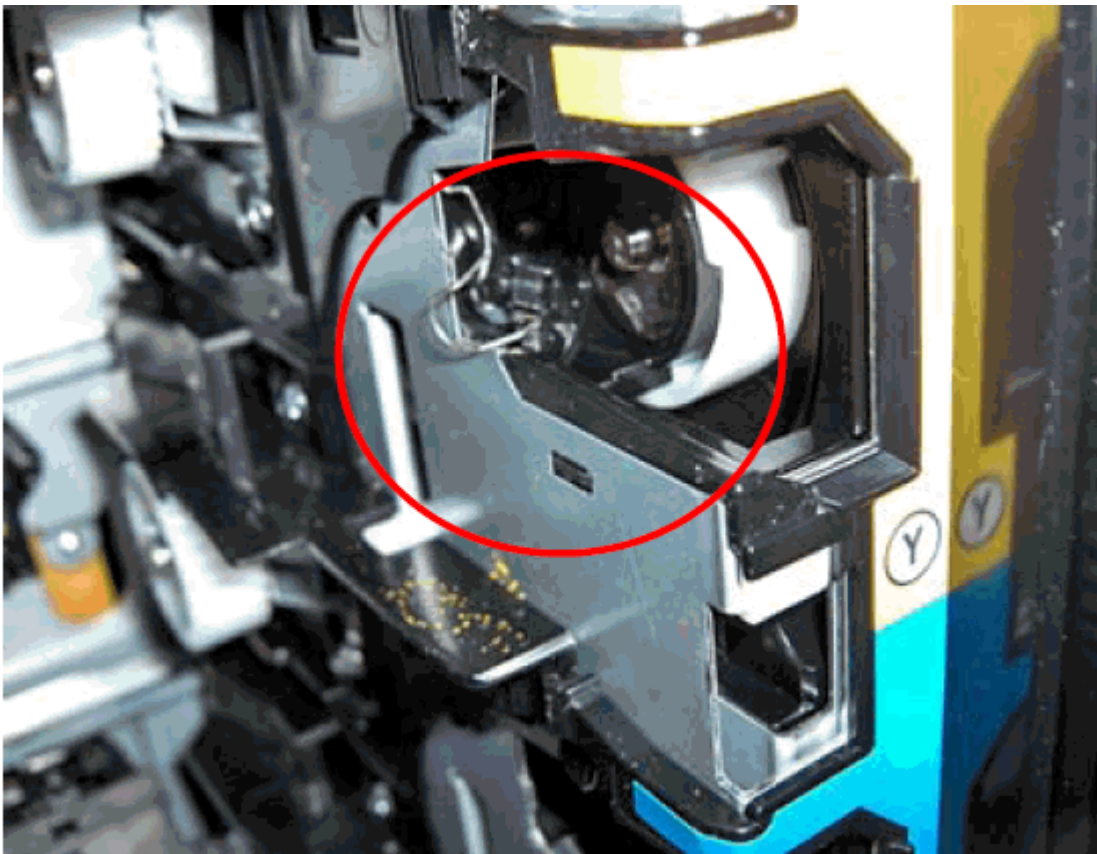
Customers may experience a 10.92.XX error or cannot seat their cartridges properly. If the part circled below is broken, the printer must be replaced. The main drive assembly is not a service part.

The following diagram identifies the area where the broken part may be located on the main drive assembly.

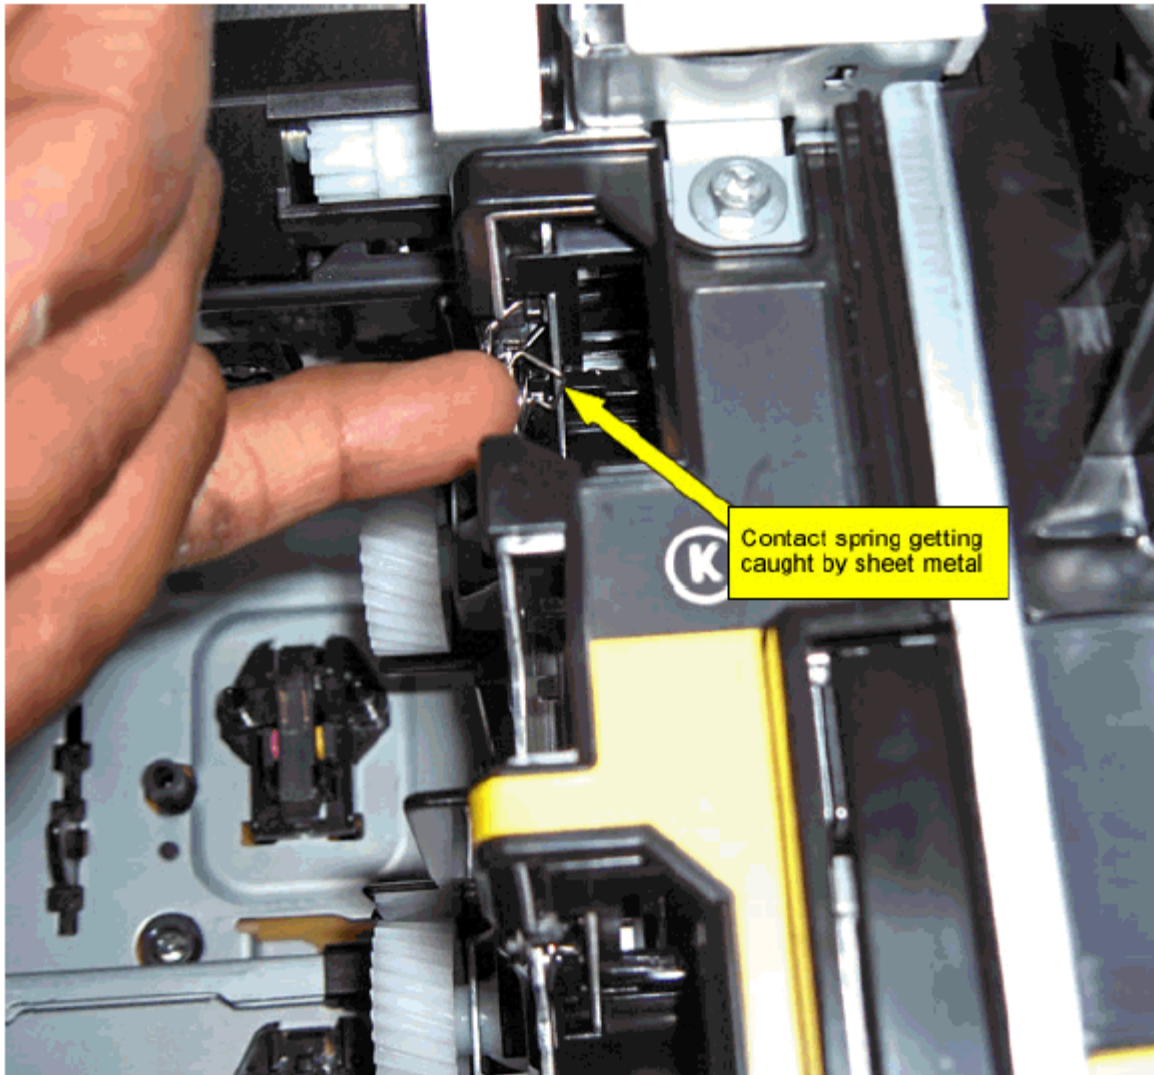
Also check if the contact spring is being caught by the side frame sheet metal when the front door is being opened. There shouldn't be an error associated with this, and you do not have to do anything if you see this.

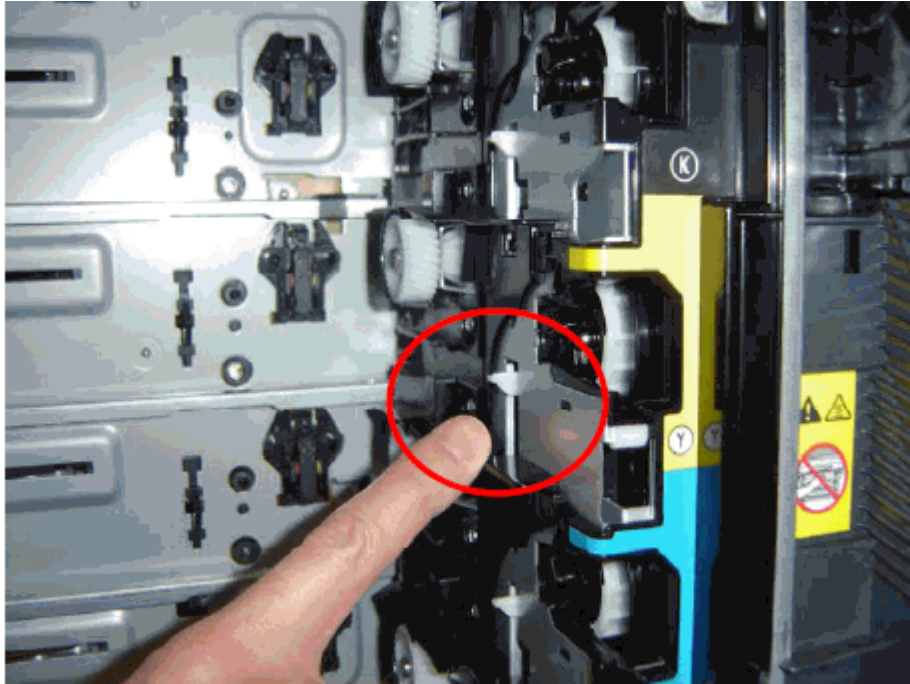
- Check to see if there is any damage to the white plastic part for the cartridge that has the lock broken (see picture).
