Plockmatic BM 2000 Booklet Maker

Title Best Practice BM 2000 Systems				Doc no. RD07-001	
					Date (ISO 8601) 2007-07-05	
Process owner R&D Dept + Tech Support	Author BOL	Sign. Quality	Section	Revision 1	Page 11(13)

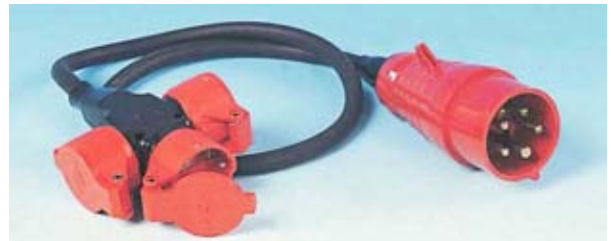
It is important that the line power is stable and the system should not be exposed to undervoltage.

Do not connect all machines to one power strip. Avoid long extension cables. Connect the units separately. Avoid connecting all units to the same wall outlet. If possible, connect Feeder VF1008 to a separate circuit.

If available, connect the system to a three phase outlet with an adaptor cable as shown right.

Make sure you have the specified voltage in the power outlet. Measure the voltage when all units are running. If necessary, tap the machines for a lower voltage.

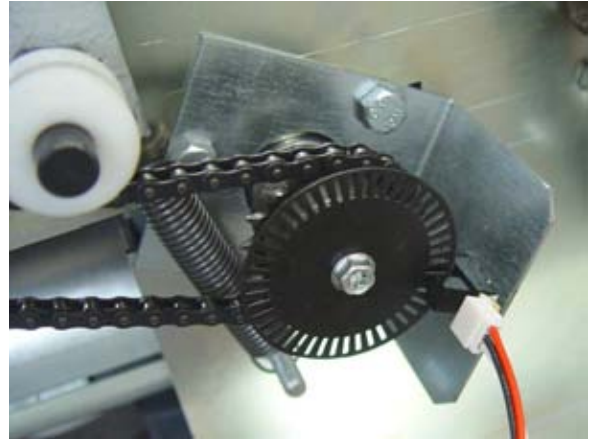
BM-026 (Fold roller motor M9 pulse timeout)

Cause a): Optic sensor not sitting correctly in place.

Cause b): Weak signal from sensor.

Possible cause c): Holes in encoder disc covered with thin film distort the signals.

Remedy: Make sure sensor is sitting correctly in place. Make sure the encoder disc is entering deep enough between the two sensor legs.

Long term solution: Sensor bracket has been redesigned.

Remedy: Replace sensor.

Remedy: Replace or clean disc with knife/file.

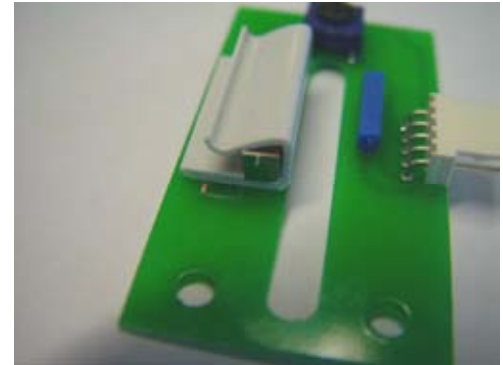
New magnet holder

Message “Cover Open” won’t go away

First generation machines have Interlock Switch PCBs where the magnet sometimes is badly attached. New PCBs have a new magnet holder that won't fall off and also positions the magnet at the right spot.

A second cause could be that the dome cap on the switch has fallen off, due to excessive force from the interlock cheater.

Remedy: In both cases, replace PCB, P/N 771134

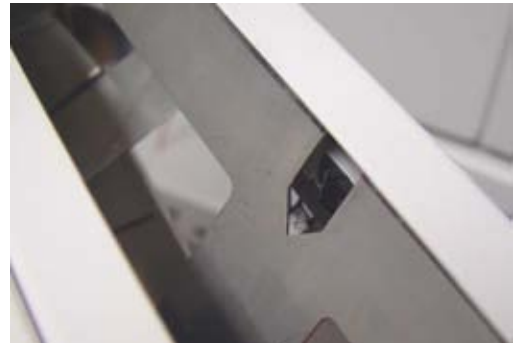
Q2 Manual Feed Sensor Problems

We have one reported case where sensor Q2 was activated by the sheet metal, i.e. the cut-out wasn't big enough for that particular sensor. The root cause was a bad sensor. It was, though, possible to use the faulty sensor by adjusting it slightly sideways. A normal sensor has a very large margin.

Symptom: This can lead to a number of different errors. Normally if there is a signal from the sensor the machine switches to manual feed mode. When a sheet enters from the Collator it will lead to a jam situation.

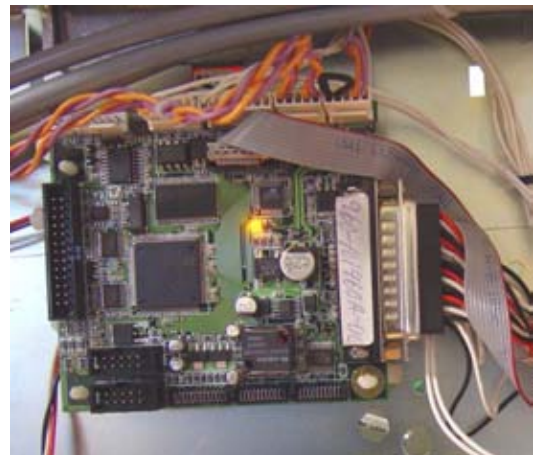
1. Remove the front cover so that you can see the control PCB.
2. Watch the blinking yellow LED on the PCB shown in picture 1 and 2. The LED makes an extra blink whenever a sensor is activated or deactivated. Normally the LED should blink regularly once per second. If the LED flickers it indicates a sensor is generating too many impulses or there is a bad connection between sensor and PCB.

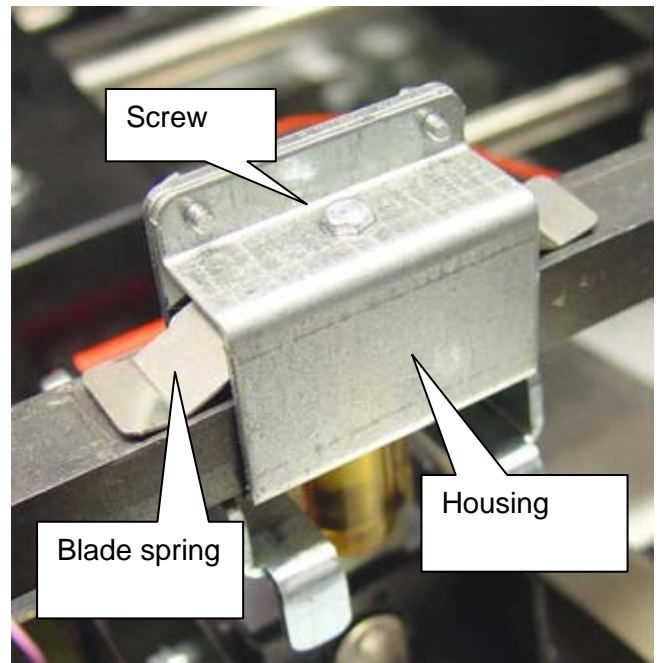
Stapler interruption

Symptom: Stapling interruptions.

Possible cause: Insufficient retraction of stapler plunger.

Remedy: Make sure blade spring mechanism is activated when stapler retracts. If necessary, place washers in between blade spring and housing on the screw shown right..

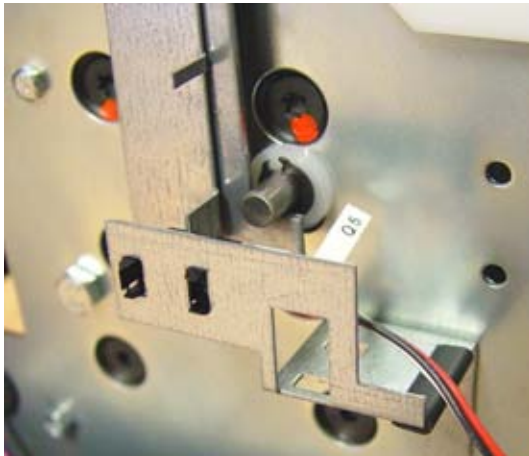
Symptom: TR-002 (Knife motor M1 cycle timeout) occurs immediately after the booklet is trimmed. The Air Blast is out of synch. The Trimmer cannot trim even a thin booklet.

Cause: Knife Sensor Bracket was deformed by cable at installation so that the sensor missed the flags.

Remedy: Bend Bracket back in shape.

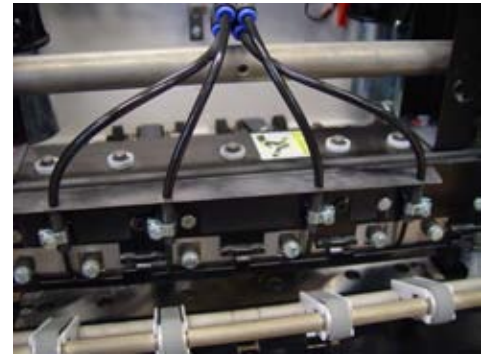
Air Blast Kit

Symptom: Trim strips exit together with the finished booklets.

Cause: Insufficient effect from built-in blower fans.

a) Install Compressor Air Blast Kit, part no. 890031, which needs compressed air

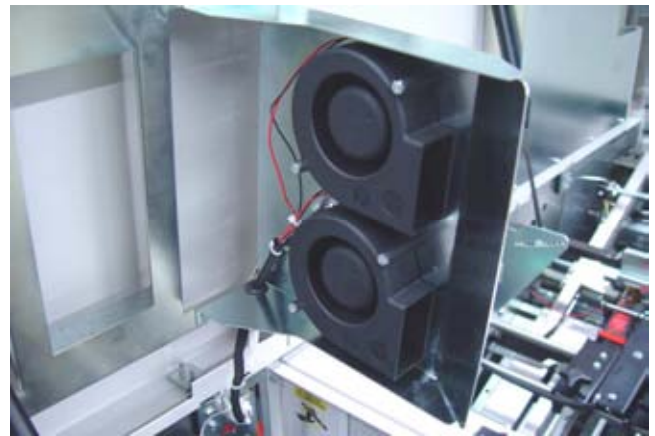
New mount

Trim waste problems can be reduced significantly if the blower fans are installed as shown right below. The new method will go in production soon.

- Remove the Blower Bracket
- Remove the blower fans from the bracket
- Newer brackets already have threaded holes for turned-over fans, if not, drill and tap these
- The connecting cable for one of the blower fans has to be extended, this can be done by crimping or soldering
- Install everything again

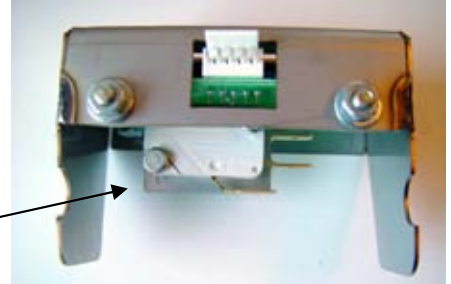
This error message is most likely caused by the interlock switch in FTR 2000. There is a microswitch installed underneath the ordinary Interlock PCB. The root cause can be one of the following:

Cause a): Microswitch mounted too low or its bracket has been bent by excessive force from interlock cheater

Remedy: Readjust (raise) microswitch.

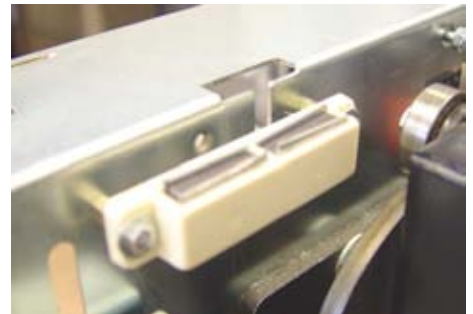
Cause b): First generation top cover without magnetic locks could vibrate and cause switch to operate

Remedy: Install magnetic lock on top cover (needs drilling).

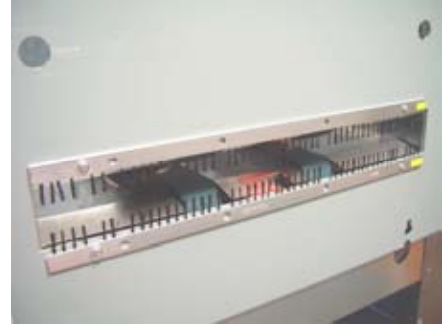
Thin booklets won't transport well through the SQF

Cause: Static sheets gets stuck inside machine.

Remedy: Antistatic brushes, P/N 56677 mounted in inlet.

Long term solution: Antistatic brushes are already standard.

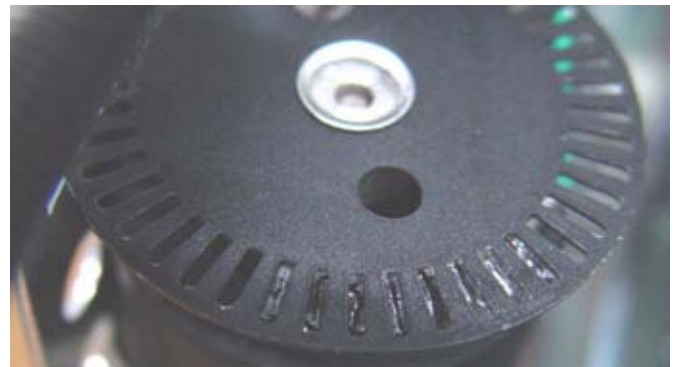
SQF-013 (Roller Motor Pulse Timeout)

Symptom: Roller motor stops intermittently for no apparent reason.

Possible cause a): Holes in encoder disc covered with thin film distort the signals.

Remedy: Replace or clean disc with knife/file.

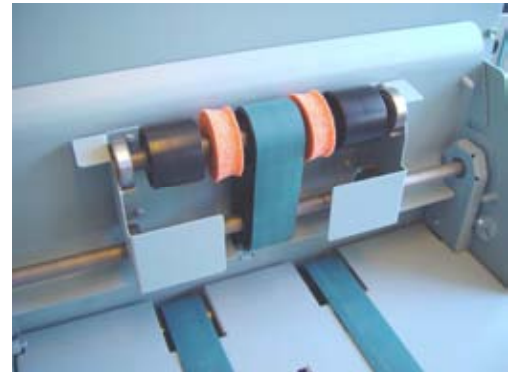
Thin/small/glossy booklets won't transport well onto the belt stacker

Symptom: Booklets get stuck in exit.

Cause: Insufficient drive from the upper drive rollers

Remedy: Install foam wheels P/N 18341 on shaft according to picture right.

Long term solution: Already standard.

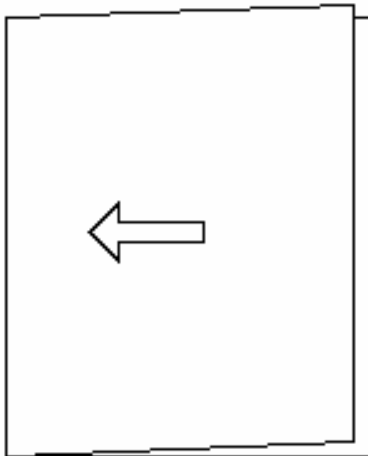
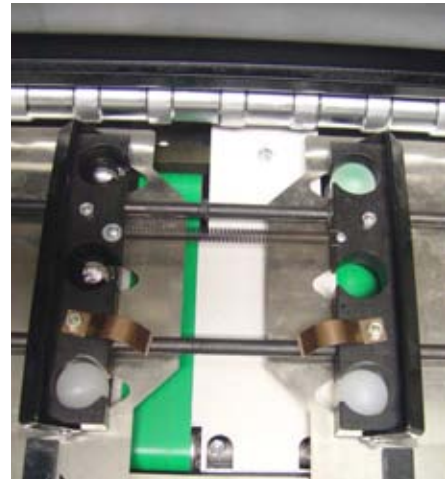
Place steel balls on the left side

Symptom: Booklets or sheets are not folded straight. Machine is well adjusted and folds white sheets perfectly.

Cause: Digitally printed sheets have different friction on printed compared to unprinted surfaces. The skewing occurs when the sheets are forced in between the fold rollers.

Remedy: Place steel balls asymmetrically to compensate for the skewing. Follow the diagram below:

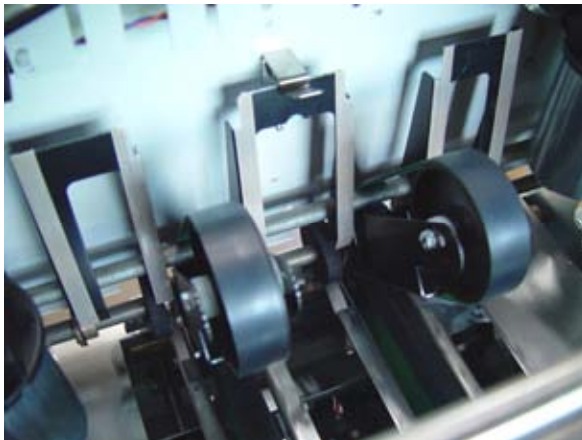
Trimmer with strips of Teflon tape

Digital paper, especially “silk” type paper is very sensitive for scratch- or pressure marks. Paper printed on some brands of printers is very sensitive. Here are some hints for how to find scratch sources and how to remove them.

5. Identify what edge causes the scratch. Measure the distance between marks or from the middle and try to find the parts in the machine that corresponds to them. Polish edges or cover with Teflon tape (Plockmatic P/N 60155).
