DOCUMENT NUMBER: 17-00166
ISSUE NUMBER: 1
ISSUE DATE: May, 96

VCO 2 Unlock in 9323 and 9360 series transceivers

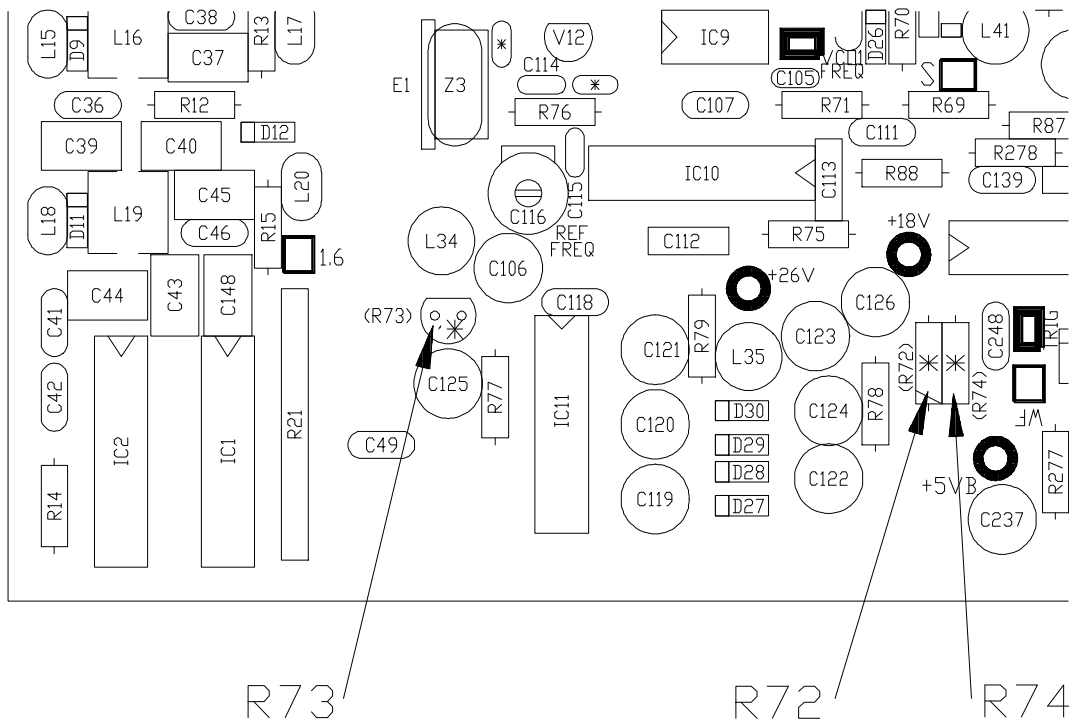
Figure 1: Position of R73 and R74 (Bottom Left Hand Corner of 08-04962)

The overlay diagram 08-04962-001 shows the position of R72 and R74 transposed. The correct position of R74 is adjacent to C248 and test point +5VB.

The silkscreen on the Receiver Exciter Assembly is CORRECT.

1. Disconnect power from the transceiver and remove from the installation.
2. Remove the top cover.
3. Referring to the diagram, locate the position of R73 and R74. (Neither of these resistors are fitted).

4. Remove the Receiver Exciter assembly from the chassis.
5. Using tinned Copper Wire (TCW), fit and solder a link into the holes marked R73. Trim excess lead length.
6. Fit and solder the 1K Ω resistor into the holes marked R74. Trim excess lead length.
7. Fit and secure the Receiver Exciter assembly into chassis.
8. Refit plugs ensuring correct placement and orientation.
9. Fit top cover
10. Reinstall
11. Connect power.
