# Replacement of power transistors SRFH1008 and MRF455

This service bulletin affects the users of transceivers with power amplifier (PA) output transistors SRFH1008 or MRF455. There are two transistors (matching pair) on each PA PCB. The following transceivers are affected:

The transistors SRFH1008 and MRF455 are obsolete. The replacement transistor is MS1253-CDN.

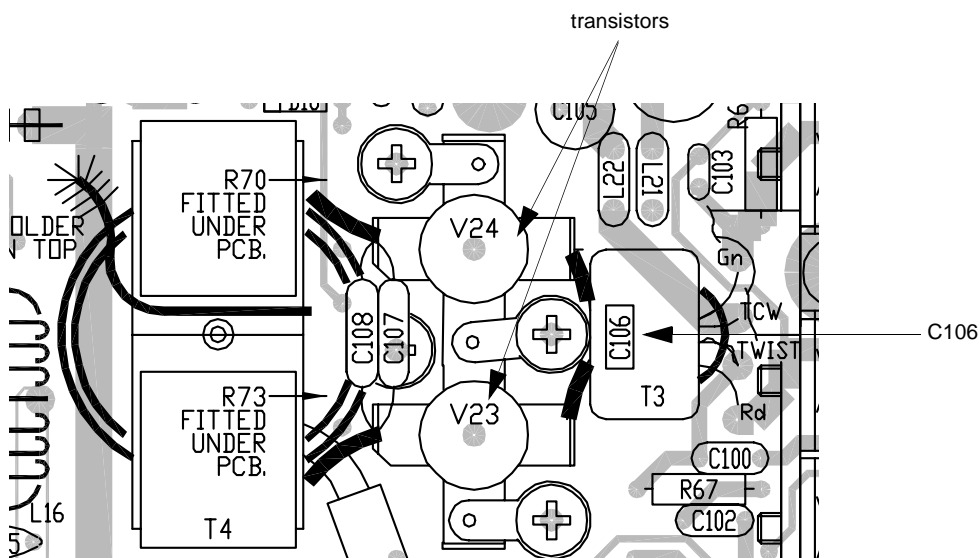
Figure 1: Power amplifier PCB for the 93xx series/9780 and LP transceivers

- Remove the two faulty transistors from the PA PCB (see Figure 1).

- Replace C106 with a capacitor that has a value of 470 pf.

Later model 93xx series/9780 PAs (Codan part number 08-04963-xxx) may already have the 470 pf capacitor in place. If you are unsure of the value of C106, it is recommended you replace it with a 470 pf capacitor as a precaution.

- Replace the transistors with MS1253-CDN.
- Continue from [page 3, Adjusting the driver bias for power amplifiers in 93xx series/9780 and LP transceivers.](#)

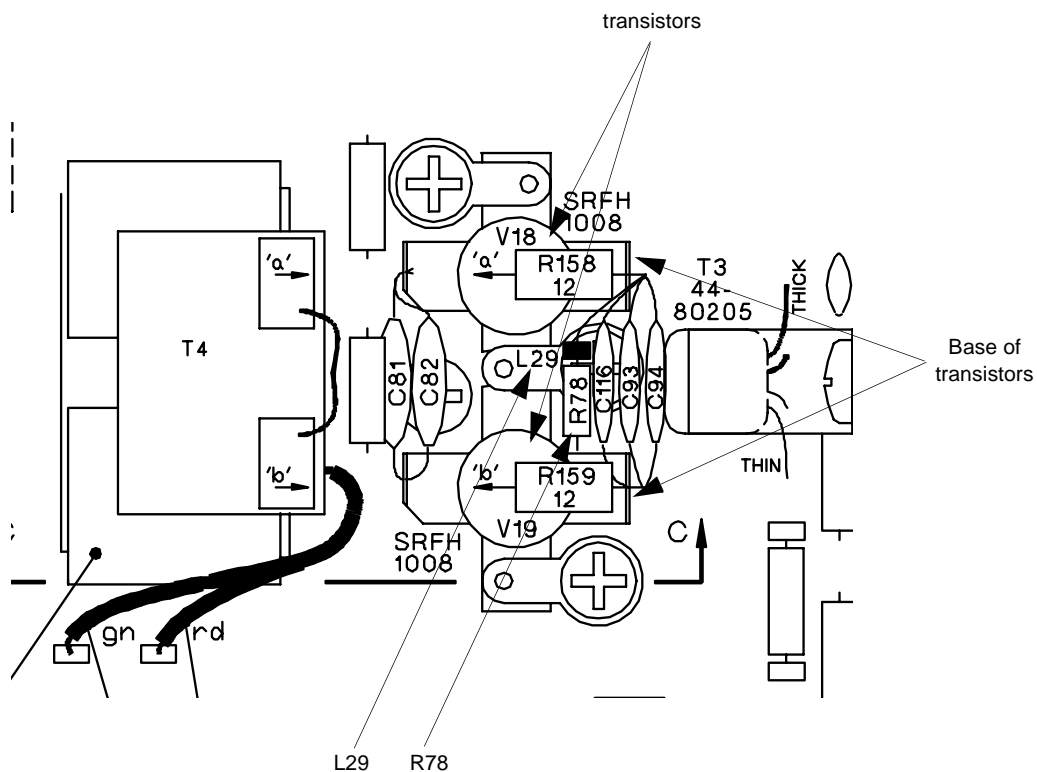
Figure 2: Power amplifier PCB for the 85xx series/9313/9480 transceivers

- Check if there is a resistor/choke (R78/L29) across the base of both transistors on the PA PCB (Codan part number 08-03743-xxx) (see Figure 2).

Without the resistor/choke in place, spurious oscillations at approximately 4 MHz occur. The resistor/choke network consists of a:

If R78/L29 is not present, it must be fitted.

- ↪ • 12  $\Omega$  ¼ W 5% resistor
- ferrite bead placed on one leg of the resistor with a small amount of silastic to stop any movement

- Replace the transistors with MS1253-CDN (see Figure 2).
- Continue from [page 5, Adjusting the output bias in all transceivers](#).
