| Product: TD | New spring, belt tensioner | Group: 22 | |
| Date: 2004-10-11 | | Number: 067 | |

Too low belt tension can result in drive belt breakage

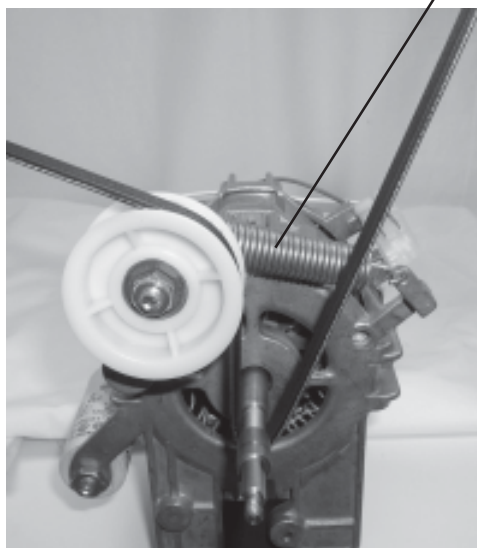
Article number 80 772 54.

The drive belt can slip on the motor shaft so that the belt breaks.

This may be caused by too low belt tension. A new stronger spring, article number 80 772 54, has been produced to ensure the correct belt tension.

The new belt tensioner spring must be used.

- Remove the old belt and carefully clean the grooves on the motor shaft.
- Replace the old spring with the new article number 80 772 54.
- Clean the cylinder by the belt's contact surface with a cloth.
- Fit the new belt article number 80 657 10.
