DISHDRAWERS

DD602 Micro-switch Failure – NZ, AUS, SGP, UK, USA

DW030

April 2002

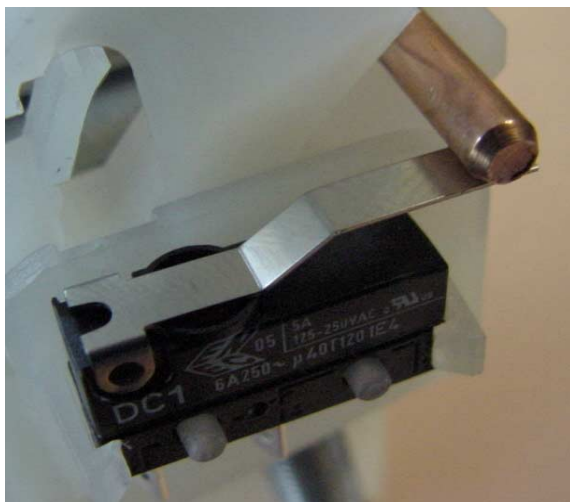
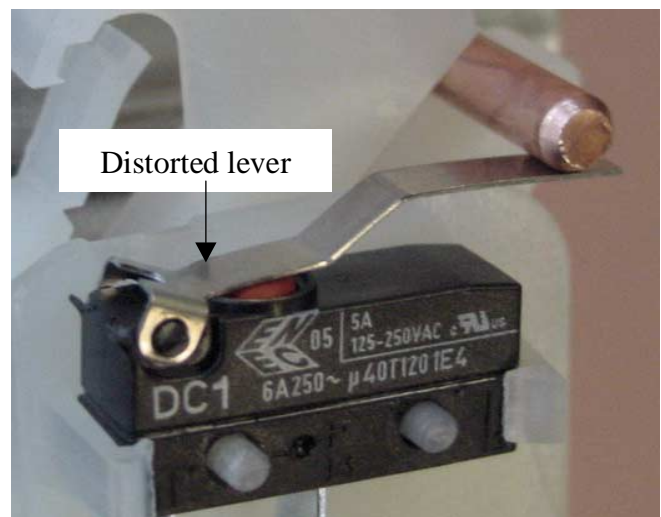
We are seeing a large number of microswitch failures in the field. The main reason switches are failing is because they were damaged during the product's assembly. The slide pin has got under the microswitch lever spring, probably as the slide was being fitted to the product. When the slide was then extended to fit the tub, the lever spring is bent back and damaged. Everything still works the same as the slide pin still activates the microswitch when the drawer is closed. However the life of the spring is reduced from approximately 50,000 operations to approximately 1000 (depending on the extent of the damage.)

Also, for a double DishDrawer, it is essential to check the microswitch in the other drawer to ensure that it hasn't also been damaged. The picture on the left shows a good microswitch, the one on the right shows a damaged microswitch.

When replacing a broken microswitch, it is important to check that the slide pin cannot get under the microswitch lever spring and damage the new part.

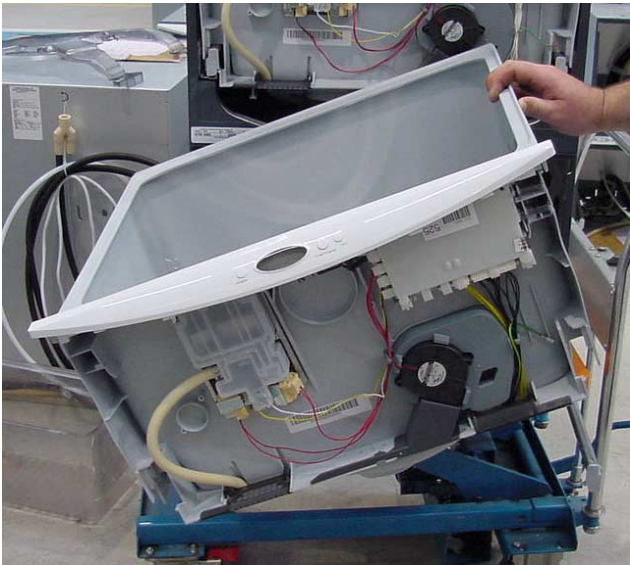
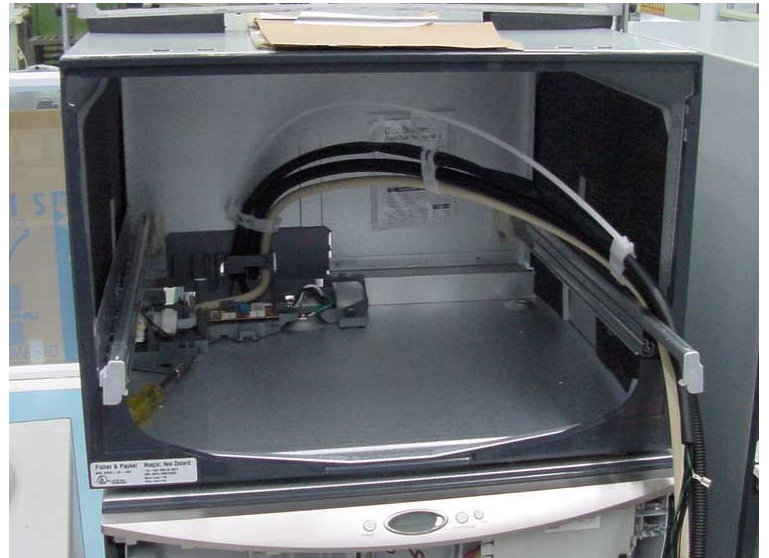
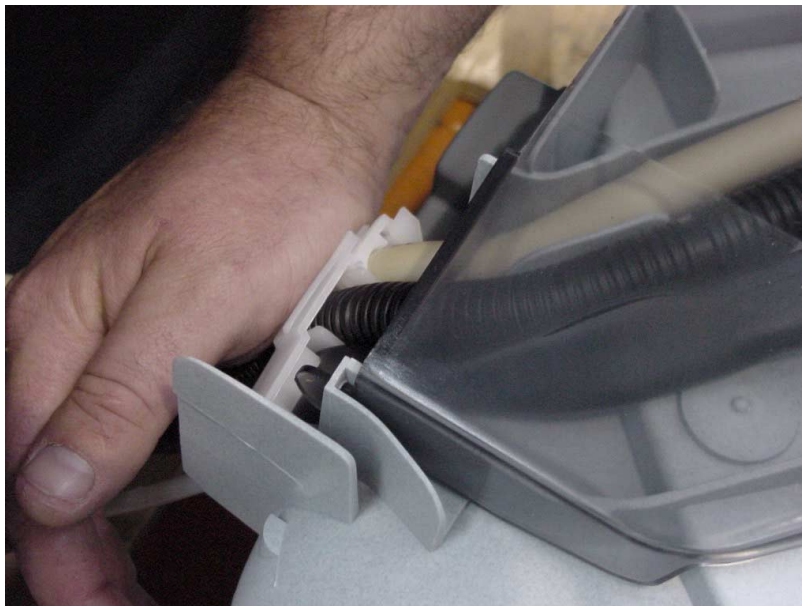
DD603 Tub Removal Tip

It is also a good idea to push the hoses and the link support down while re-fitting the wiring cover. This ensures that the link support does not interfere with the tub when the drawer is closing. If the hoses have become twisted in the link support, or if the link support is too close to the tub, this can cause drawer closing problems. Either the drawer will not close fully or will close slowly over the last 35 mm. (1 ½ inches)

When a tub is lifted off the slides and turned upside down for servicing, e.g to replace a heater plate, it is best to rotate it in an anti-clockwise direction. This is the opposite way to which it was assembled and will help prevent the hoses from getting twisted inside the link support. Once upside down, the hoses and wiring can be removed and placed over the right hand slide. These can then be reassembled to the tub without the need to twist them awkwardly.

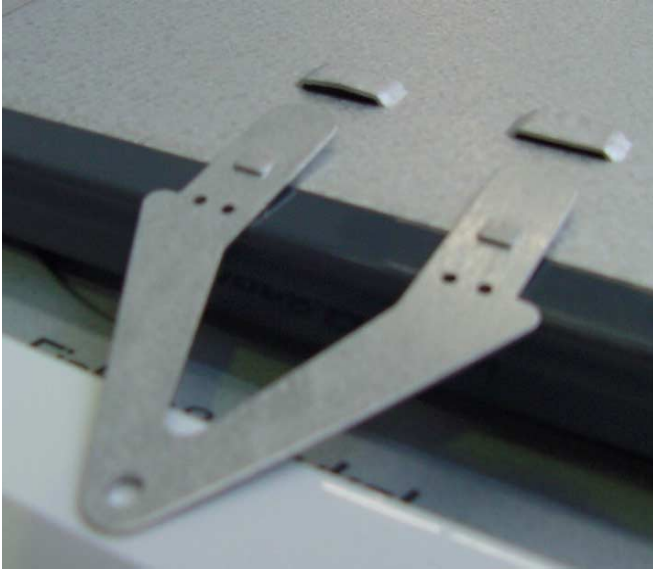
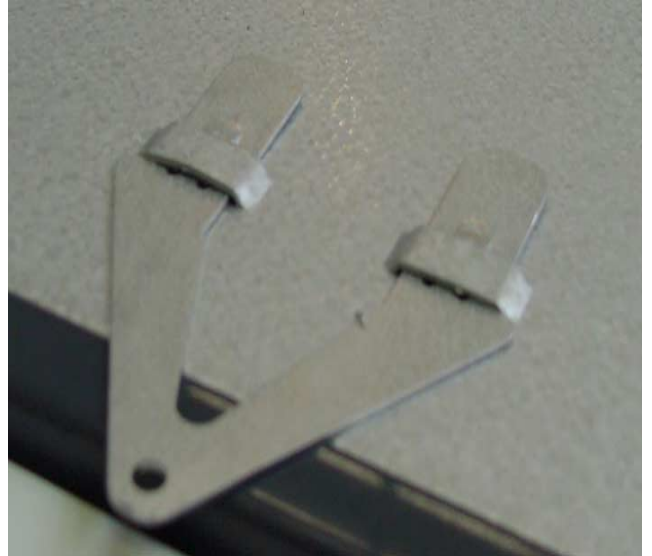
DD603 Chassis – Top Installation Tabs

The top installation tabs on double DishDrawers were changed to the new type (illustrated) on 20/02/02. The tabs push into the slots in the chassis from the front. The clips on the tab lock it into place once inserted.

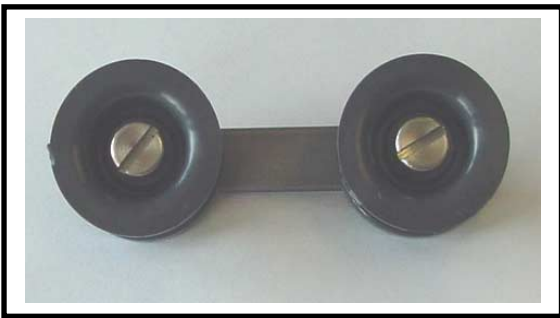
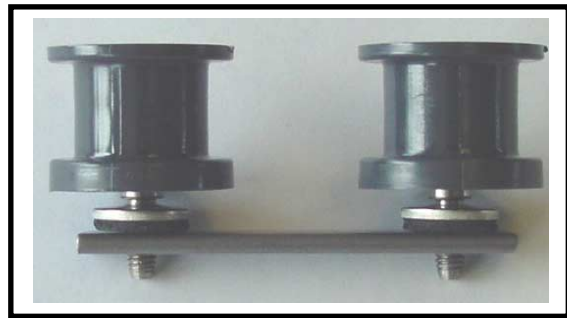
When servicing a Dishwasher with a F1 fault code, first determine the cause of the leak. If you suspect the leak has come from the tub roller assembly we advise that you remove the cabinet wrapper and inspect the outside of the tub for any visible water stains or marks.

The old design of tub roller is shown below with the tapping plate and screws.

Please order and fit the new spare part kit, part number 521428, if there is any sign of stripping or damage to the tub roller assembly or if there has been a repeat call for leaking tub rollers on the product being serviced.

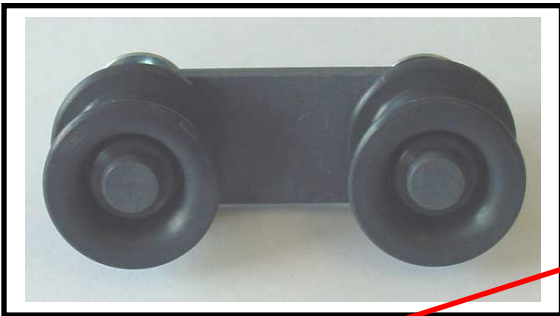
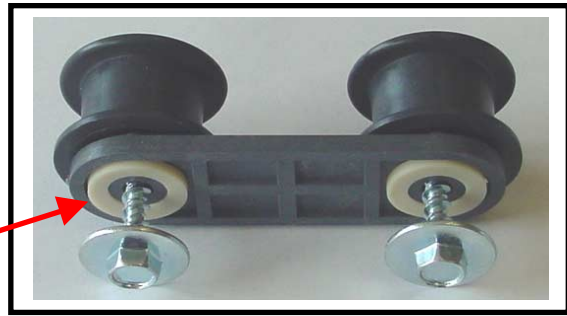
The new design of tub roller is shown below and is available in a spare part kit part number 521428.

Note: Please check the white seal is correctly fitted before installing the rollers in the product.
The new kit, part number **521428**, includes:

To fit the new design of tub roller, first remove the cabinet wrapper. This must be done because the screws on the new assembly tap directly into the tub rollers from the outside of the tub. Tighten the screws until they are firm. The large head on the new screws gives adequate support to clamp the rollers to the tub. After fitting the new design of tub roller you will notice that the tapping plate is no longer required.
