DISHDRAWER

DW025

June 2001

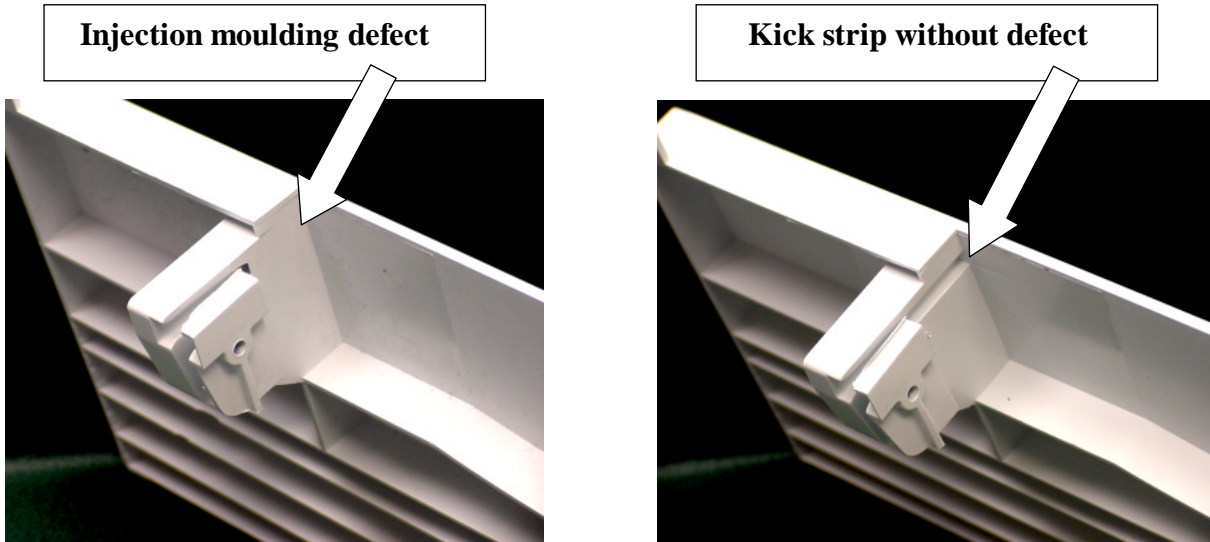
KICK STRIP DEFECT PHASE 3 DISHDRAWER (NZ, AUS, USA, UK)

We have found a batch of phase 3 kick strips with an injection-moulding defect around the mounting detail. The implications are that if a kitchen toe kick is any deeper than 50mm it may not be possible to slide the kick strip far enough back on the tub to line up with the adjacent joinery. If this problem is encountered, simply cut away the thin piece of plastic that is interfering. Refer pictures below.
