October 2017

WPA/WPA2 Vulnerability Mitigation

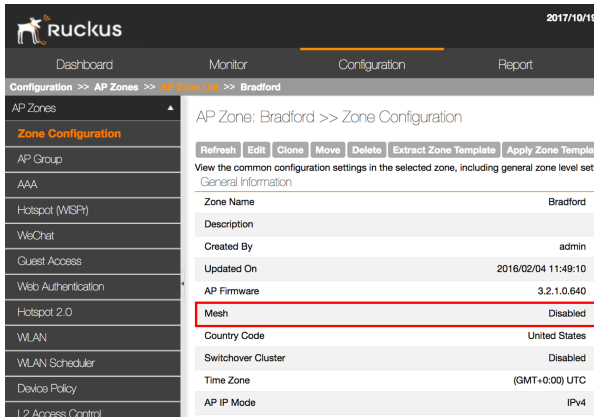
Figure 1: Mesh vSZ-H

Verify that Mesh is not enabled for your vSZ-H network (this is the default setting). Navigate to your AP Zone by selecting Configuration> AP Zones> (Your AP Zone Name). In the General Information area, if Mesh is disabled, no further action is needed.

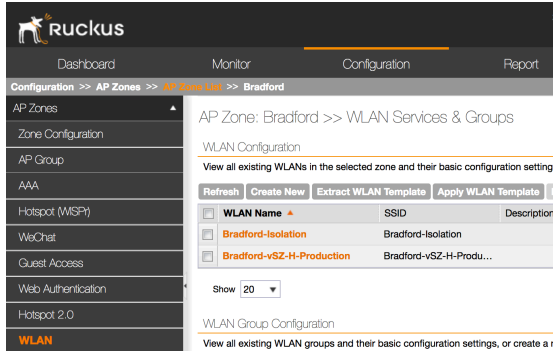
Figure 3: 802.11r vSZ-H

The Fast BSS Transition (802.11r) feature is found under each Wi-Fi Network (WLAN) configured. This feature is disabled by default. To verify that 11r is not enabled for your WLAN, navigate to Configuration > AP Zones > (Your AP Zone) > (Your WLAN Name).
