**MINISTRY OF TRANSPORTATION  
AND INFRASTRUCTURE**

# **ISLAND RAIL CORRIDOR CONDITION ASSESSMENT**

**SUMMARY REPORT**

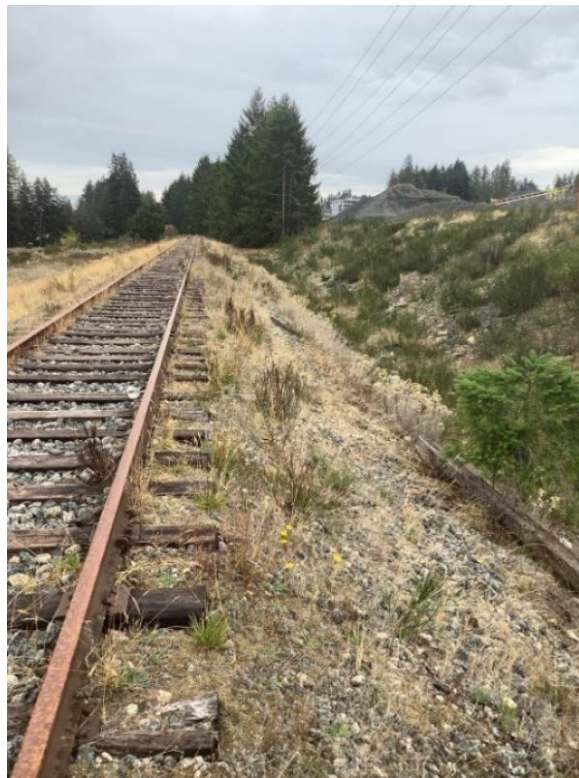
**Figure 5: Typical Drainage Ditch Observed at Langford.**

Figure 5: Typical Drainage Ditch Observed at Langford. shows a typical example of the drainage along the Island Rail Corridor. Vegetation within ballast and drainage ditch but still deemed to be in fair condition allowing the water to flow away from the track maintaining it's integrity.

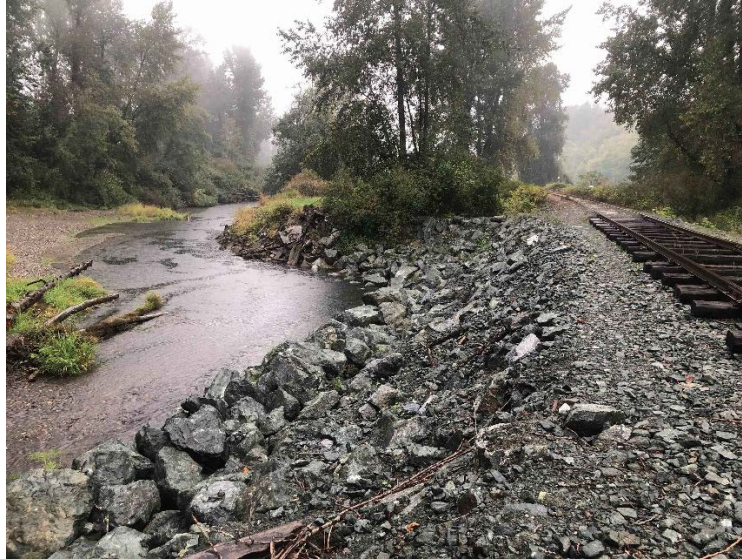
**Figure 6: Washout at mile 37 – Victoria Subdivision**

During the site investigation two repaired washouts were observed. The first was a washout of the track at approximately mile 37 of the Victoria Subdivision. SVI had repaired the washout by placing armouring material at the base of the road bed and re-establishing the track. Washout repairs typically require the dumping of armouring material into the waterway to re-establish and protect the track bed. On operating railways this is done as quick as possible (and mandated by federal regulators in some cases) to re-open the track for the movement of goods and passengers and to generate revenue. Without being present during the placement of the armouring material WSP cannot confirm the slope's integrity. However, from visual inspection it appeared to be suitable for rail loading and to mitigate washouts. Given the proximity, angle of approach and history of the waterway, this site should be monitored to confirm the repair is performing. SVI indicated they have not observed issues at this site since the repair was made. Refer to Figure 6: Washout at mile 37 – Victoria Subdivision.

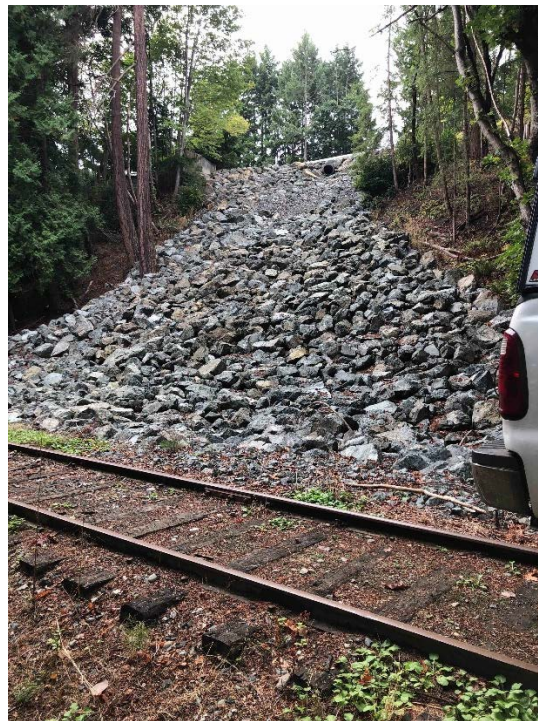
**Figure 7: Washout at mile 84.4 - Victoria Subdivision**

The second repaired washout was observed at approximately mile 84.4 of the Victoria Subdivision which was created by the washout of Rummying road located directly above the rail corridor. The slope from the rail up to the road was repaired. A new 900mm culvert was installed under the rail track to convey drainage from the above road safely under and away from the track. Refer to Figure 7: Washout at mile 84.4 - Victoria Subdivision.

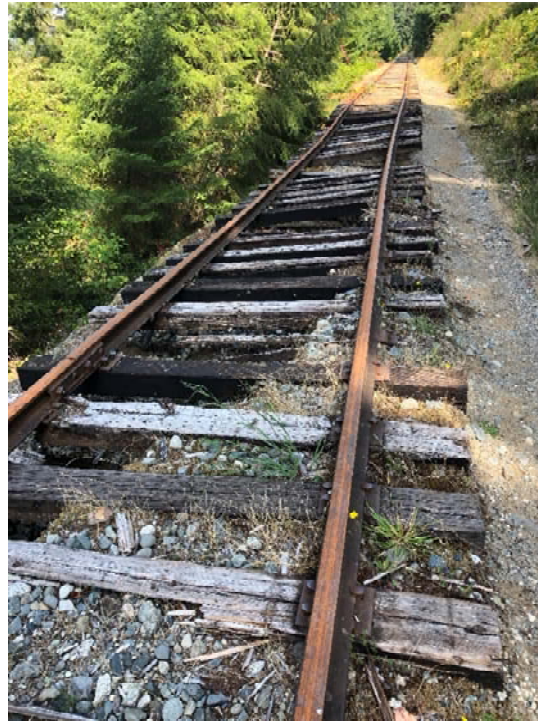
**Figure 8: Slope Failure at mile 22**

A slope failure was observed at approximately mile 22 of the Victoria Subdivision just south of Shawnigan Lake. SVI indicated that the downside slope failure was not caused naturally but by a third-party excavation of the toe of the slope approximately 100 feet below the rail line. Due to this slope failure the track was impassable at this location. WSP did not confirm the cause of the slope failure as repair of the slope failure is in the process of being addressed with the parties involved. Refer to Figure 8: Slope Failure at mile 22.

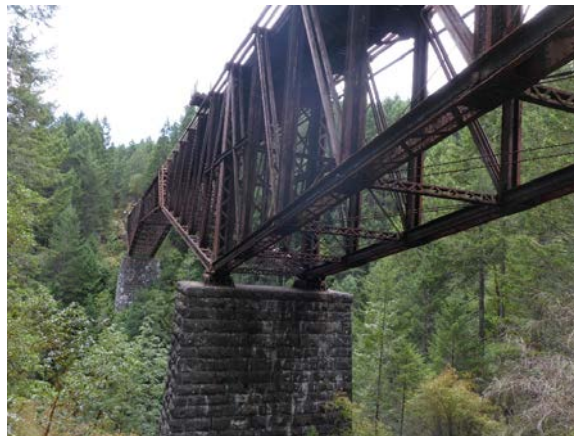
Figure 20: Niagara Canyon Bridge - mile 14.0

Considering the age of the structure and results of the inspection which identified several minor deficiencies the risk of replacement over the next 50 years was estimated at 70%. The estimated cost to replace the structure is \$22,000,000.

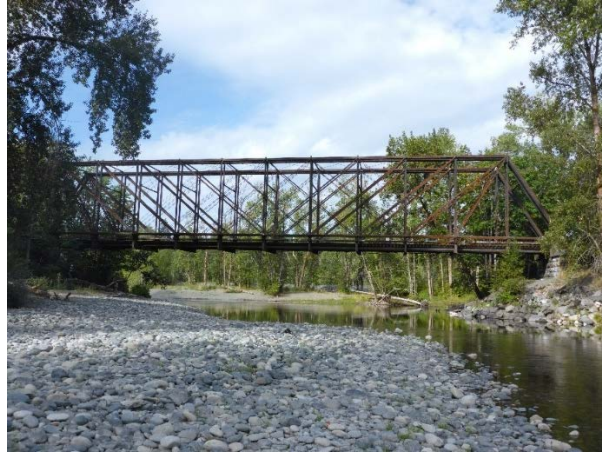
**Figure 21: Cowichan River Bridge – mile 39.30**

Initial rehabilitation costs to support recommencement of passenger vehicle rail traffic has been estimated at \$748,000. The cost is largely due to several deficiencies identified during the inspections. However, even with the required bridge rehabilitation the bridge still has a high risk of replacement within the next 50 years. Therefore, bridge replacement prior to the recommencement of rail traffic may be the most cost effective. Bridge replacement is estimated to cost \$4,950,000.

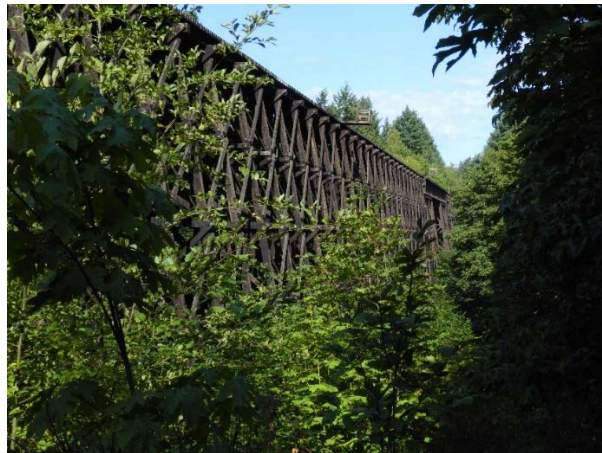
**Figure 22: French Creek - mile 98.60**

The timber trestle spans were assessed to be in good condition however it is not expected that the timber elements will last another 50 years. Due to the combined length of the timber spans (275m) the cost to replace or rehabilitate the spans is appreciable. The cost to replace the timber spans with a concrete and steel structures is estimated to cost \$17,000,000 while rehabilitating the timber spans over the next 50 years is estimated to cost \$14,000,000.

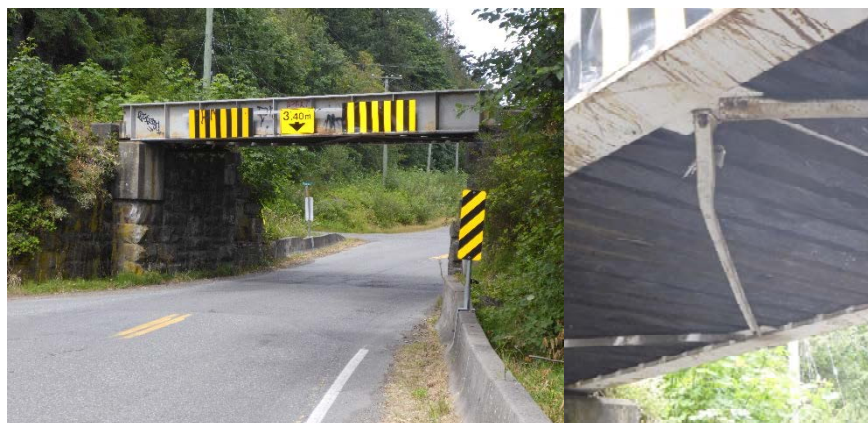
**Figure 23: Shawnigan Lake Road Bridge Impact.**

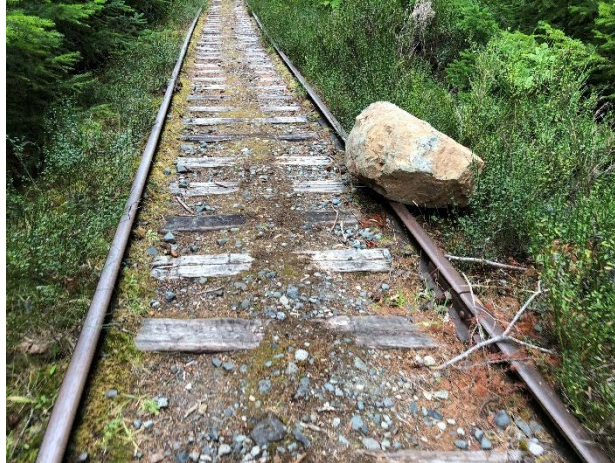
The 2019 site inspection conducted a similar assessment along the Victoria Subdivision, identifying areas between Langford and Shawnigan Lake as having potential rockfall risks. Areas of risk were noted between Mile 13.1 and 21.3. The Port Alberni Subdivision was also inspected and noted potential risks east of Cameron Lake to Summit Lake.

**Figure 24: Rockfall Located on Port Alberni Subdivision**
