Business Class M2
Cascadia
108SD/114SD
> New Cascadia

**Freightliner
Service Bulletin**

General Information

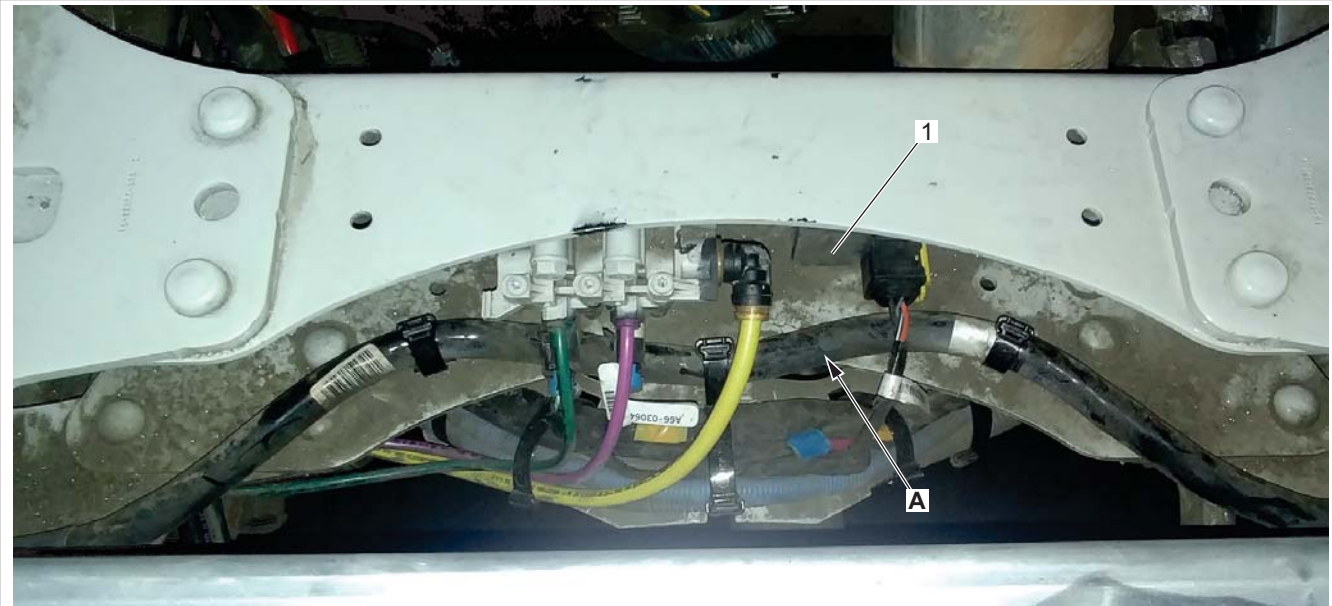
Fig. 1, Cable Routing

Fault code SA 11 SPN 520247 FMI 31 - *Failure Memory Bit (ESC) Condition Exists* may display if the electronic stability control (ESC) ECU is not mounted properly. Use the instructions in this bulletin to inspect and repair the ESC module.

- 3.4 Check the power, ground, and CAN wires from the ABS module to the ESC module for damage. If these wires are OK, replace the ESC module.
4. Route the ground cable away from the ESC module, attaching it to the chassis harness just below the crossmember. See [Fig. 1](#).

- A. Route the ground cable away from the ESC module.
- 1. ESC
