Troubleshooting Guide

imagePRESS

C10000VP Series

January, 2019
Canon U.S.A., Inc.

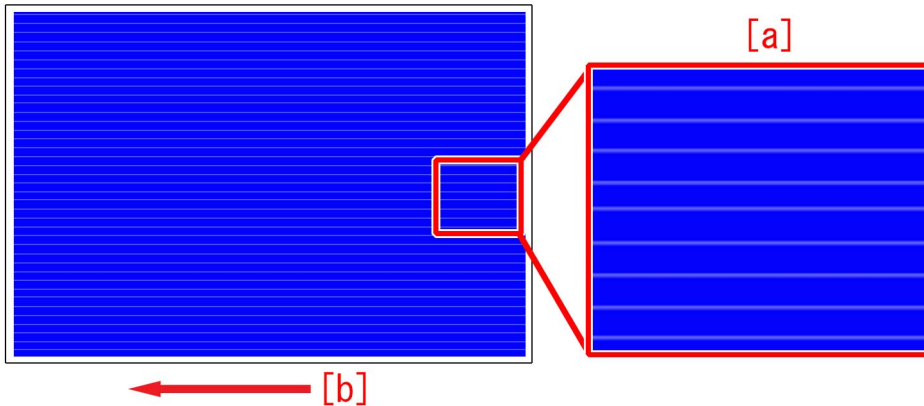
Several 1 mm-wide glossy lines [a] may occur at intervals of 5 mm in the high-density area on the first side of duplex printing. The arrow [b] indicates the direction of feeding.

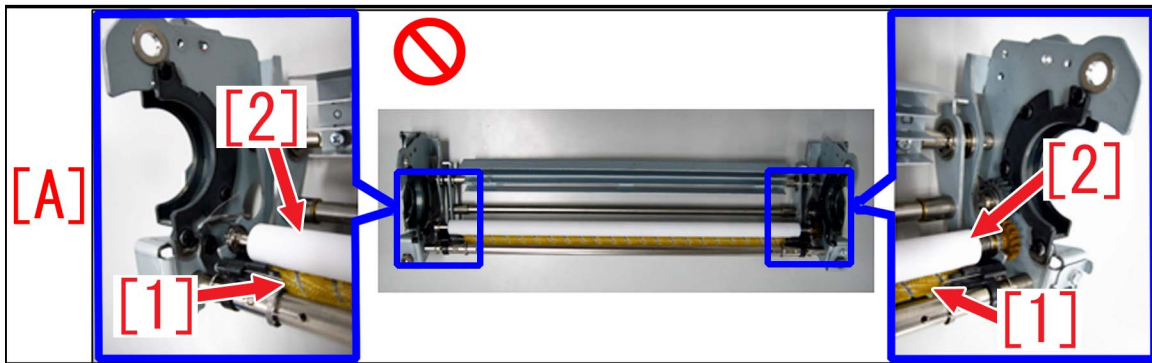
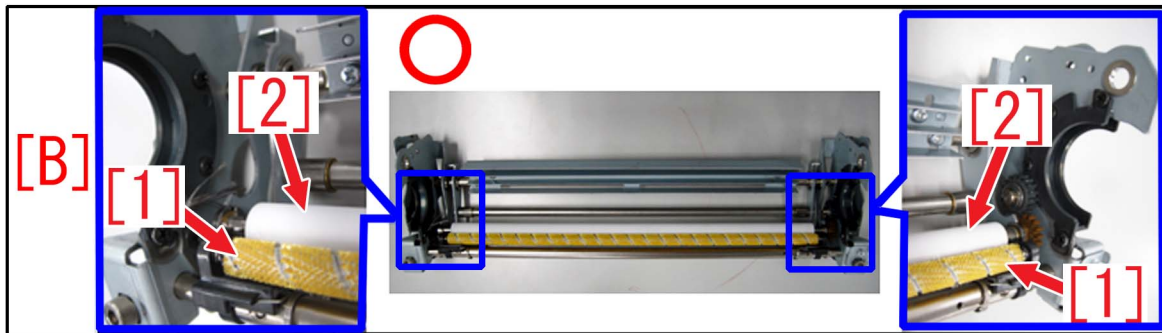
The following photos [A] show the state of that the cleaning brush roller [1] getting under the pressure refresh roller [2]. The photos [B] show the proper state.

When the pressure refresh roller is replaced, assemble the parts in proper order referring Service Manual. After the assembling, make sure that the cleaning brush roller is placed at proper position [a]. If the pressure refresh roller [b] can be seen, it has been assembled in a wrong way. Please assemble them again.

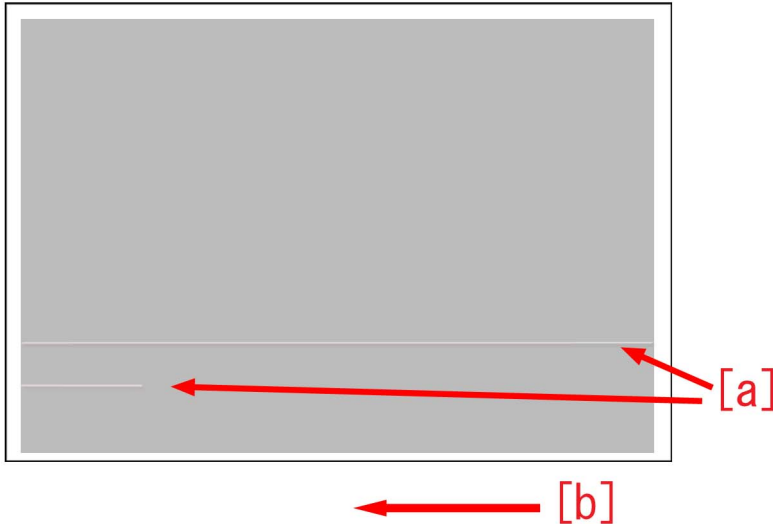
Vertical lines due to cross feed roller pressure

The arrow [b] indicates the direction of feeding.

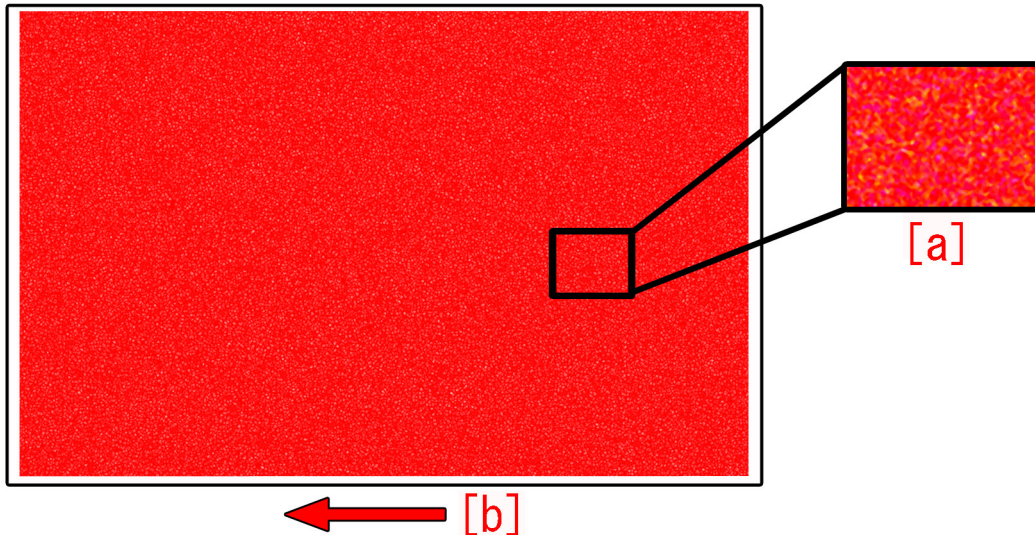
When printing a high density image on a device having high operation rate, uneven density [a] may occur in a grid pattern. More visible on green and red high density images. The arrow [b] indicates the direction of feeding.

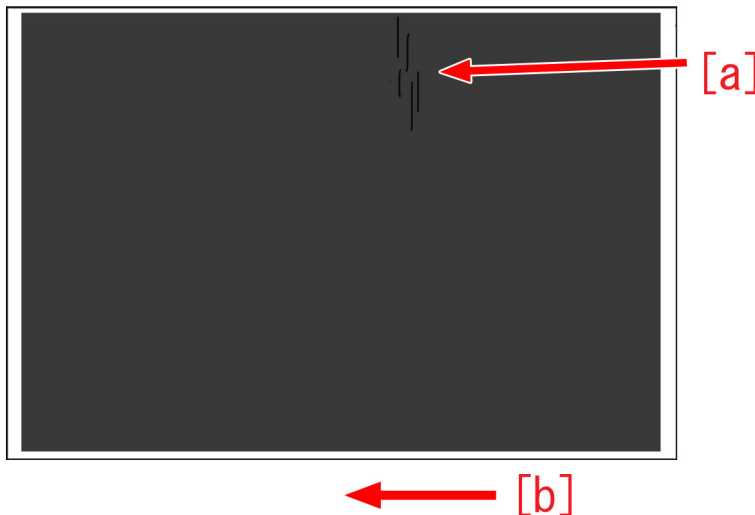
Uneven density [a] may occur on the 2nd side of 2-sided page when a Bk high density image is output. The arrow [b] indicates the feed direction.

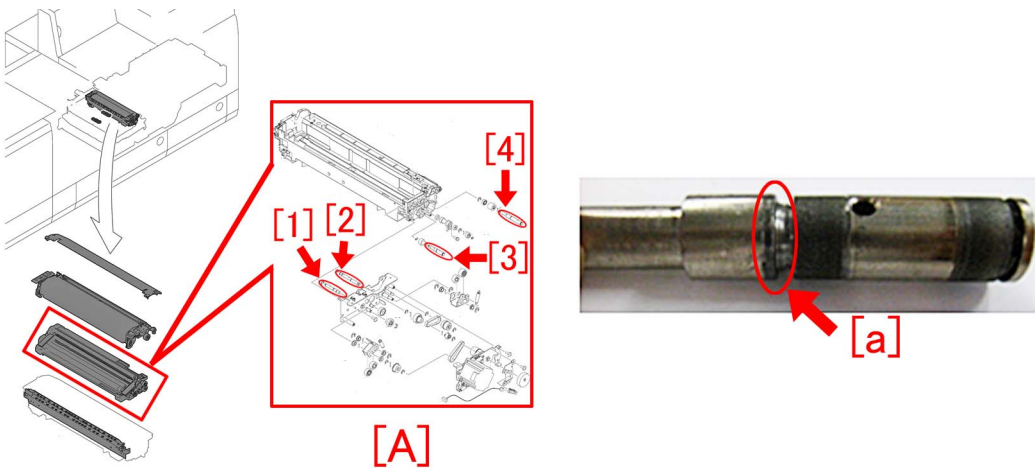
- There is a possibility that the symptom occurs in all the 4 shafts shown in the Figure [A], however, the scrape occurs most on the shaft [1] for structural reasons.

- If the shaft is replaced by itself, prepare the new-type shafts to replace.
- The scraped shaft cannot be limited to 1 location, but other shafts may be scraped, Therefore, replacing the 4 shafts at the same time is recommended.

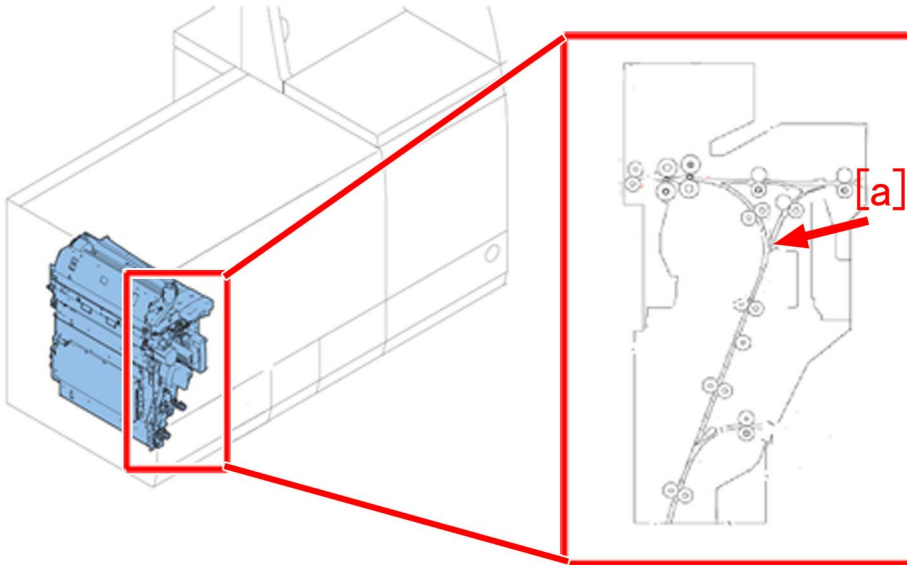
When printing on one-sided heavy paper with face-down delivery, the leading edge and trailing edge of the paper rub strongly against the flapper [a] in passing through the delivery reverse unit, which may result in the above-mentioned symptom. One-sided and two-sided printing with face-up delivery does not cause the symptom.

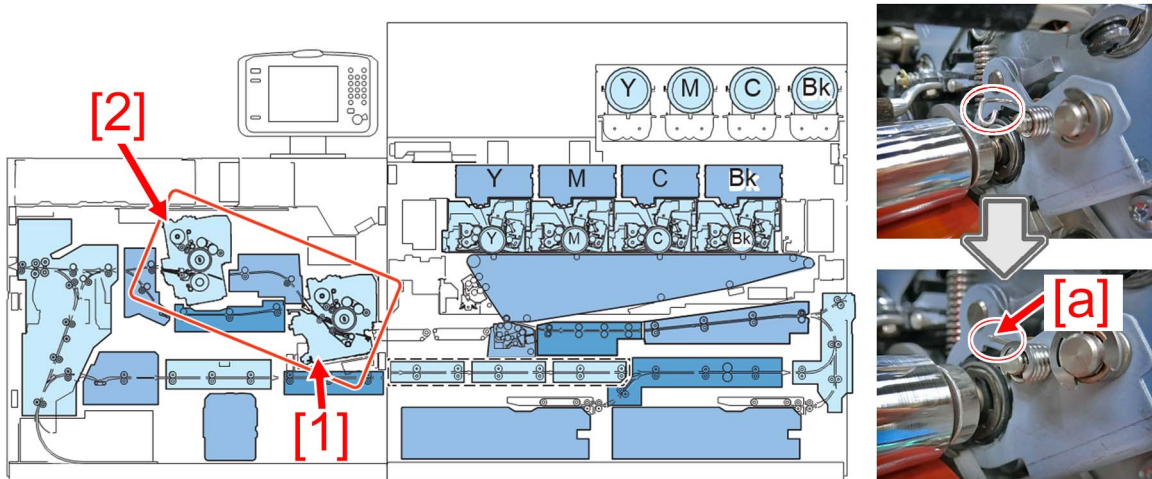
The torsion spring, which is used for the primary fixing assembly [1] and the secondary fixing assembly [2], to pressurize the collection roller may be damaged [a]. If the torsion spring is damaged, the pressure runs short and cleaning performance reduces, resulting in the above-mentioned symptom.

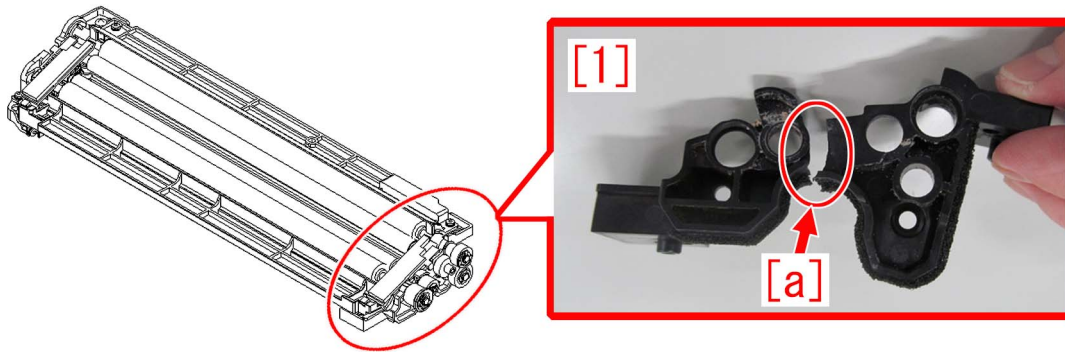
As the life of the machine advances, cleaner front side plate [1] of a belt cleaner assembly of a secondary transfer assembly may break [a]. Such breakage of a cleaner front side plate may cause cleaning failure, resulting in the above-mentioned symptom.
