SERVICE ACTION: GSM COMBOX DEACTIVATION / DISCONTINUATION WITH 4 YEAR ASSIST SERVICE

This Service Information bulletin supersedes SI B84 03 16 **dated December 2016**.

UPDATE! **MODEL**

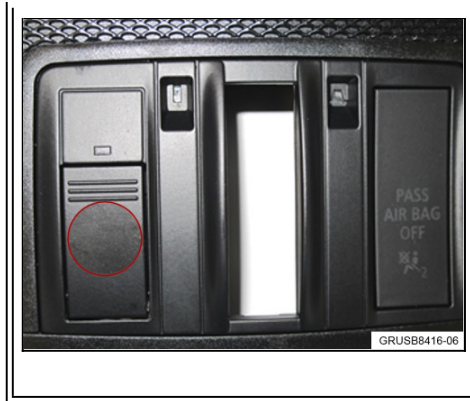
| | 7. Dealer installs sticker on the door for the E-Call |

button in the FZD as seen in the picture.
