PRODUCT CAMPAIGN BULLETIN

NUMBERS: TKA-20R
 TKB-20R
 TKC-20R

DATE: 01/06/20

SUBJECT: Takata Front Passenger Airbag Module / Inflator “Like for Like” Recall

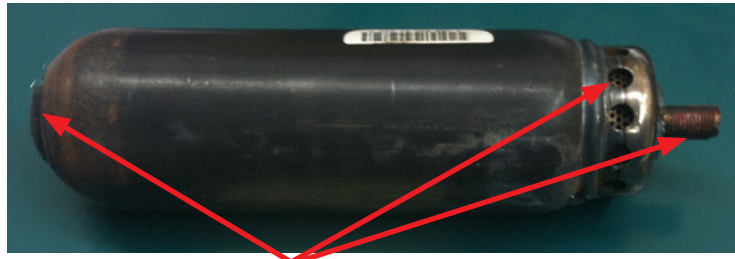
The shape, holes, and copper-colored stud indicate this is not a Genuine Subaru inflator.

- **Do not proceed with this repair if your inspection reveals a non-Genuine Subaru airbag module has been installed in the vehicle.** Follow the instructions described in the “Counterfeit Airbag Information” Dealer Advisory Bulletin.

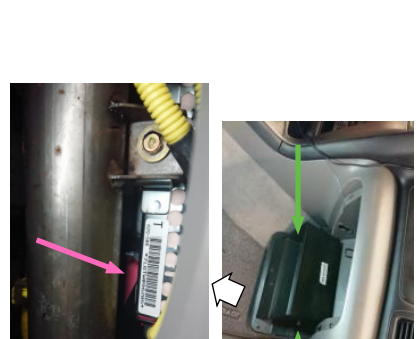
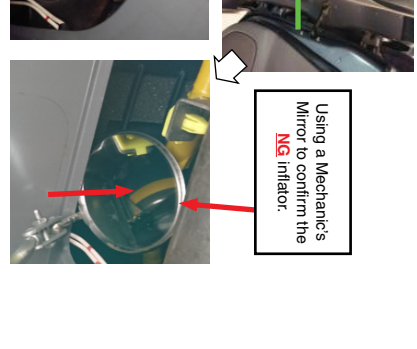
Using a Mechanic's Mirror to confirm the **NG** inflator.

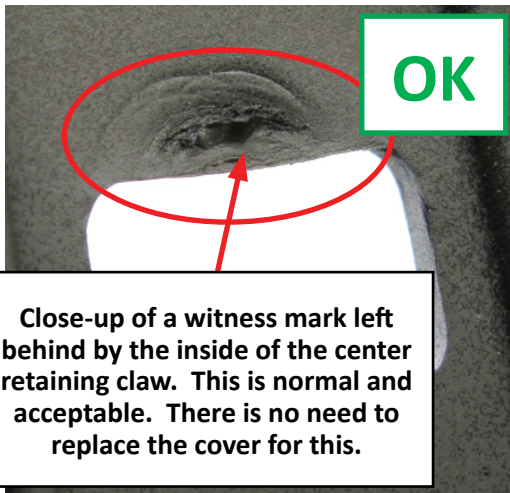
Close-up of a witness mark left behind by the inside of the center retaining claw. This is normal and acceptable. There is no need to replace the cover for this.

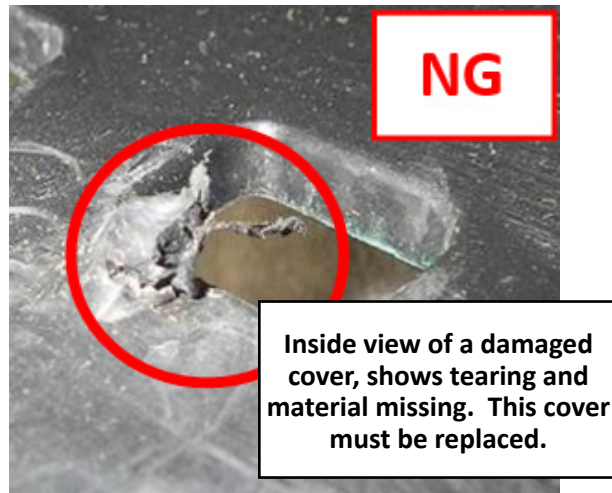
Inside view of a damaged cover, shows tearing and material missing. This cover must be replaced.

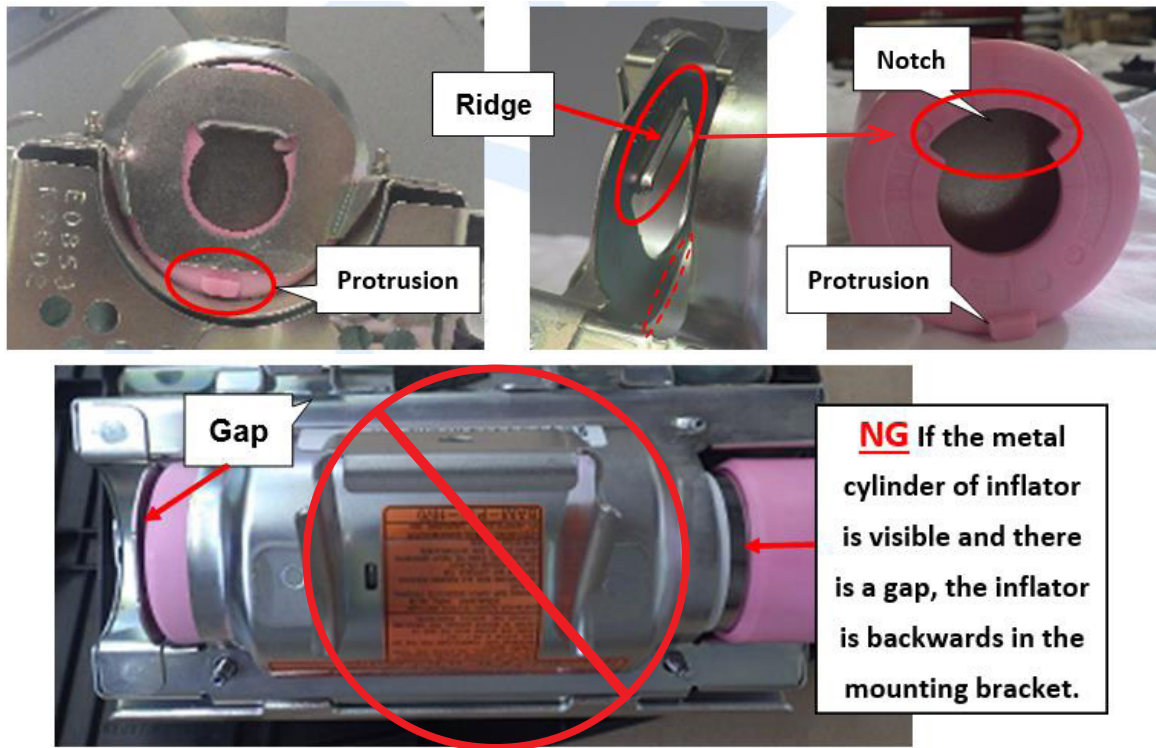
NG If the metal cylinder of inflator is visible and there is a gap, the inflator is backwards in the mounting bracket.

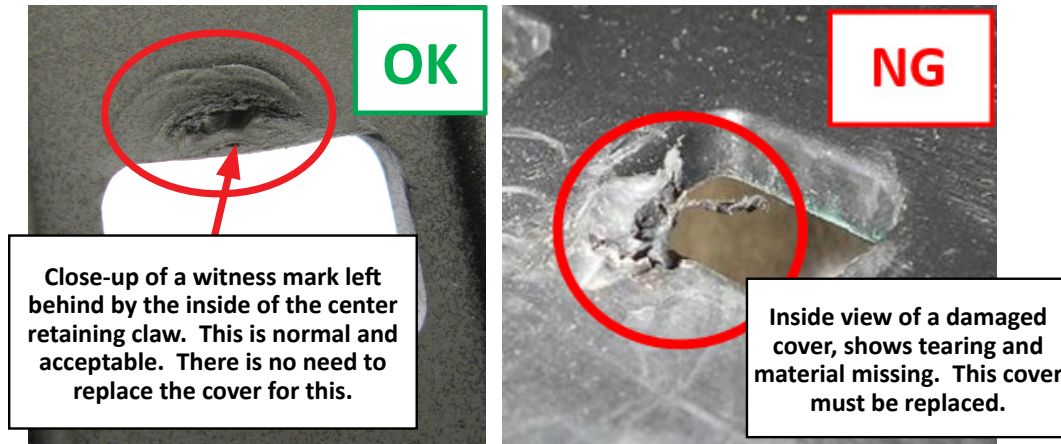
- Inspect the claw openings on the outside and inside of the cover for damage. If any found to look like the NG example photo below, the cover must be replaced.
