GE Generator Rotor Retaining Rings: Experience and Fleet Data

Ronald J. Zawoysky
GE Power Systems
Schenectady, NY

SUMMARY

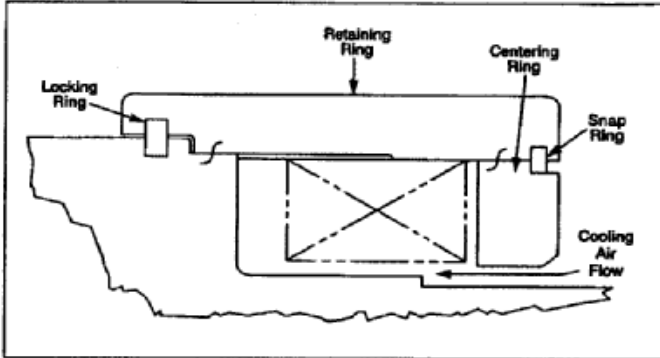
GT18062A

Also, the inside diameter is inspected with the ring in place using ultrasonic techniques which has a reliable repeatability limit of approximately 0.050 inches. As a result, most small (0.005 to 0.050 inch) indications are missed. It should also be noted that many retaining rings are painted on the outside surface (Figures 1, 2, 3 and 4).

Figure 1. Body-mounted retaining ring assembly

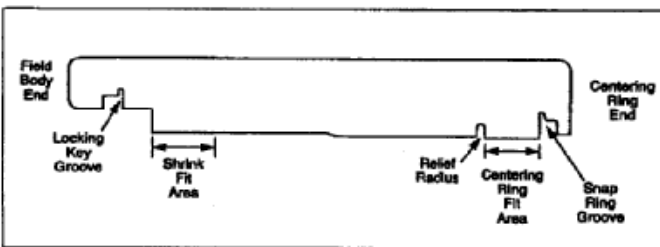
GT18063

Figure 2. Typical body-mounted retaining ring

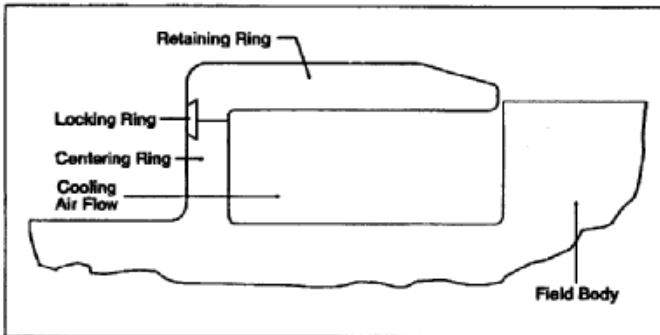
GT22330

Figure 3. Spindle-mounted retaining ring assembly

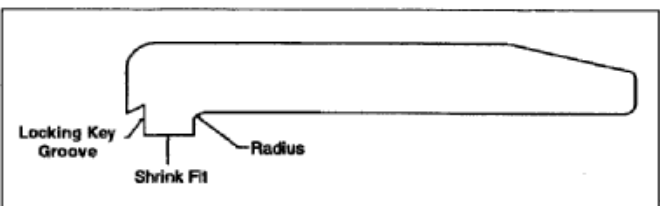
GT22331

Figure 4. Typical spindle-mounted retaining ring

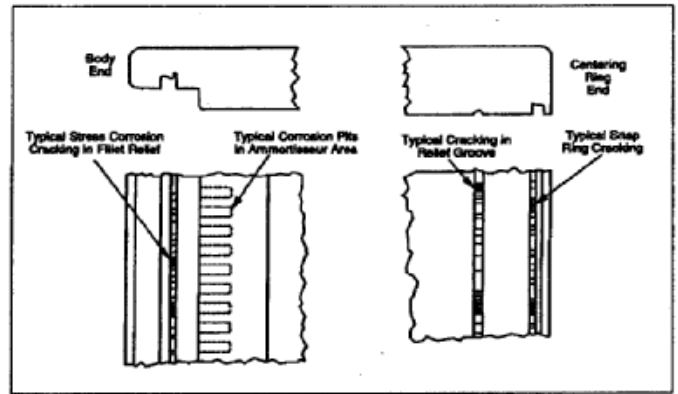
GT18066

When the cooling flow for the generator field is examined, it becomes apparent why the inside diameter of the field is more vulnerable. The cooling medium (air or hydrogen) is directed under the retaining rings from both ends of the field and contaminants and moisture can be

trapped under the retaining rings. The only way to ensure that 18Mn-5Cr retaining rings do not have stress corrosion cracking or pitting is to inspect all surfaces of the rings using eddy current and fluorescent penetrant techniques (Figures 5 and 6).

Figure 5. Body-mounted retaining ring schematic; typical indications found on inside diameter of rings

- In the interim, inspect, protect and repair 18Mn-5Cr retaining rings per the recommendations of TILs 1001-3 and TIL 1097-3. To ensure the best confidence of a ring being stress corrosion free, the entire retaining ring, both inside and outside diameters, should be tested using eddy current and fluorescent penetrant techniques. It should be noted that even if an 18Mn-5Cr retaining ring is found free of stress corrosion cracking, experience has shown that there is no guarantee against subsequent stress corrosion cracking and an in-service retaining ring failure.

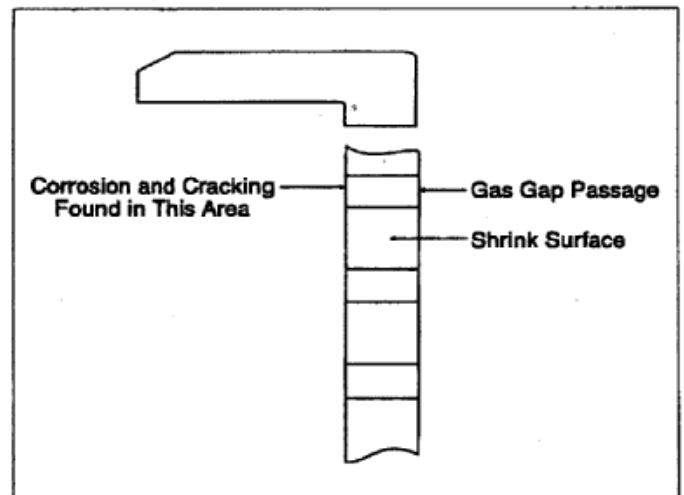
GT22368

Figure 6. Spindle-mounted retaining ring; typical indications found on inside diameter
