## Service Information Bulletin

| SUBJECT | DATE |
|---|---|
| SPN 4364 (ACM) (GHG17) | June 2016 |

## 2 SPN 4364/FMI 17 - GHG17

### SCR NOx Conversion Efficiency

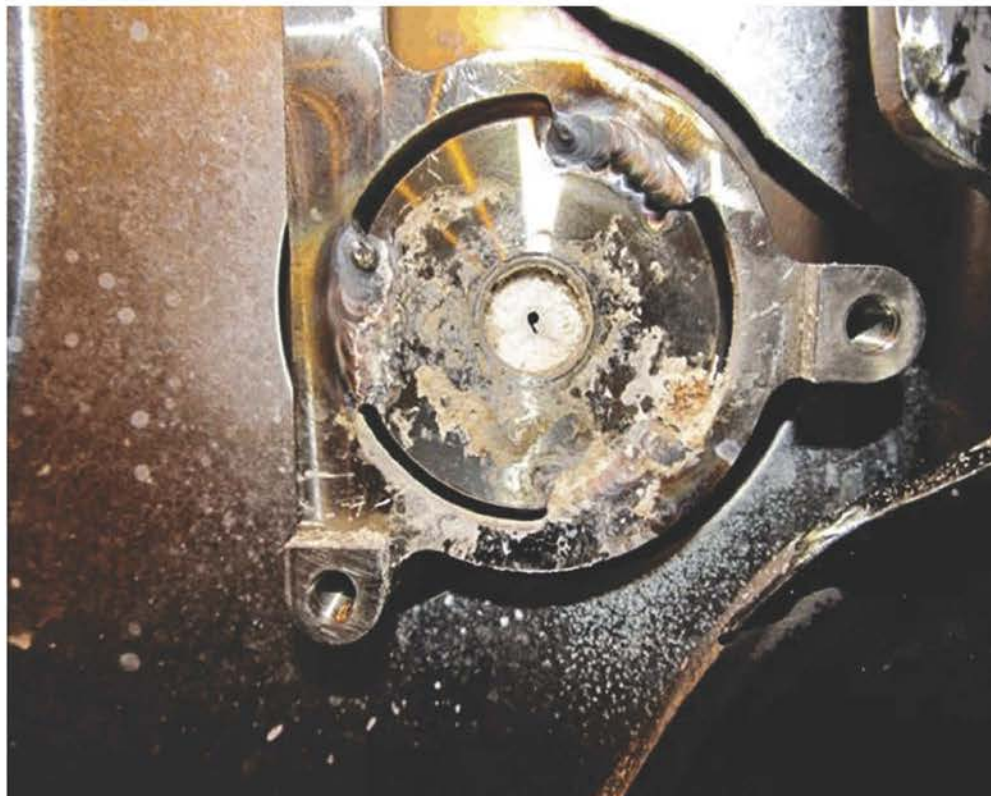
d140642

13. Inspect the area around the DEF dosing unit gasket for DEF crystallization. Is there any DEF crystallization build-up present?
  - a. Yes; this indicates the gasket has failed, NOT the DEF dosing unit. Replace the gasket after completing the DEF quantity test in the next step. Go to step 14.
  - b. No; Go to step 14.
14. Unbolt the DEF doser from the aftertreatment; do not disconnect the DEF lines or electrical connector.

**Figure 1. Normal DEF Crystallization in the DEF Doser Port Hole**

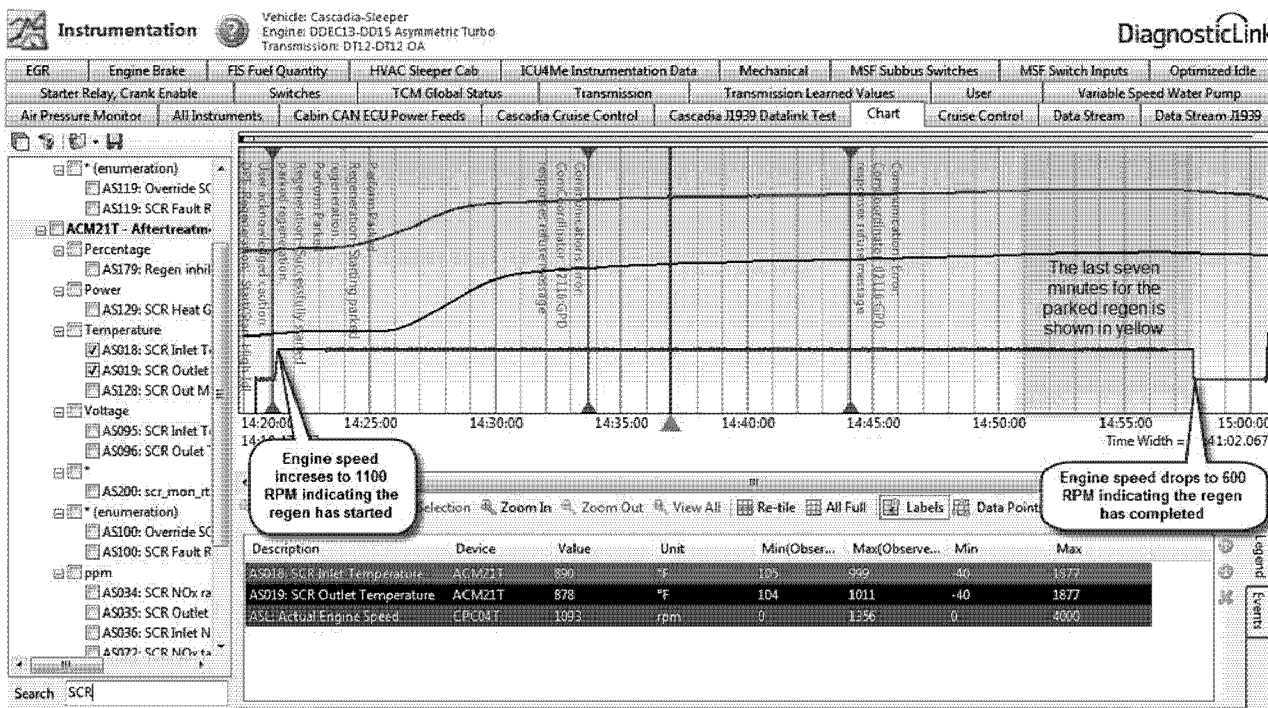
d500301

24. Review the last seven minutes of the parked regeneration log data from step 23. The illustration below identifies the last seven minutes of the parked regen.

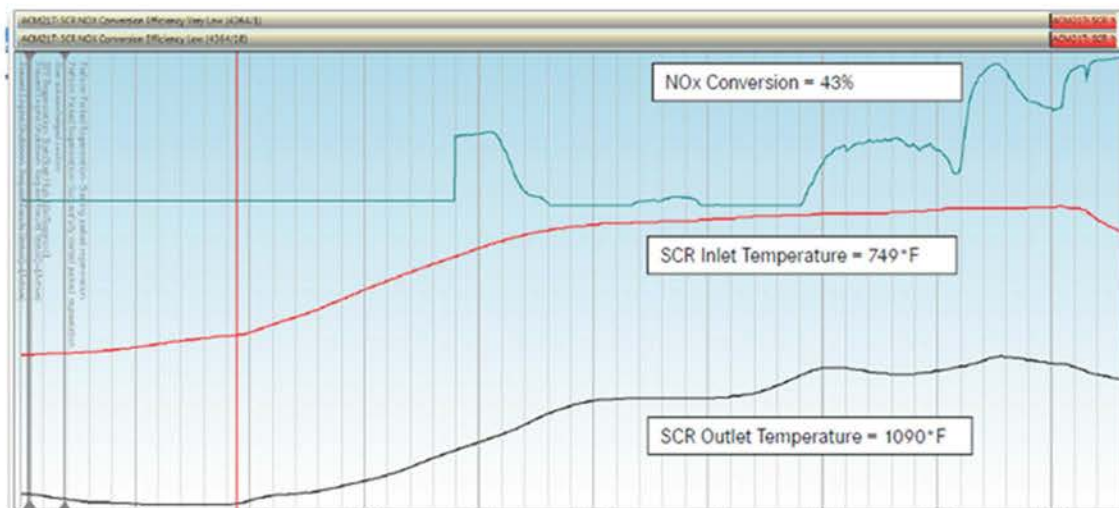
d500302

25. Is the Selective Catalyst Reduction (SCR) inlet temperature lower than SCR outlet temperature by more than 38°C (68.4°F)?

**Example:** SCR outlet temperature is 588°C (1090°F) - SCR Inlet Temp 398°C (749°F) = 171°C (341°F). Difference between inlet and outlet is 171°C (341°F), which is greater than 38°C (68.4°F)?

- a. Yes; Go to step 27.
  - b. No; for a 1-Box™ system, replace the DOC/SCR module. For a Two-Box system, replace the SCR module. Complete the ATD checklist to identify cause of failure. Go to step 26.
26. Perform a Parked SCR Efficiency Test to clear the regulatory fault. Refer to section "GHG17 Perform Parked SCR Efficiency Test".
27. Review the data from the "Perform the GHG17 Perform Performance Check - Low Temperature ATD" check in step 20. Is the calculated SCR inlet temperature and SCR outlet temperatures sensor readings within 25°C (45°F) at the end of the low temp regen?
- a. Yes; this indicates internal structural damage for a One-Box, replace the DOC/SCR module. The ATD checklist is **NOT** required since the ATD is the primary failed part. This image below illustrates the possible internal damage to the aftertreatment. Go to step 28.
