GLOBAL SAFETY FIELD INVESTIGATIONS
DCS5111
URGENT - DISTRIBUTE IMMEDIATELY

Subject: N192210570 - Special Coverage
Center High Mount Stop Lamp Water Leak

Models: 2016 – 2017 Chevrolet Malibu

N192210570 Center High Mount Stop Lamp Water Leak

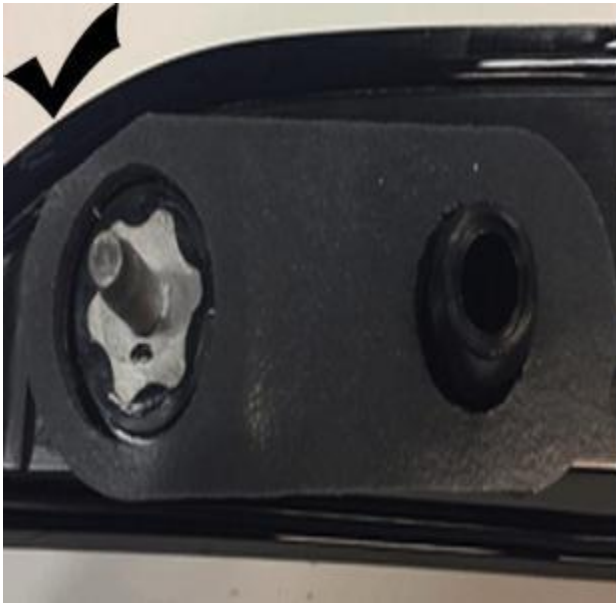
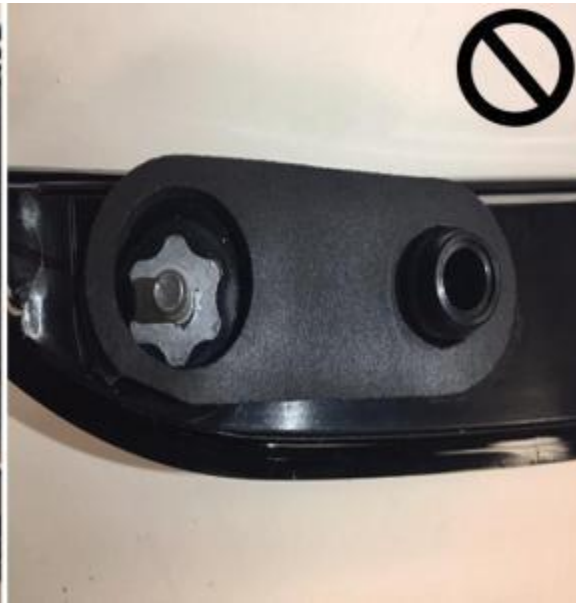
4641386

Caution: Make sure the gasket is centered and does NOT ride up the fastener joint. A water leak may occur if the gasket is not installed properly. Refer to the pictures above.

4. Install the NEW gaskets on the high mount stop lamp.
5. Install the high mount stop lamp in the vehicle.
