## SERVICE BULLETIN

**APPLICABILITY:** 2015-16MY Legacy and Outback Models

**NUMBER:** 12-192-15R

**SUBJECT:** Windshield Cracking Concerns

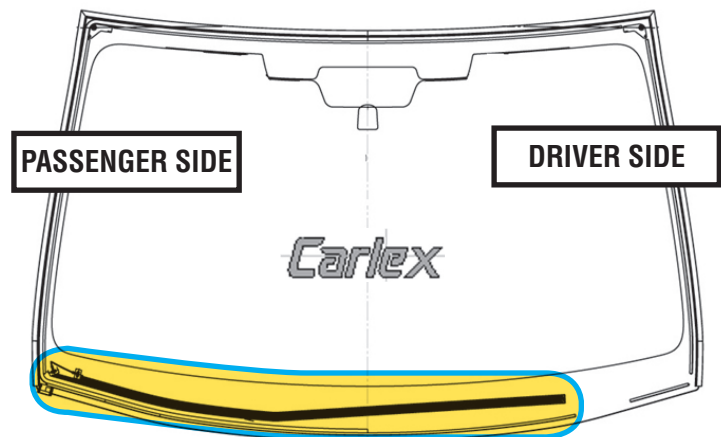
**IMPORTANT:** The information in this bulletin is only applicable to certain windshield glass manufactured by CARLEX and equipped with the windshield wiper deicer feature (part of the All-Weather Package) on vehicles within the specified VIN ranges. The affected windshields can develop cracks when impacted in the printed black area of the highlighted wiper deicer area shown in the illustration below.

**IMPORTANT NOTE:** The illustration to the right shows the windshield as viewed from OUTSIDE the vehicle.

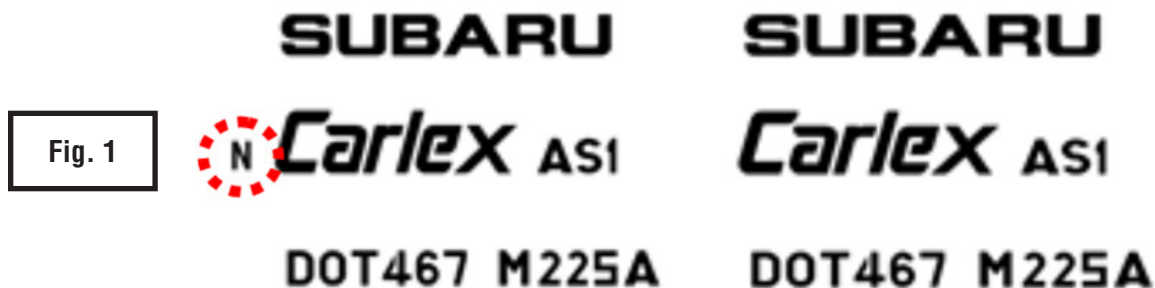
Fig. 1

The original windshields (before production change) can be easily identified by the identification markings found in the lower left, driver's side corner shown in Figure 1 below.

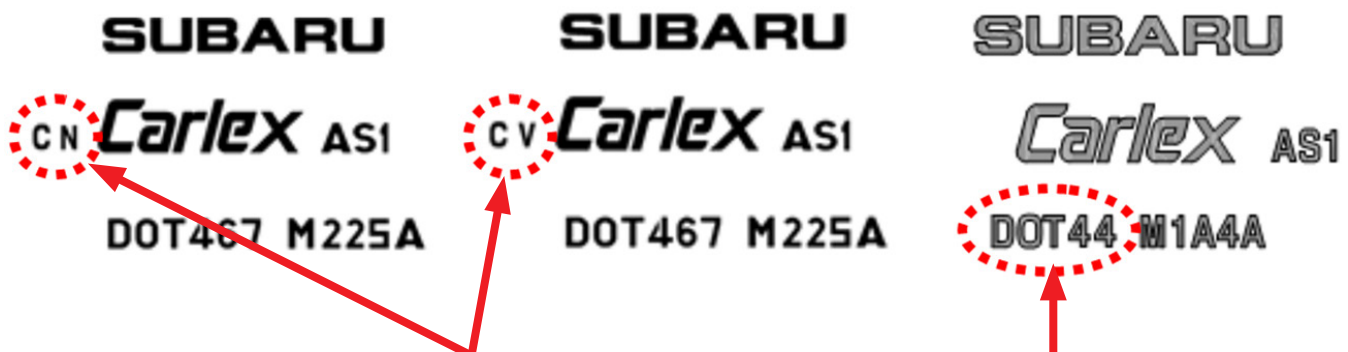
Fig. 2

The enhanced production parts and replacement part windshields are identified by the additional identification markings (CN, CV, DOT44) as shown in Figure 2 below. Windshields with these markings are NOT eligible for replacement under the warranty extension.

These 2 production markings can be found on production or replacement part windshields.

This marking is found on replacement part windshields only.

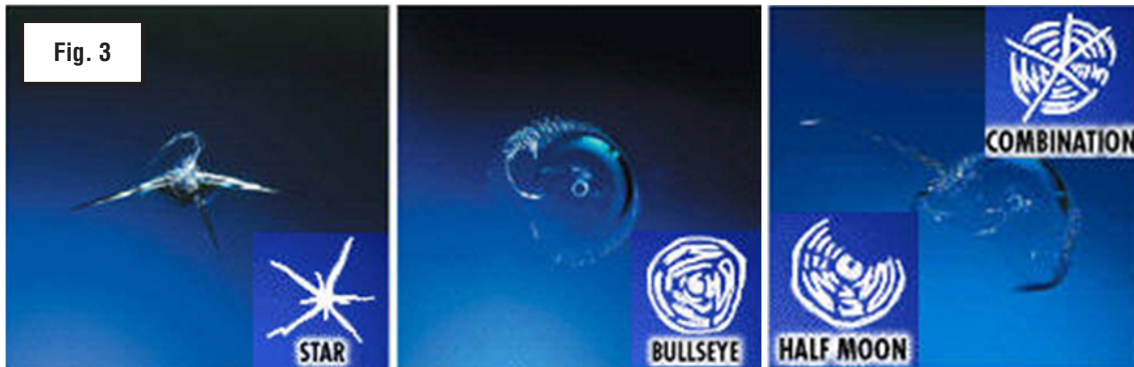
Confirm the windshield is actually cracked and the crack does not originate from a bulls eye, star, or combination impact (refer to the images in Figure 3 below). These types of damage would only be covered by this warranty extension if the windshield is identified as having the above outlined condition and the damage originates in the affected wiper deicer area. **DO NOT submit an Authorization Request for a windshield replacement which will be covered by the warranty extension outlined in this Service Bulletin.**

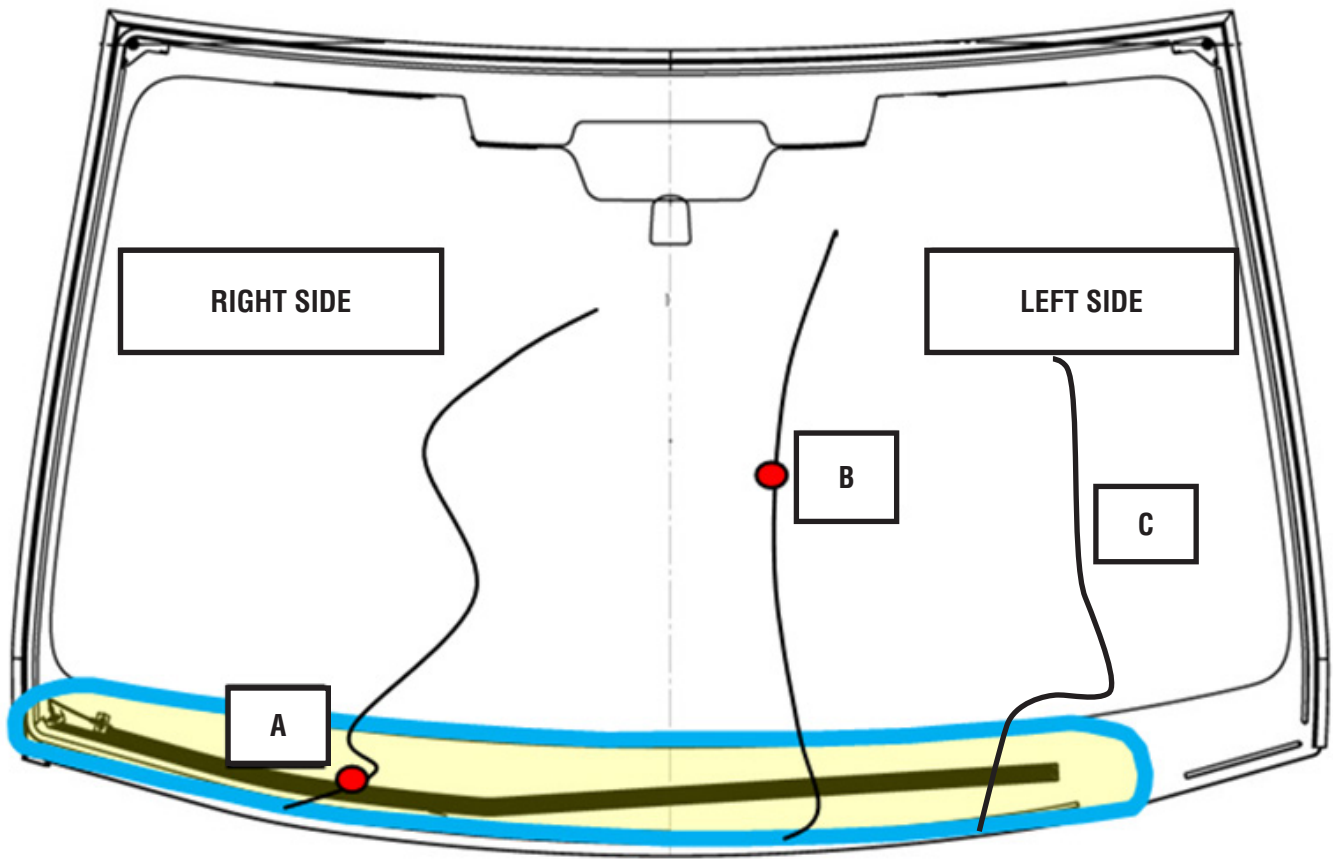
- If an impact point is found within the affected deicer area (as shown by "A" in the illustration below), proceed with windshield replacement under the terms of this warranty extension.
- If the impact point is found outside of the affected area (as shown by "B" in the illustration below), this bulletin and warranty coverage do not apply.
- If an impact point cannot be identified and the crack passes through the affected area (as shown by "C" in the illustration at the top of the next page), proceed with windshield replacement under the terms of this warranty extension.

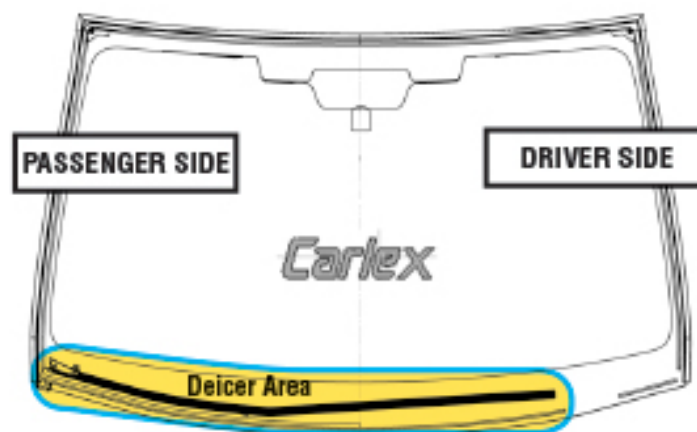
During the windshield glass manufacturing process certain compounds used to adhere the deicer to the lower portion of the windshield created a condition where the glass became more susceptible to cracking following a minor wound to the glass due to some outside force such as a stone impact. When this occurs the damage to the glass generally appears very minor or may even be invisible but the glass may crack as a result. If the crack originates or passes through the deicer (lower) area of the windshield then this condition may be the cause. (Please refer to the diagram below.) If the impact is severe enough to cause glass penetration, starring, or other severe damage, it is not caused by this condition since such an impact would also result in damage to the windshield even at its normally expected strength. Damage to other areas of the windshield, regardless of the cause, do not result from a manufacturing defect and consequently are not eligible for coverage either under your vehicle's original limited warranty or under the extended warranty described in this letter. In addition, only genuine Subaru original or replacement windshields are eligible for warranty coverage.

**NOTE:** The illustration shows the windshield as viewed from the **OUTSIDE** of the vehicle.
