PRODUCT CAMPAIGN BULLETIN

APPLICABILITY: 2003-2004 Baja
 2003-2008 Legacy and Outback
 2004-2005 Impreza, WRX, STI

SUBJECT: Takata Front Passenger Air Bag Inflator Replacement

NUMBER: WQR-53R
DATE: June 2, 2015
REVISED: April 12, 2016
NHTSA ID: 15V-323

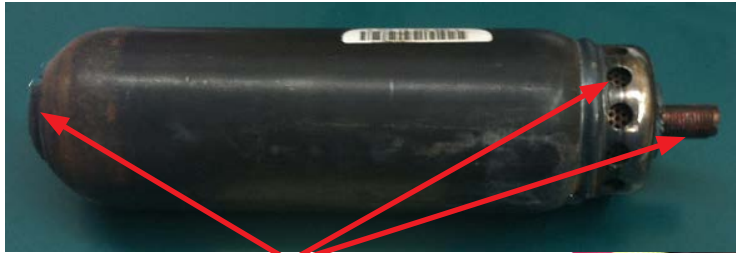
The shape, holes, and copper-colored stud indicate this not a Genuine Subaru inflator.

- **Do not proceed with this repair if your inspection reveals a non-Genuine Subaru air bag module has been installed in the vehicle.** Follow the instructions described in the “Counterfeit Air Bag Information” Dealer Advisory Bulletin and contact the SOA Warranty Helpline to close out the WQL-48 recall coverage on the vehicle.

- Document the presence of the aftermarket or counterfeit device on the repair order and with photos. Report this information immediately on a Quality Monitoring Report (QMR).
- Once the QMR has been submitted, contact the Subaru Claims Helpline to discuss the details. They will advise you on how to proceed with treatment of the open campaign.

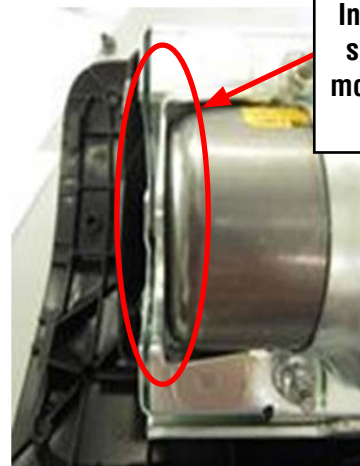
Inflator properly seated against mounting bracket (NO GAP)

STEP 9- Install the new inflator into the mounting bracket so the yellow taped end aligns with the removed stopper plate. Make sure the “D-shaped” portion of the inflator harness connector boss aligns with the “D-shaped” portion of the hole in the end of the mounting bracket as shown below. When properly installed, the end of the inflator will be seated tight against the mounting bracket. Do not peel the white harness connection dust cover at this time.
