Device	XMC1400
Marking/Step	EES-AA, ES-AA, AA
Package	PG-VQFN-40/48/64, PG-LQFP-64, PG-TSSOP-38

Overview

This “Errata Sheet” describes product deviations with respect to the user documentation listed below.

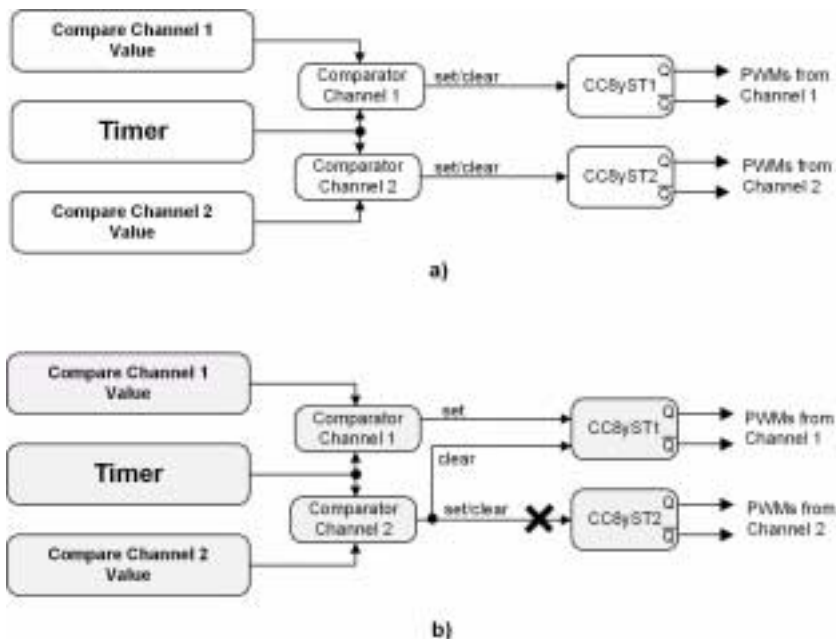
Figure 1 CCU8 simplifier PWM generation scheme - a) normal mode; b) asymmetric mode

The asymmetric mode has a bug, where the PWM signal of Compare Channel 2 is not stored in CC8yST2. This means that from the Compare Channel 2 the timer cannot generate any PWM signal - depicted by the cross on **Figure 1 b**).

Note that the asymmetric PWM is still stored in CC8yST1 and can be used normally by the application.

None

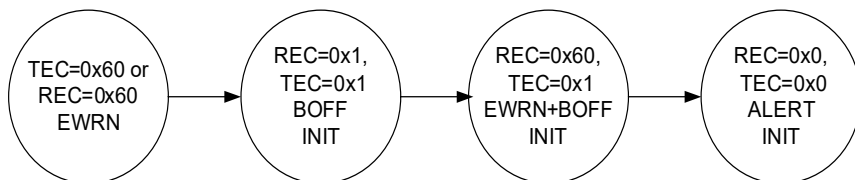
Figure 3 Alert Interrupt Behavior in case of Bus-Off

The MultiCAN module shows the following behavior in case of a bus-off status:

When the threshold for error warning (EWRN) is reached (default value of Error Warning Level EWRN = 0x60), then the EWRN interrupt is issued. The bus-off (BOFF) status is reached if $TEC > 255$ according to CAN specification, changing the MultiCAN module with REC and TEC to the same value 0x1, setting the INIT bit to 1_B, and issuing the BOFF interrupt. The bus-off recovery phase starts automatically. Every time an idle time is seen, REC is incremented. If REC = 0x60, a combined status EWRN+BOFF is reached. The corresponding interrupt can also be seen as a pre-warning interrupt, that the bus-off recovery phase will be finished soon. When the bus-off recovery phase has finished (128 times idle time have been seen on the bus), EWRN and BOFF are cleared, the ALERT interrupt bit is set and the INIT bit is still set.

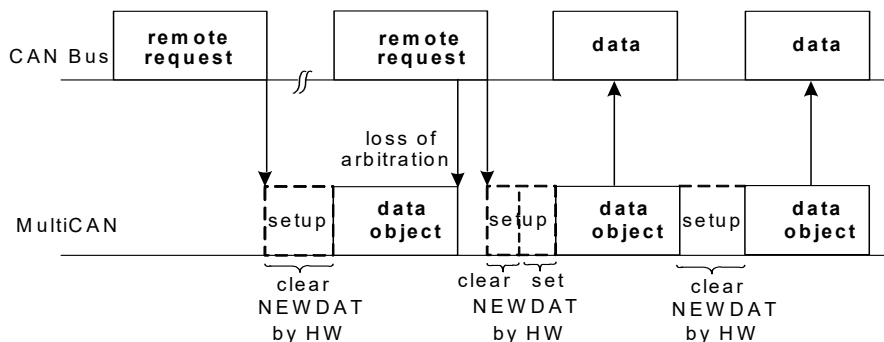
Figure 4 Loss of Arbitration

When the appropriate message object (data frame) triggered by the first remote frame wins the arbitration, it will be sent out and NEWDAT is not reset. This leads to an additional data frame, that will be sent by this message object (clearing NEWDAT).

There will, however, not be more data frames than there are corresponding remote requests.
