# 2018 Annual Inspection Report

for Compliance with the Coal  
Combustion Residuals Rule  
(40 CFR Part 257)

## **Valmont Station**

**January 18, 2019**

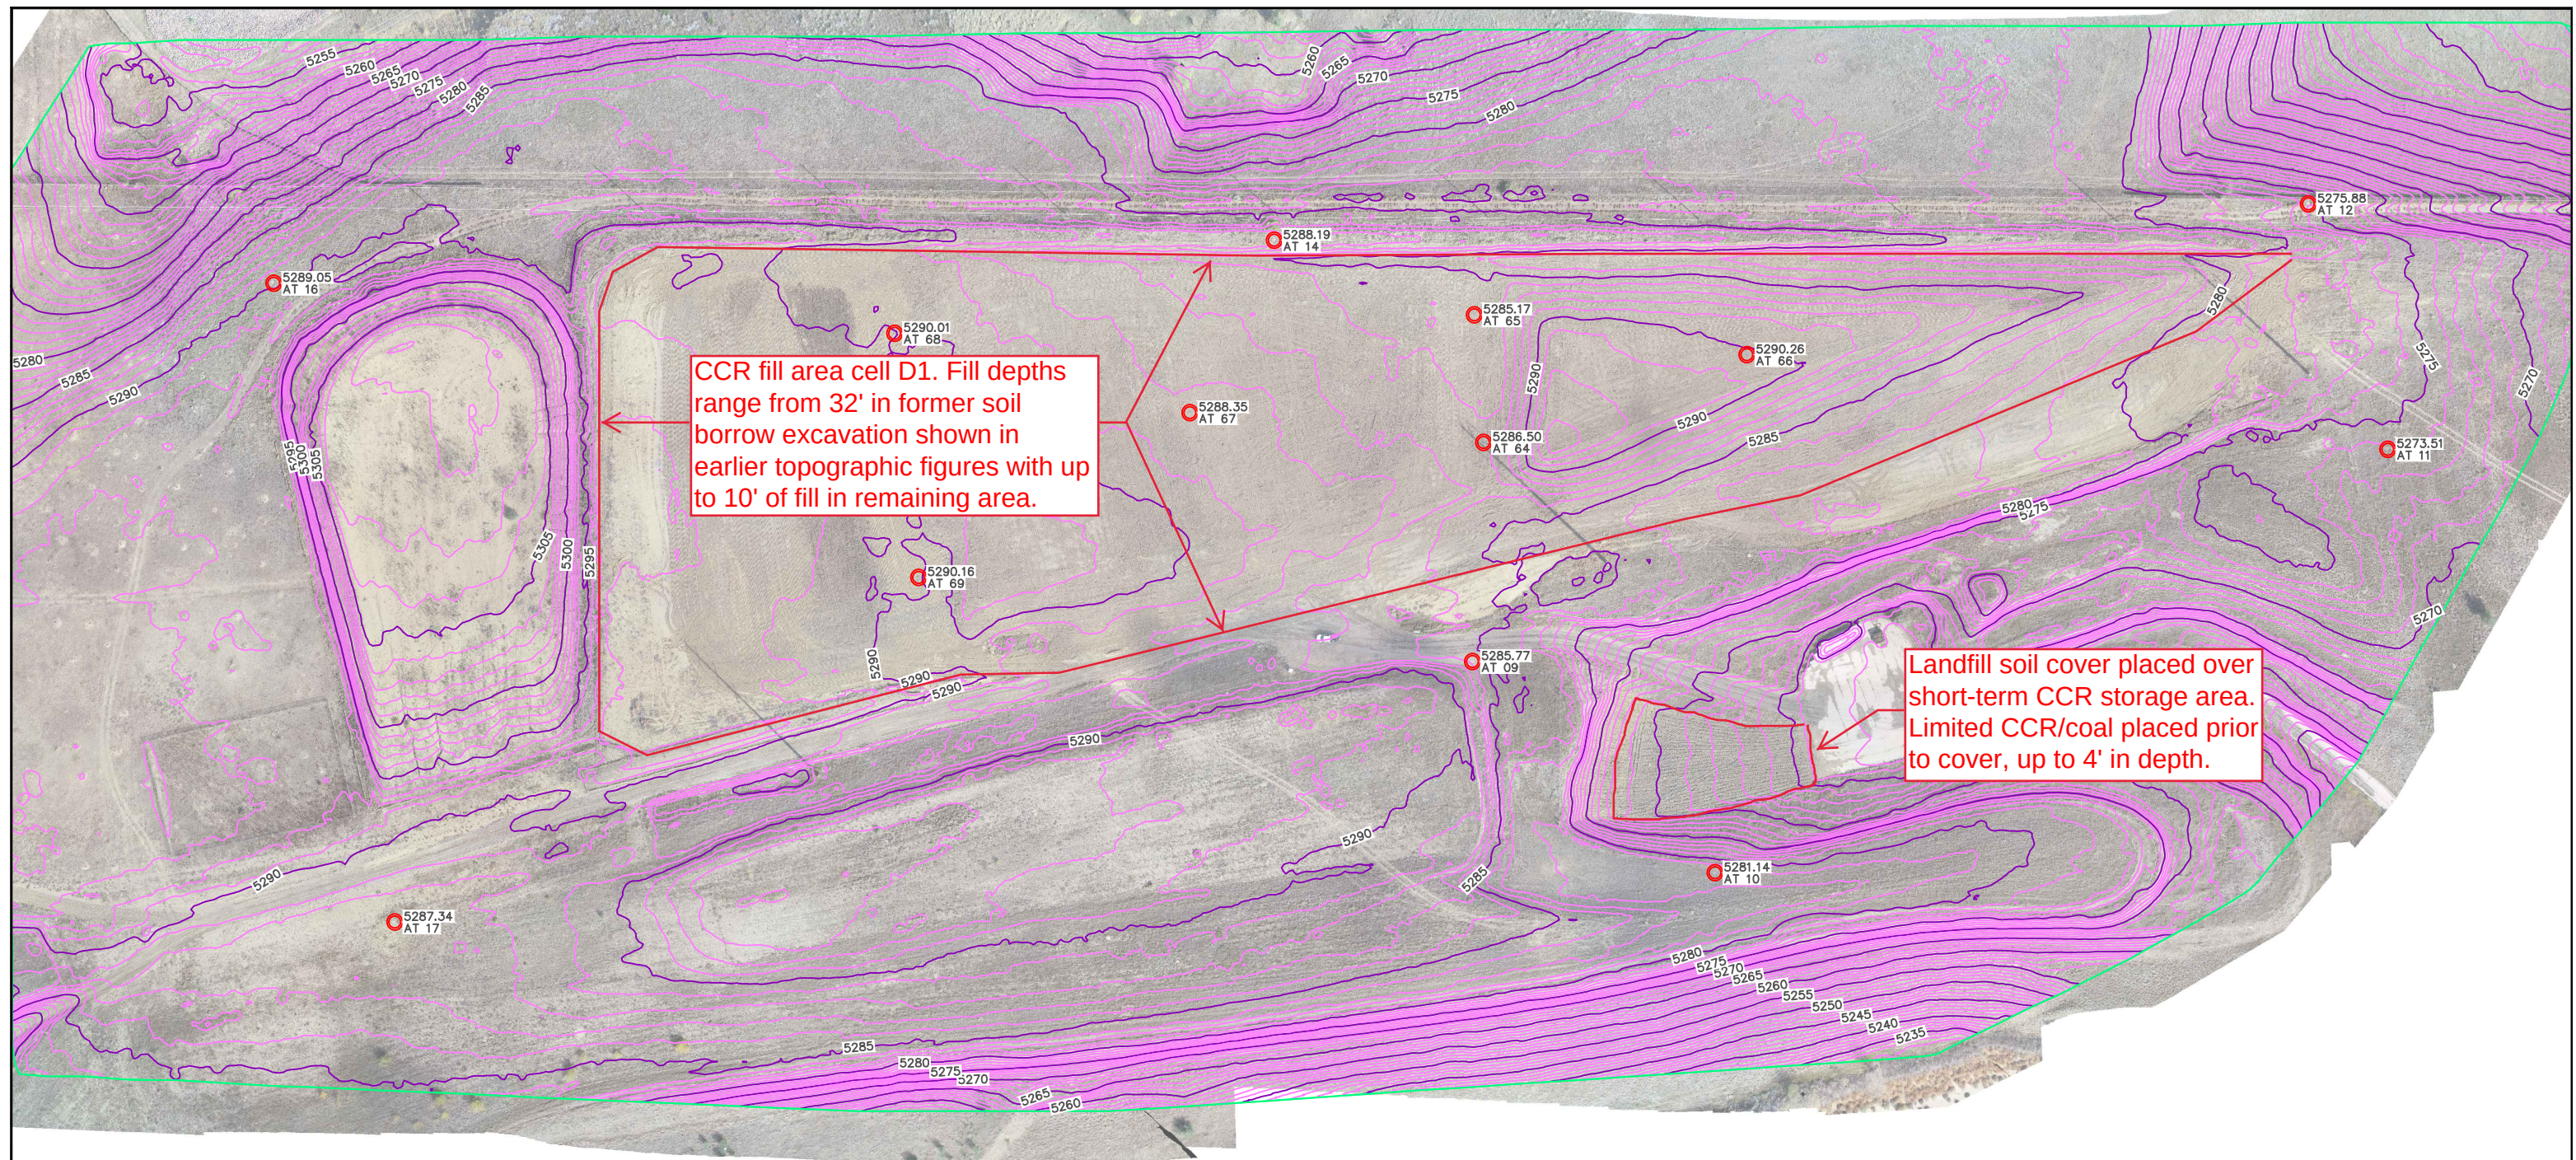
## XCEL ENERGY - VALMONT ASH IMPOUNDMENT CLOSURE ASH DISPOSAL FACILITY FINAL GRADE BOULDER, CO

Red boxed text added by HDR as part of Site CCR Landfill Annual Inspection, reporting date January 2019  
CCR Annual Report Figure 3.
