David J. Johnson
 Director
 Service Engineering Operations
 Ford Customer Service Division

May 21, 2021

SUBJECT: Safety Recall 19S54 – Supplement #2
 Certain 2006-2010 Model Year Fusion/Milan/MKZ/Zephyr Vehicles Equipped with Anti-Lock Brake Systems
 DOT 3 Brake Fluid and Anti-Lock Brake System Function

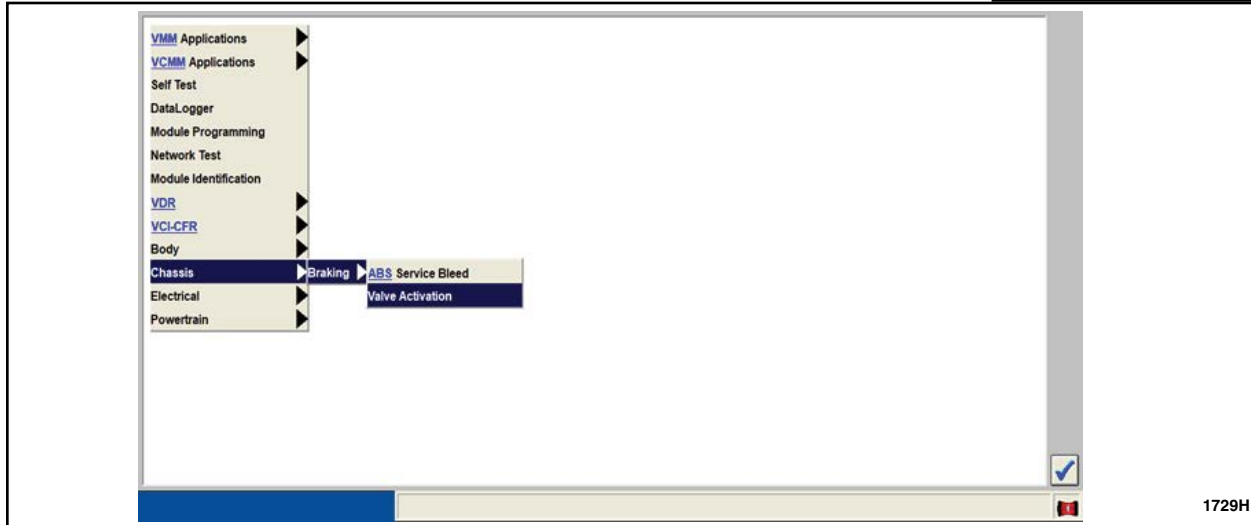
FIGURE 1

6. Select the "Tool Box" tab then "Chassis", "Braking" then "Valve Activation". See Figure 1.
7. Follow the on screen prompts to complete the procedure. See Figures 2 through 11, for screenshots of the process, and applicable notes.
 - The procedure will complete the activation of the valves a total of four times.

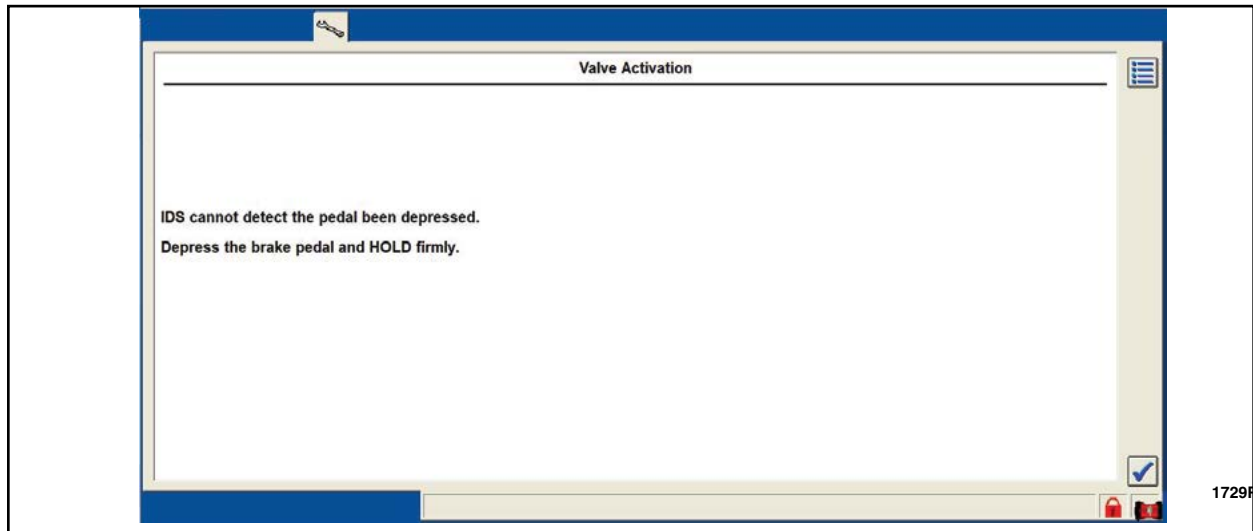
FIGURE 6

NOTE: Brake pedal must be depressed when prompted to complete the IDS routine, **if brake pedal is not depressed** you will receive a message prompting you to do so. See Figure 6.

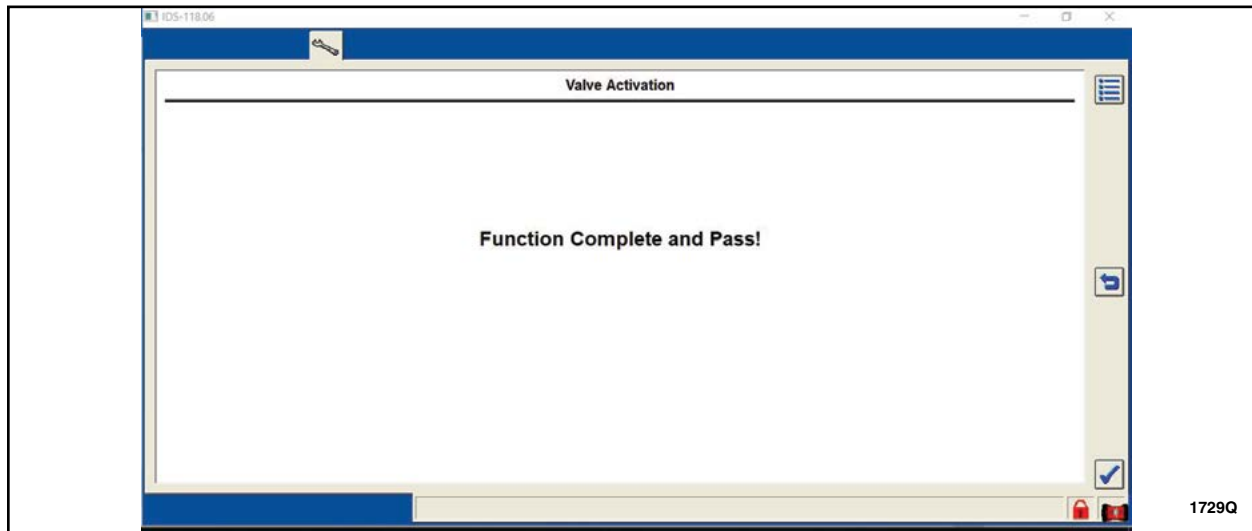
FIGURE 10

NEW ! NOTE: At the end of the IDS routine, after the activation of the valves has completed a total number of four times, you will receive one of the two possible screens shown below determining if the IDS routine has passed or failed. **The activation of the valves four times is completed within the IDS service function. Do NOT repeat the IDS Valve Activation routine multiple times - this is recorded in the IDS log file. SSSC contacts with multiple pass or fail results will not be approved, additional information will be requested.** See Figures 10 and 11.

NOTE: If the IDS routine ends with a Function Complete and Pass screen, See Figure 10 the brake system will need to have the DOT 3 brake fluid removed and replaced with DOT 4.

HCU Passes inspection - Proceed to Valve Activation PASSES IDS Routine, on Page 9.
HCU Replacement Not Required.

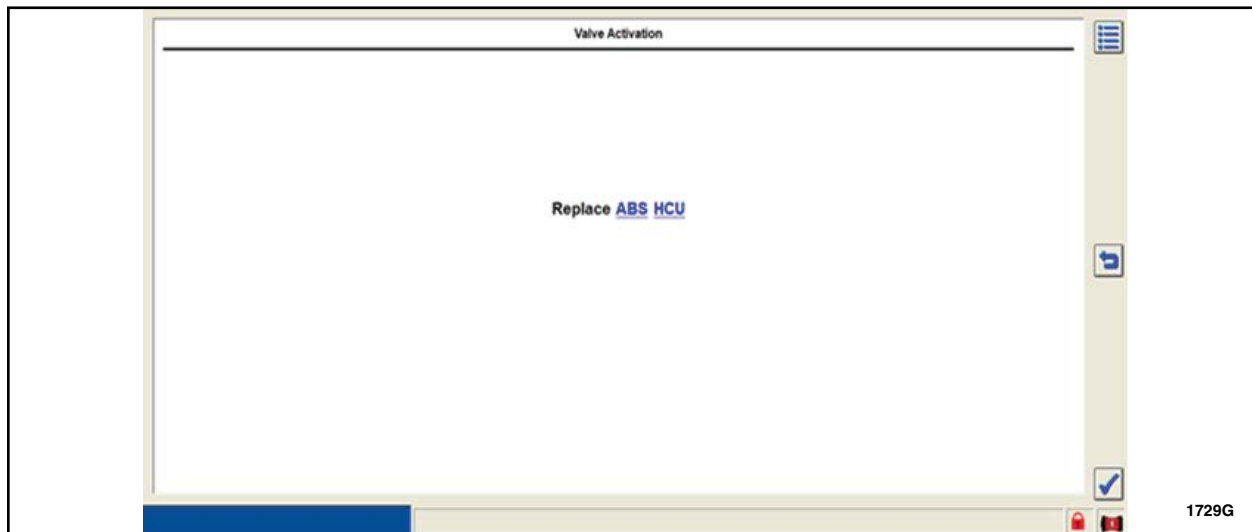
FIGURE 11

NOTE: If the IDS routine ends with a Replace ABS HCU screen, See Figure 11. Documents will be required to be submitted to the SSSC prior to HCU Replacement.

HCU DOES NOT PASS inspection - Proceed to Valve Activation FAILS IDS Routine, on Page 14.
This procedure will include the HCU Replacement procedure,
and Brake Fluid Change Procedure.
