## SERVICE BULLETIN

**NUMBER:** 02-166-17R

**SUBJECT:** Upper Oil Pan Assembly- Design Changes

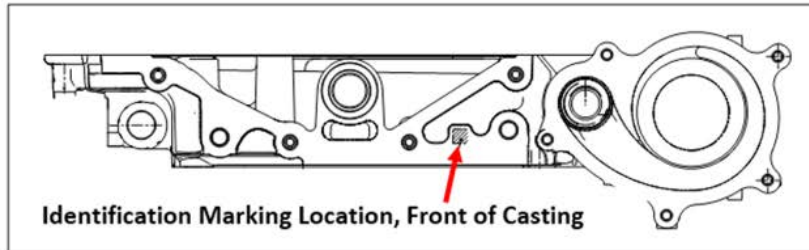
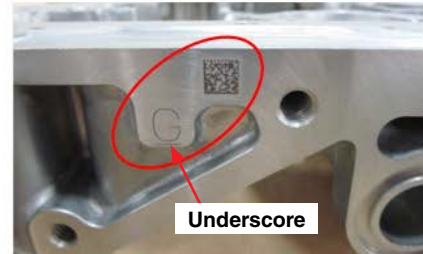
- An underscore has been added to the identification letter found on the front face next to the water pump cavity and QR code box.

**IMPORTANT NOTE:** If the identification letter is a “N”, the casting is a p.n. 11120AA250 which is NOT affected by this TSB.

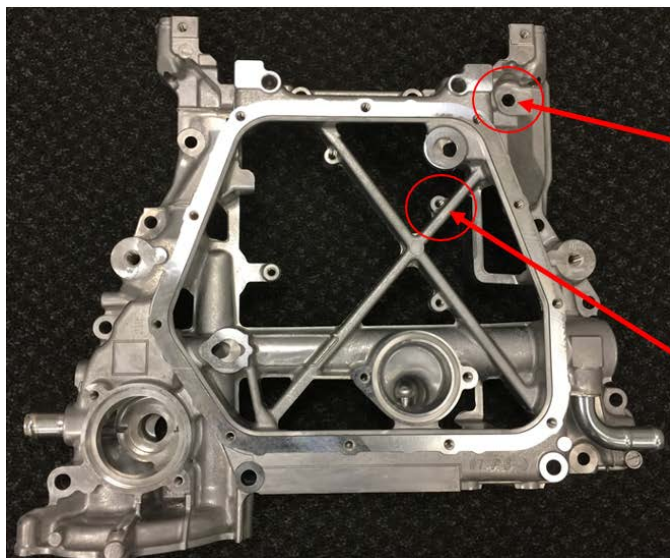
- The mating flange thickness of the casting in the area identified as the cause for the seepage has been increased by 5.5mm. (See images provided in the Parts Information section below.) This thickness increase creates the need for a longer bolt to provide proper tightening and retention.
- An additional mounting point has been added to the ribbing inside the casting to increase retention of the steel baffle plate and eliminate vibration.

- Thicker casting and an additional mounting point for the baffle plate added to the internal ribbing.

Because the thickness of the casting has been increased by 5.5mm in this area, a new, longer socket-head cap screw, p.n. 800408250 is required replacing the original hex head bolt.

An additional mounting point / bolt hole has been incorporated here to improve retention of the baffle plate. Use hex bolt p.n. 808206010.
