## PRODUCT CAMPAIGN BULLETIN

**APPLICABILITY:** 2010-2014 model year Legacy  
 2010-2014 model year Outback  
 2010-2013 model year Forester  
 2010-2014 model year Tribeca  
 2010-2011 model year Impreza  
 2010-2014 model year WRX and STI

**NUMBERS:** TKA-19  
 TKB-19  
 TKC-19

**SUBJECT:** Takata Front Passenger Airbag Inflator Replacement  
 (2019 Calendar year expansion)

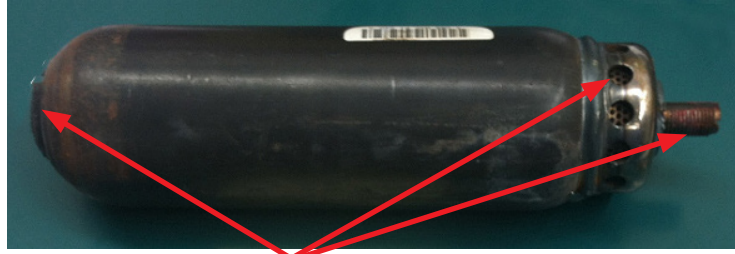
**The shape, holes, and copper-colored stud indicate this not a Genuine Subaru inflator.**

- **Do not proceed with this repair if your inspection reveals a non-Genuine Subaru airbag module has been installed in the vehicle.** Follow the instructions described in the “Counterfeit Airbag Information” Dealer Advisory Bulletin.

- Document the presence of the aftermarket or counterfeit device on the repair order and with photos. Report this information immediately on a Quality Monitoring Report (QMR). **IMPORTANT:** When entering a related QMR, use failure code **ULF** and **NOT** the campaign fail code.
