November 12, 2020

**SUBJECT: NEW VEHICLE DEMONSTRATION / DELIVERY HOLD**  
**Safety Recall 20S65**  
Certain 2020 Model Year Explorer/Aviator Vehicles  
Driveshaft Weld Seam

## CERTAIN 2020 MODEL YEAR AVIATOR AND EXPLORER VEHICLES EQUIPPED WITH A 3.0L OR 3.3L ENGINE — REAR DRIVESHAFT WELD SEAM

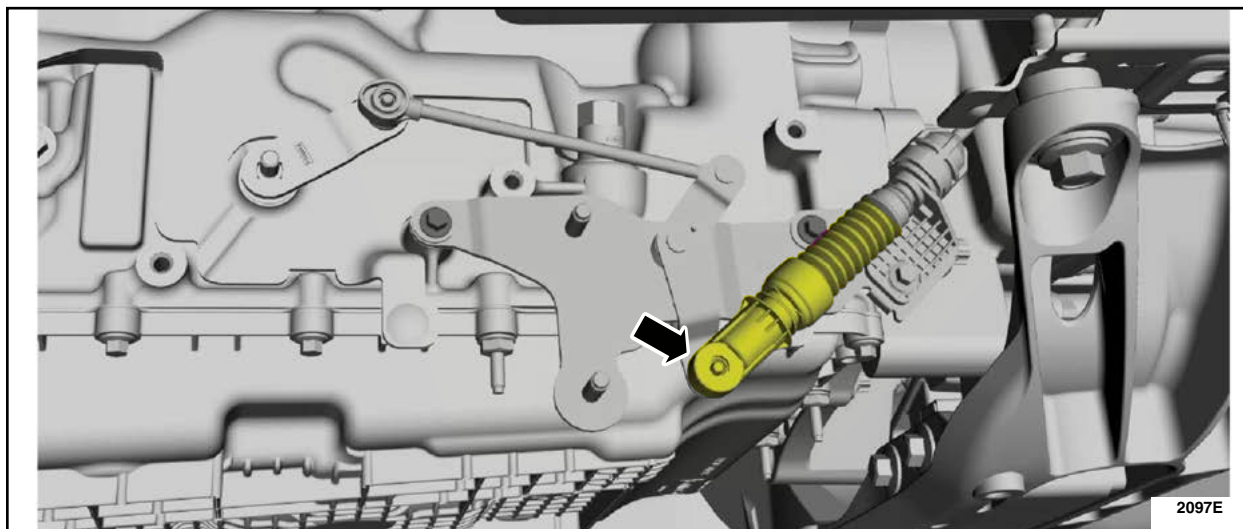
FIGURE 1

1. Position the vehicle on a hoist. Please follow the Workshop Manual (WSM) procedures in Section 100-02.
2. Disconnect the transmission park manual release cable by pulling the cable end off of the transmission manual release lever. See Figure 1.

5. Attach the transmission park manual release cable to the manual release transmission lever.

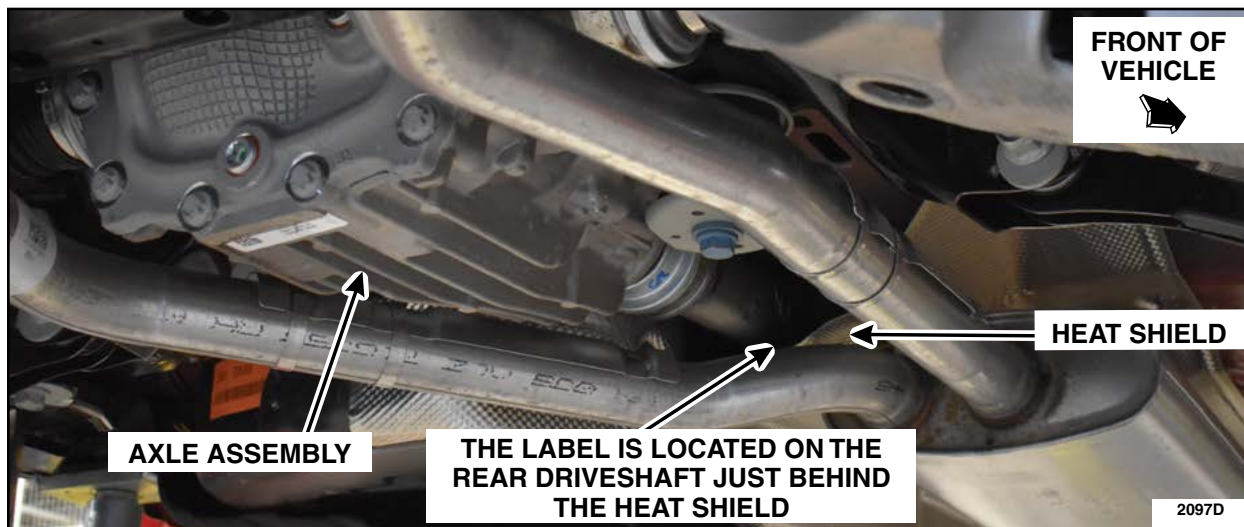
FIGURE 2

3. From the axle end of the rear driveshaft, rotate the driveshaft as needed and locate the factory driveshaft label. Then, using a flash light and a mirror record the serial number located on the lower portion of the label as shown in Figures 2 and 3.

Yes - Replace the rear driveshaft assembly. Please follow the Workshop Manual (WSM) procedures in Section 205-01. Then, proceed to Step 5.
