### ABOUT ADSP-21369 SILICON ANOMALIES

These anomalies represent the currently known differences between revisions of the SHARC® ADSP-21369 product(s) and the functionality specified in the ADSP-21369 data sheet(s) and the Hardware Reference book(s).

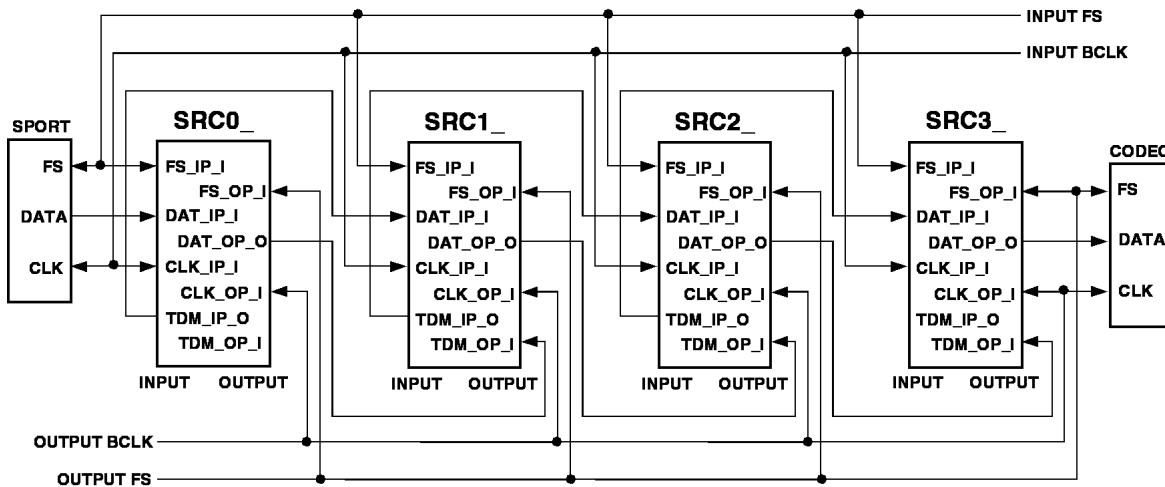
## 10. 08000020 - Input Shift Register Anomaly in ASRCs (Asynchronous Sample Rate Converters) impacts Daisy-Chained TDM mode:

In the TDM Daisy chain mode the ASRCs can be connected as follows to achieve TDM mode:

When the ASRCs are used in TDM Daisy chain mode, the MSB of the input data is lost at the output of each ASRC in the chain. This anomaly is applicable for the TDM mode in both the bypass and non-bypass modes. The following example provides the expected failure pattern for the bypass mode, since in bypass mode the incoming data is not modified by the ASRC.

The workaround for this anomaly must be carried out in software only on the device providing input data to the ASRCs in TDM daisy chain mode. It can not be implemented on the output data from the ASRCs. The workaround implementation in software adds some core MIPS to the application. For devices like ADCs/CODECs, the workaround may not be implemented directly. For such systems, two serial ports of the SHARC should be dedicated for this purpose. One serial port should be used for receiving the data from the ADC/CODEC and the other one should be used for transmitting the modified input data to the ASRC.

When the ASRCs are used in TDM daisy chain mode, only the 24-MSBs of the input 32-bit data is used and the 8-LSBs are not used by the ASRC. The anomaly can be worked around by shifting the 24-MSBs of the data to the 8-LSBs as follows:

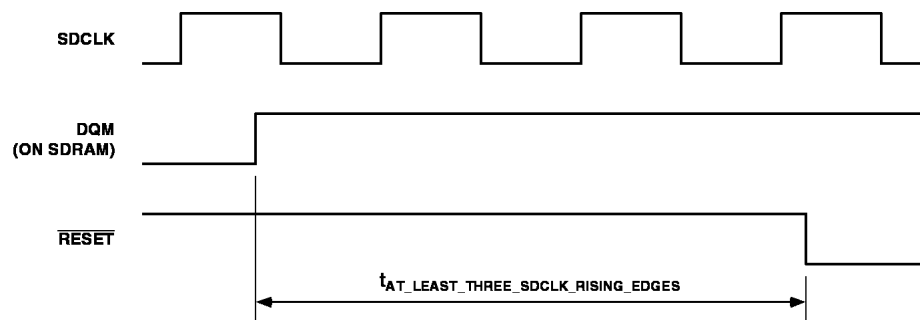
If the SHARC processor is in the process of fetching data from external SDRAM memory, initiating a Hard (hot) reset during this process may cause the SDRAM device to continue to drive the data bus during the entire duration of /RESET being asserted, and also failing to relinquish the external data bus even when the DSP comes out of /RESET.

If the DSP had been configured to boot via parallel external FLASH or EPROM (which shares part of the same data bus with the external SDRAM), the resulting bus contention on the external data bus between the DSP trying to boot from the FLASH memory and the SDRAM continuing to drive the data bus causes incorrect boot data to be loaded in, and the booting operation fails.

Providing an external delay of at least 3 SDCLK clock cycles between the SDRAM's DQM signal and the /RESET\_IN to the DSP will also cause the problem to be avoided (see attached Figure).
