Device **TC29x**
Marking/Step **ES-BC, BC**
Package **see Data Sheet**

This Errata Sheet describes the deviations from the current user documentation.

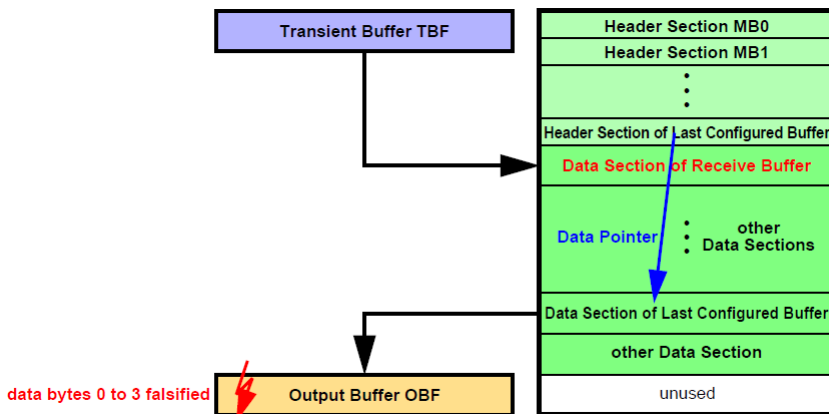
Figure 1 Message buffer transfer from Message RAM to OBF

When the message buffer has its payload configured to maximum length (PLC = 127), the OBF word on address 00h (payload data bytes 0 to 3) is overwritten with unexpected data at the end of the transfer.

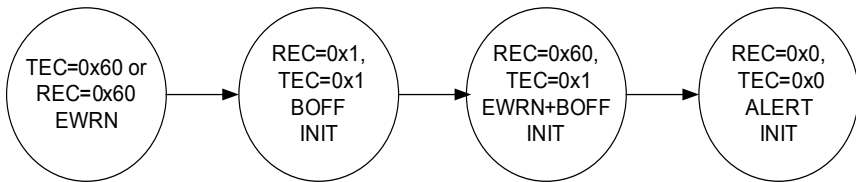
a) In 2 following ARU transfers the ARU word which shows the captured ECNT do not increment by 1.

When the threshold for error warning (EWRN) is reached (default value of Error Warning Level EWRN = 0x60), then the EWRN interrupt is issued. The bus-off (BOFF) status is reached if TEC > 255 according to CAN specification, changing the MultiCAN module with REC and TEC to the same value 0x1, setting the INIT bit to 1_B, and issuing the BOFF interrupt. The bus-off recovery phase starts automatically. Every time an idle time is seen, REC is incremented. If REC = 0x60, a combined status EWRN+BOFF is reached. The corresponding interrupt can also be seen as a pre-warning interrupt, that the bus-off recovery phase will be finished soon. When the bus-off recovery phase has finished (128 times idle time have been seen on the bus), EWRN and BOFF are cleared, the ALERT interrupt bit is set and the INIT bit is still set.

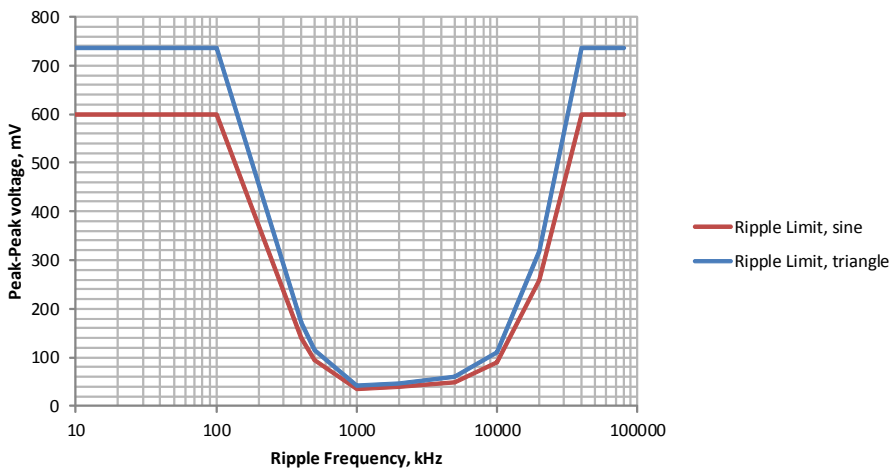
Figure 11 Ripple Voltage vs. Frequency Characteristic

The internal back-up clock is sensitive to specific power supply voltage disturbance/ripple caused by a voltage ripple intrinsic to DC-DC converters. Specific conditions such as insufficient filtering of the ripple may lead to improper behavior of the start-up scheme of the back-up clock, and thus stuck-at state during the start-up of the microcontroller until this condition is removed.

The diagram reflects acceptable ripple level during the cold start of the microcontroller at the respective VDDP3/VEXT/VEVRSB supply of the PMS subsystem, depending on the device and package type, as shown in the following table.
