April 2019  
FL807A-D  
NHTSA #19V-093  
Transport Canada #2019-066

## **Subject: Hendrickson 5 Inch Drop Axle Tie Rods**

**Models Affected: Specific Freightliner Cascadia vehicles manufactured April 30, 2012, through May 26, 2015, equipped with Hendrickson 5 inch drop axle tie rods, brake linings, and stamped spiders.**

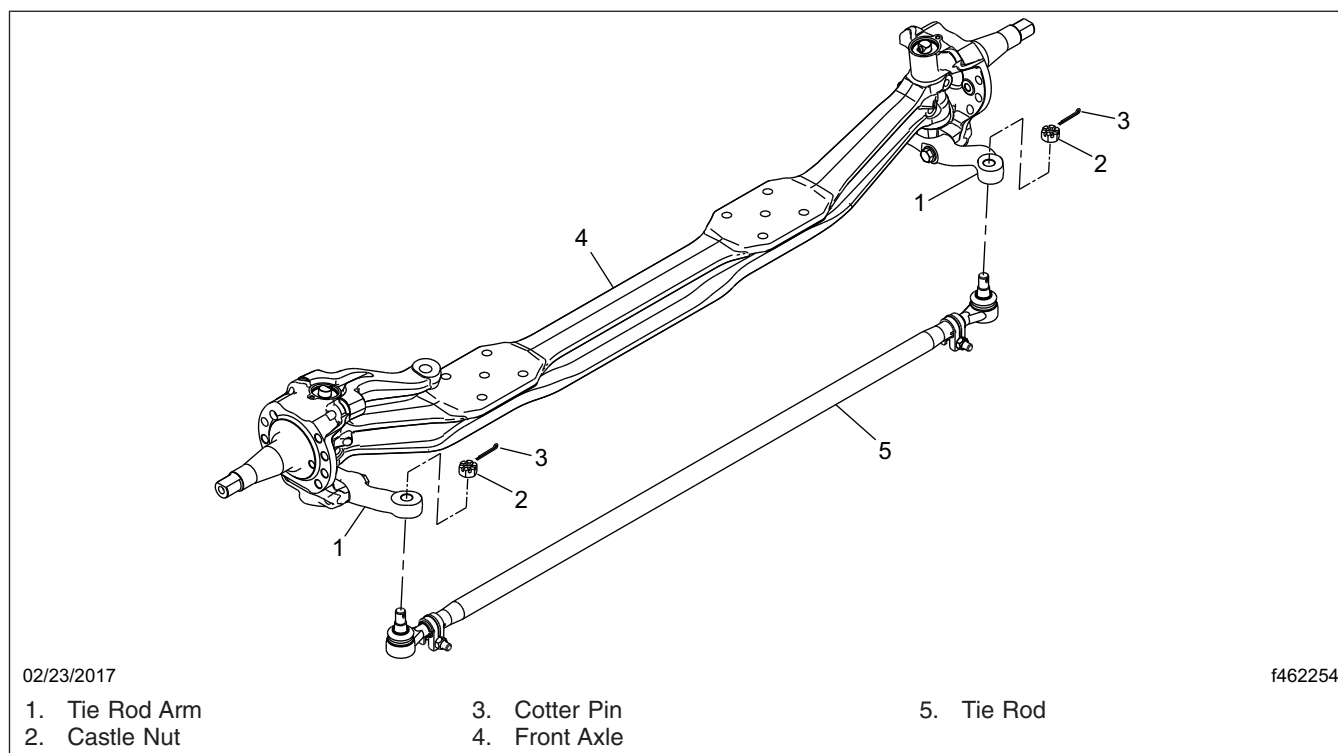
Fig. 1, Tie Rod Assembly

6. Remove the brake assembly. Refer to the applicable section in **Group 42** of the *Cascadia Workshop Manual*.
7. Disconnect the tie rod from the tie rod arms; see [Fig. 1](#). Remove the tie rod from the vehicle and discard it.

8. Attach a new tie rod to the tie rod arms. Tighten the castle nut 120 to 170 lbf-ft (163 to 230 N·m) plus a maximum of one-sixth of a turn to align a slot in the castle nut with the cotter pin hole in the tie rod stud. Insert the cotter pin and bend the tangs to secure it.
9. Clean and inspect all brake parts that will be reused. Refer to the applicable section in **Group 42** of the *Cascadia Workshop Manual*.
