## Technics SLP8

# AUDIO FAULTS

# DVD

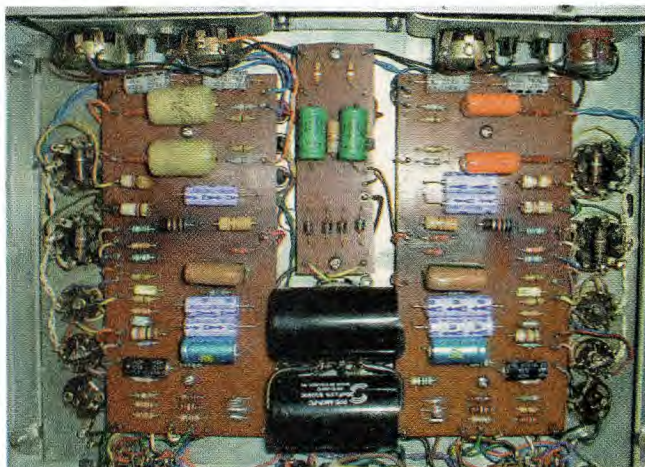
*Photo 2: Layout under the chassis. There are three PCBs, one each for the right and left channels and a small one (centre) for the silicon HT rectifiers and the bias supply components.*
