**SUBJECT: NEW VEHICLE DEMONSTRATION / DELIVERY HOLD -  
Safety Recall 21S22**

Certain 2016 - 2019 Model Year Explorer Vehicles equipped with Painted Roof Rail  
Covers  
Roof Rail Cover Detachment

## CERTAIN 2016-2019 MODEL YEAR EXPLORER VEHICLES — ROOF RACK REPAIR

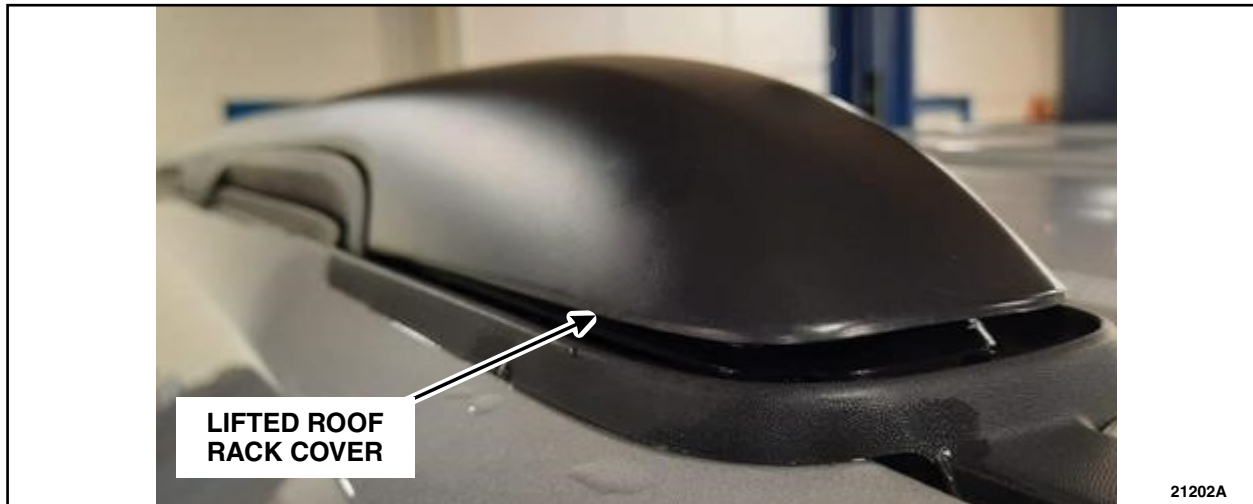
**FIGURE 1**

A loose or lifted roof rail cover in the front or rear does not indicate the need for parts to be replaced, the root cause needs to be identified in the inspection procedure. See Figures 1, 2 and 3.

**NOTE:** The roof rail base front end caps do not need to be replaced if the roof rail passes inspection. Only replace the roof rail base front end caps if damage has occurred during transfer of parts.

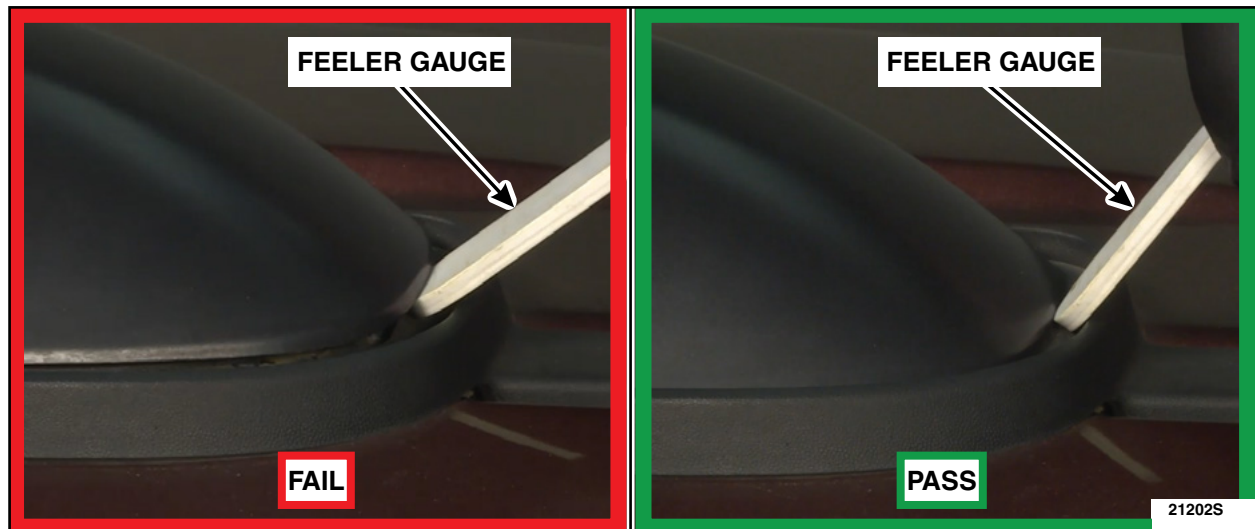
**FIGURE 4**

1. Using a 2 mm feeler gauge, check the spacing on the front and rear of both the RH and LH roof rail covers. See Figure 4. If the feeler gauge fits between the roof rail cover and the roof rail base then it fails inspection. Does the roof rail covers pass or fail?

**NOTE:** A failing roof rail cover does not require replacement at this time, further investigation is required.

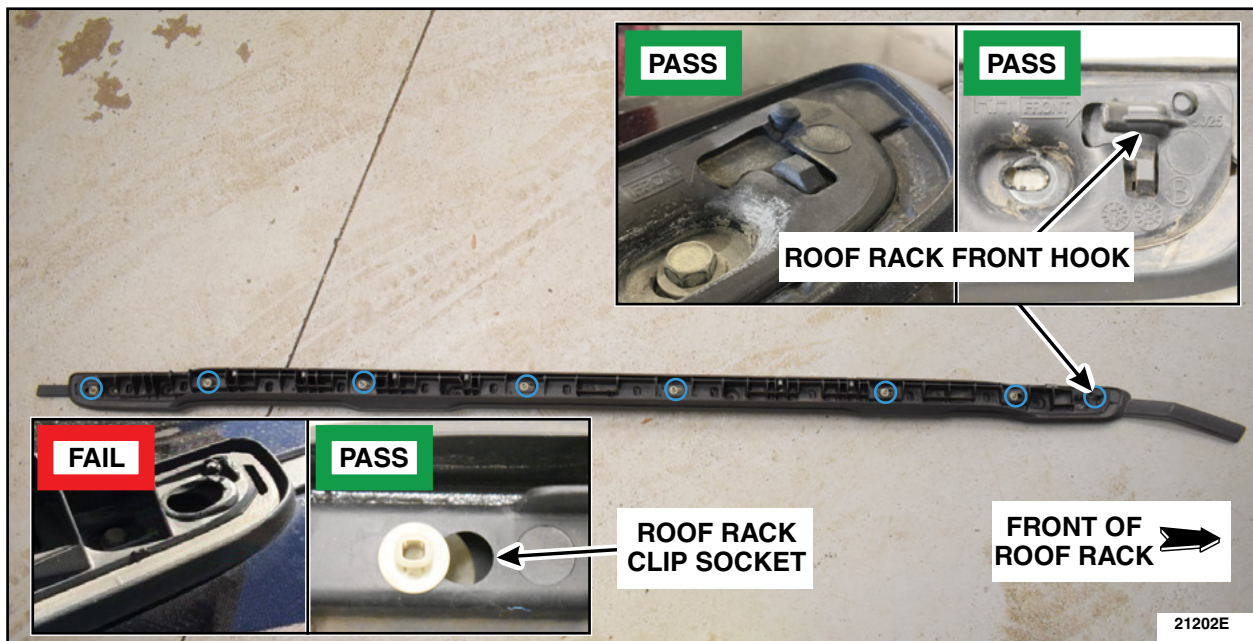
**FIGURE 6**

**NOTE:** A broken roof rail base hook does not need to be replaced.

i. If broken, take photos of roof rail base for both the RH and LH.

2. Damaged roof rail bases must be clearly identified with a bright highlighter or similar.

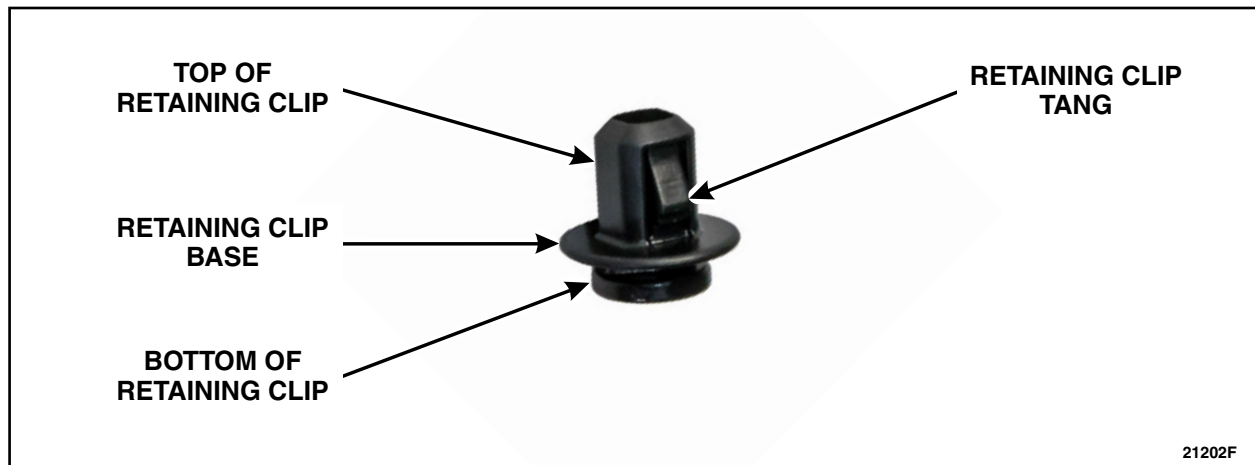
**FIGURE 7**

ii. Clips that cannot be reused:

- Missing.
- All or partial of the top missing from the clip base.
- Broken retaining tang.
- Covered in epoxy from a previous repair.

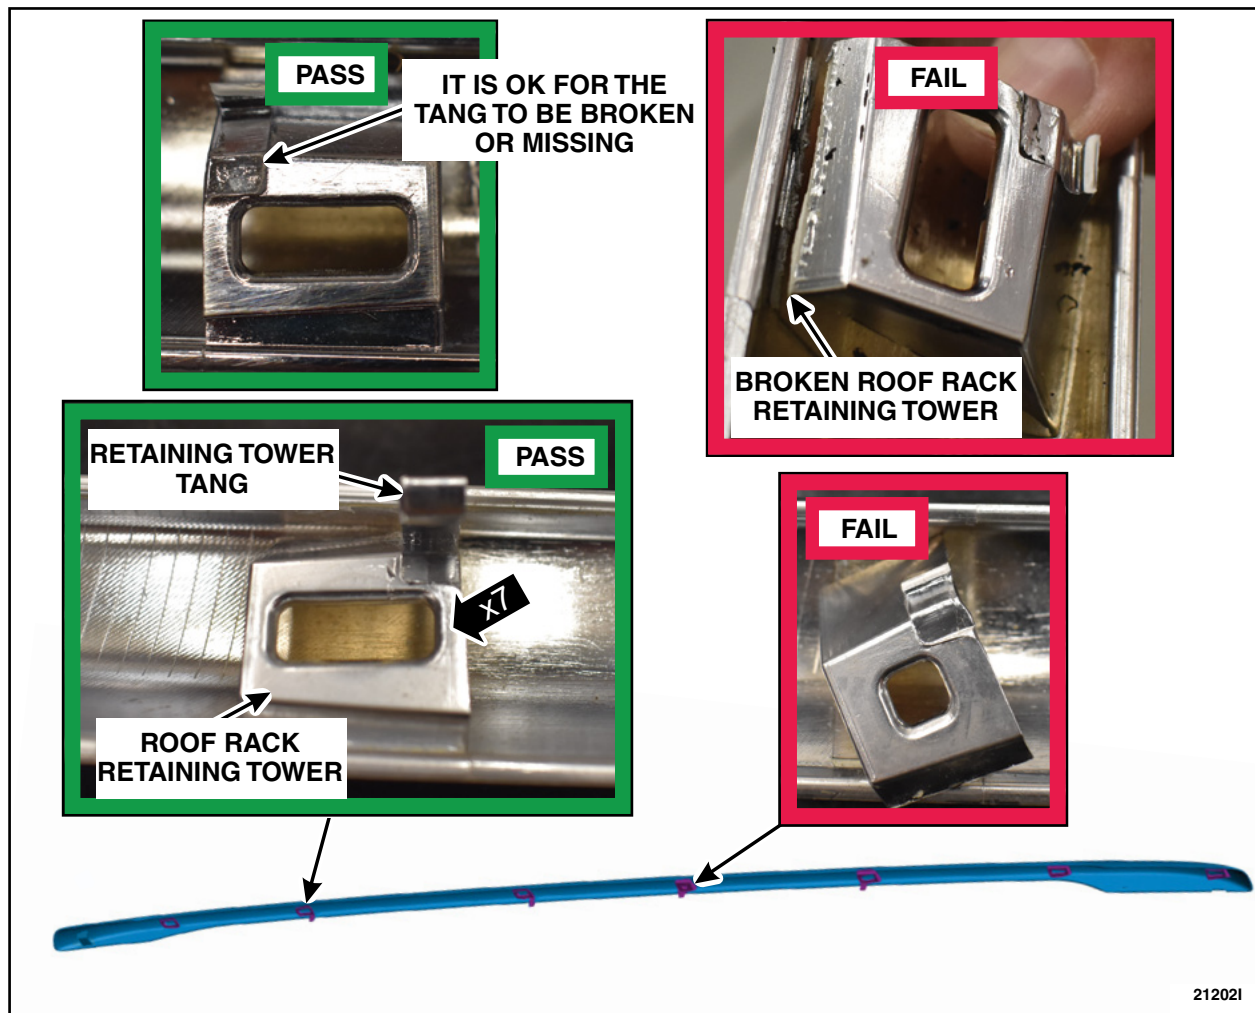
FIGURE 9

i. Broken tangs do not require replacement.

ii. If broken, take photos of retaining towers on the roof rail covers.

2. Broken retaining towers must be clearly identified with a bright highlighter or similar.

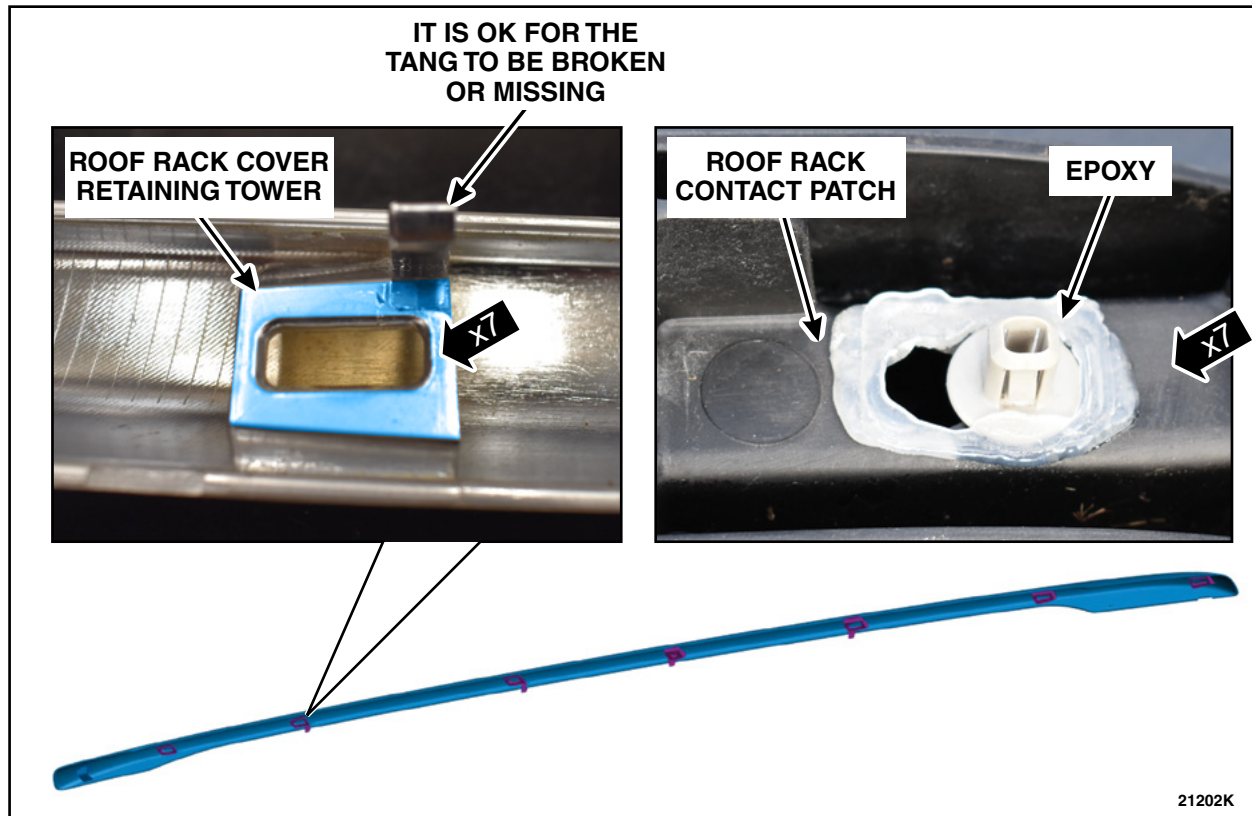
**FIGURE 11**

1. If Technical Service bulletin (TSB) 19-2364 or 20-2154 was performed, evidence of RTV or expoxy will be seen on the roof rack cover and or roof rail contact patch. Inspect the roof rack cover retaining tower and roof rail contact patch for signs of RTV or epoxy adhesive. See Figure 11. Was evidence of RTV or epoxy found?

If **YES** - Replace all the roof rail clips on the affected side, then proceed to Step 2 on Page 11.
