2015 Initial Annual Inspection Report

for Compliance with the Coal
Combustion Residuals Rule
(40 CFR Part 257)

Hayden Station

January 18, 2016

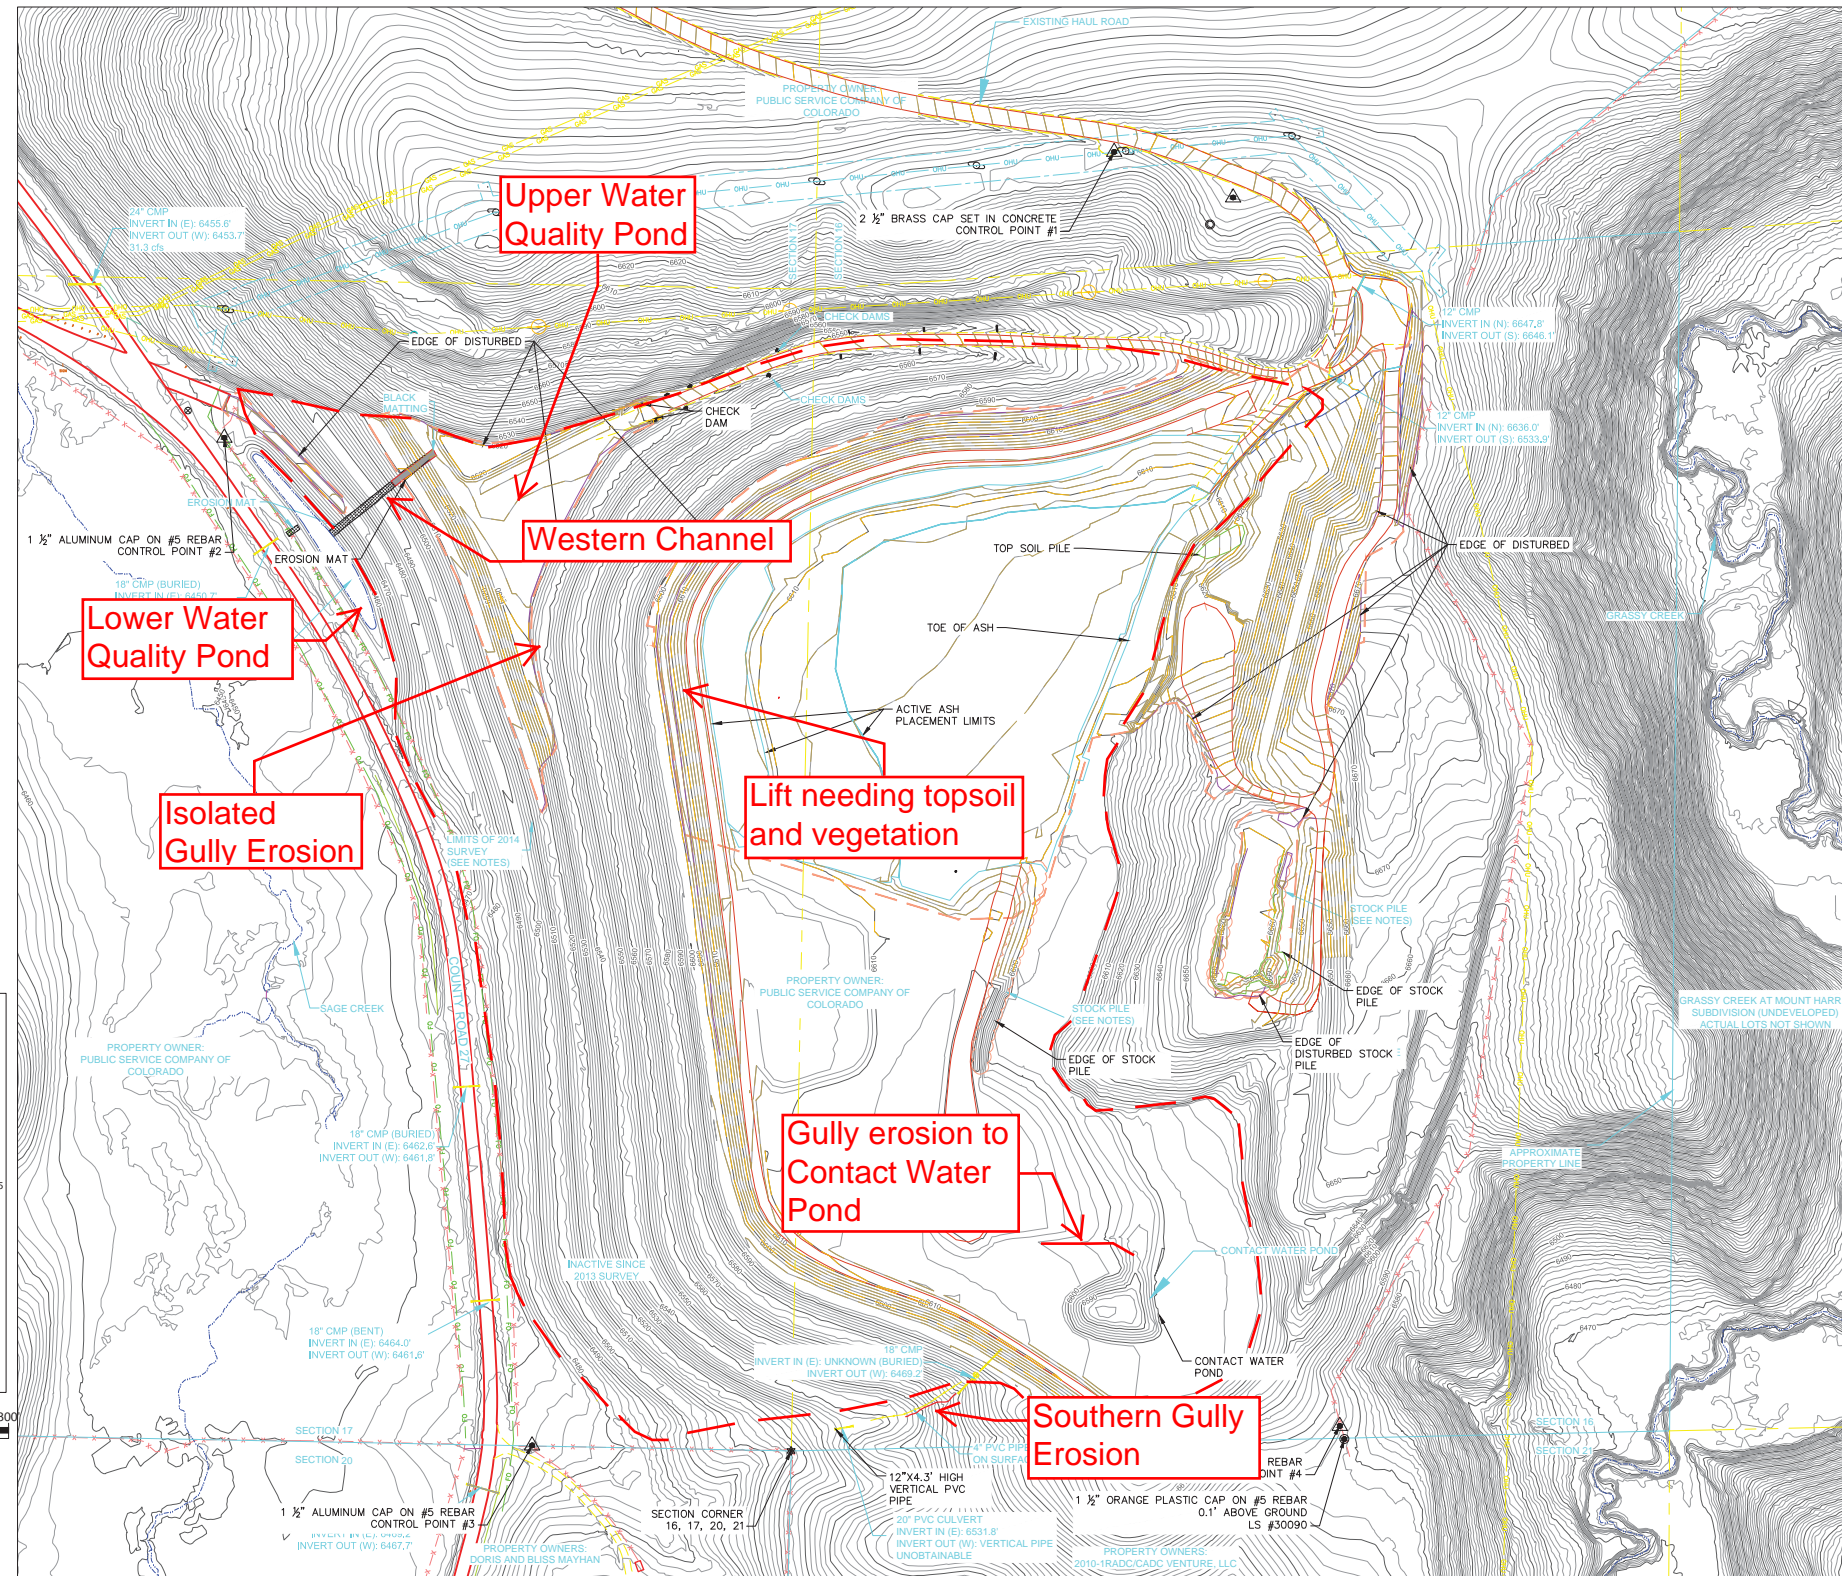
Appendix A – Landfill Site Map

Inspected site grades in the CCR landfill area are different than shown due to continued activity between the survey date and inspection date. The general site layout remains the same.
