Device TC39x
Marking/Step (E)ES-BD, BD
Package see Data Sheet

10219AERRA

This Errata Sheet describes the deviations from the current user documentation.

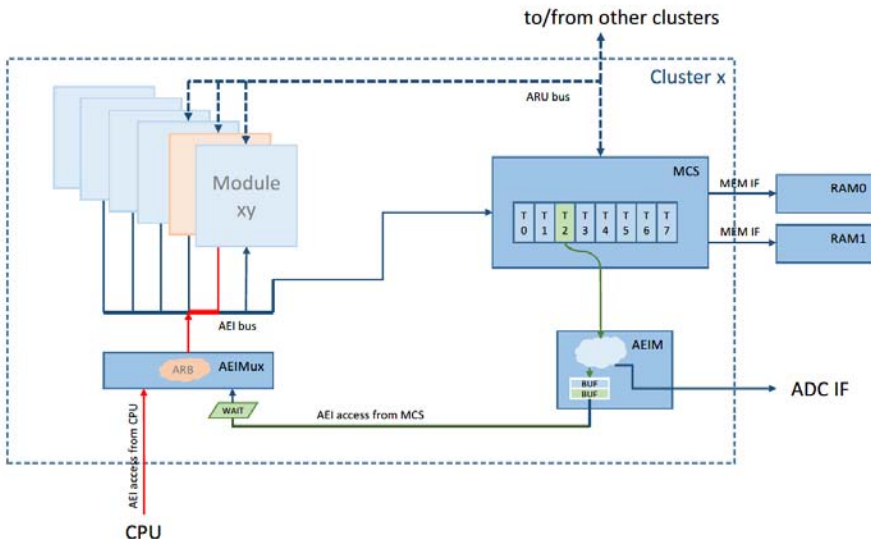
Figure 6 MCS AEI master access path

Figure 6 shows an uncritical traffic situation. Here an access of a MCS thread to the AEI bus (green access path) is temporarily delayed due to an ongoing AEI bus access from the CPU (red access path). The MCS access to the AEI bus will be safely buffered at the AEIM (green buffer). As soon as the CPU access to the AEI bus completes, the buffered AEI bus access from MCS will be executed.

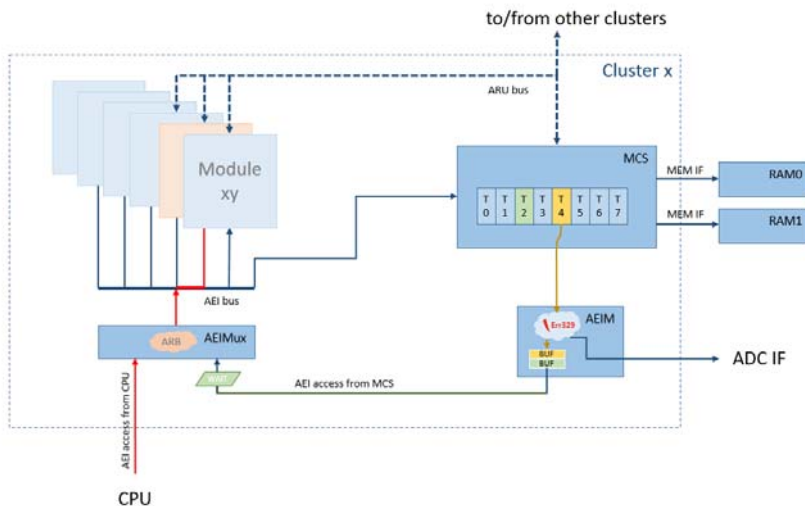
Figure 7 Critical MCS AEI master scenario

In [Figure 7](#), a potential risk for the occurrence of problem GTM_AI.329 is illustrated. Here the first buffer of the AEIM (green) is still waiting for the access to the AEI bus while a second AEI bus access from MCS arrives at the AEIM (yellow access path). Under certain, but for the user unpredictable timing conditions, this second AEI bus access arriving at the AEIM can trigger the misbehavior described in problem GTM_AI.329.

The workarounds described in the following section will ensure that not more than one AEIM buffer will be filled and therefore the occurrence of problem GTM_AI.329 is avoided. All workarounds have been tested and proven correct.

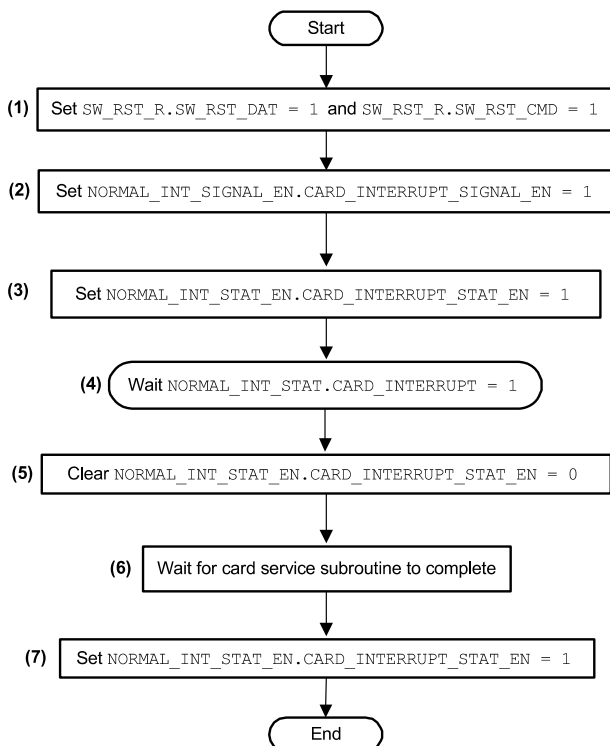
Figure 13 SDIO Card Interrupt Sequence

Figure “SDIO Card Interrupt Sequence” in the SDMMC chapter of the current version of the TC3xx User’s Manual is wrong. The correct sequence is shown in the following [Figure 13](#).
