Device	TC23x
Marking/Step	ES-AC, AC
Package	see Data Sheet

10210AERRA

This Errata Sheet describes the deviations from the current user documentation.

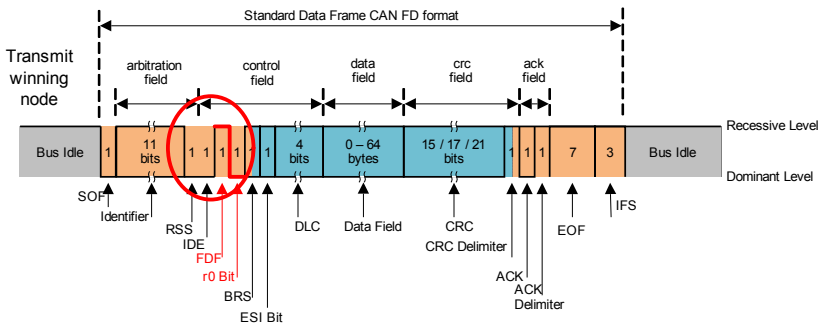
Figure 4 Transmitter - winning CAN FD node

The device is producing more error frames within a network than a device with a hardsync at the FDF bit.

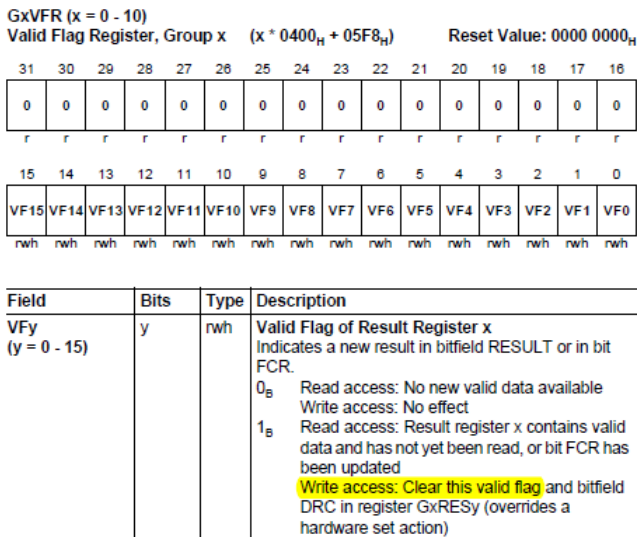
Figure 7 Register GxVFR in the VADC Module of TC2xx Devices

The bits in the GxVFR register have to be written with 1_B to clear a valid flag VFy indicating a valid result. Assuming VFy = 1_B, if one of the RMW instructions listed above is used, the write to VFy would never happen since VFy is already set to 1_B. This means that the next read of VFy may lead to incorrect conclusions by software.

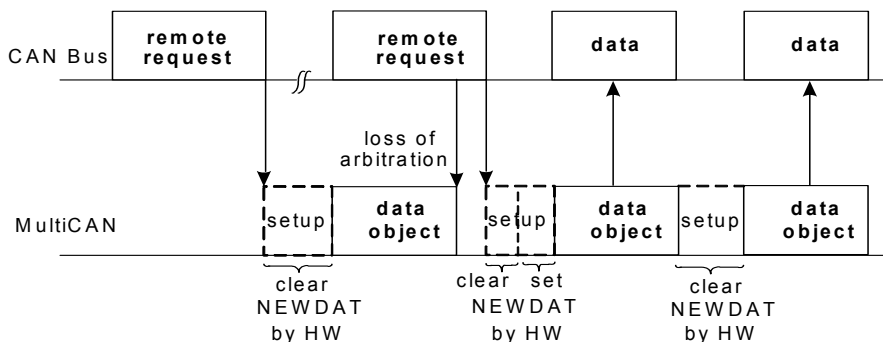
Figure 9 Loss of Arbitration

When the appropriate message object (data frame) triggered by the first remote frame wins the arbitration, it will be sent out and NEWDAT is not reset. This leads to an additional data frame, that will be sent by this message object (clearing NEWDAT).

There will, however, not be more data frames than there are corresponding remote requests.

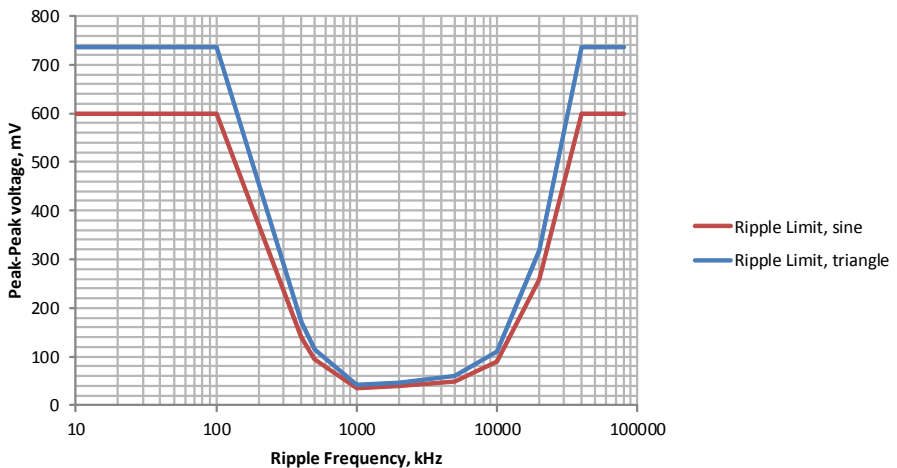
Figure 12 Ripple Voltage vs. Frequency Characteristic

The internal back-up clock is sensitive to specific power supply voltage disturbance/ripple caused by a voltage ripple intrinsic to DC-DC converters. Specific conditions such as insufficient filtering of the ripple may lead to improper behavior of the start-up scheme of the back-up clock, and thus stuck-at state during the start-up of the microcontroller until this condition is removed.

The diagram reflects acceptable ripple level during the cold start of the microcontroller at the respective VDDP3/VEXT/VEVRSB supply of the PMS subsystem, depending on the device and package type, as shown in the following table.
