2019 Annual Inspection Report

for Compliance with the Coal
Combustion Residuals Rule
(40 CFR Part 257)

Comanche Station

January 18, 2020

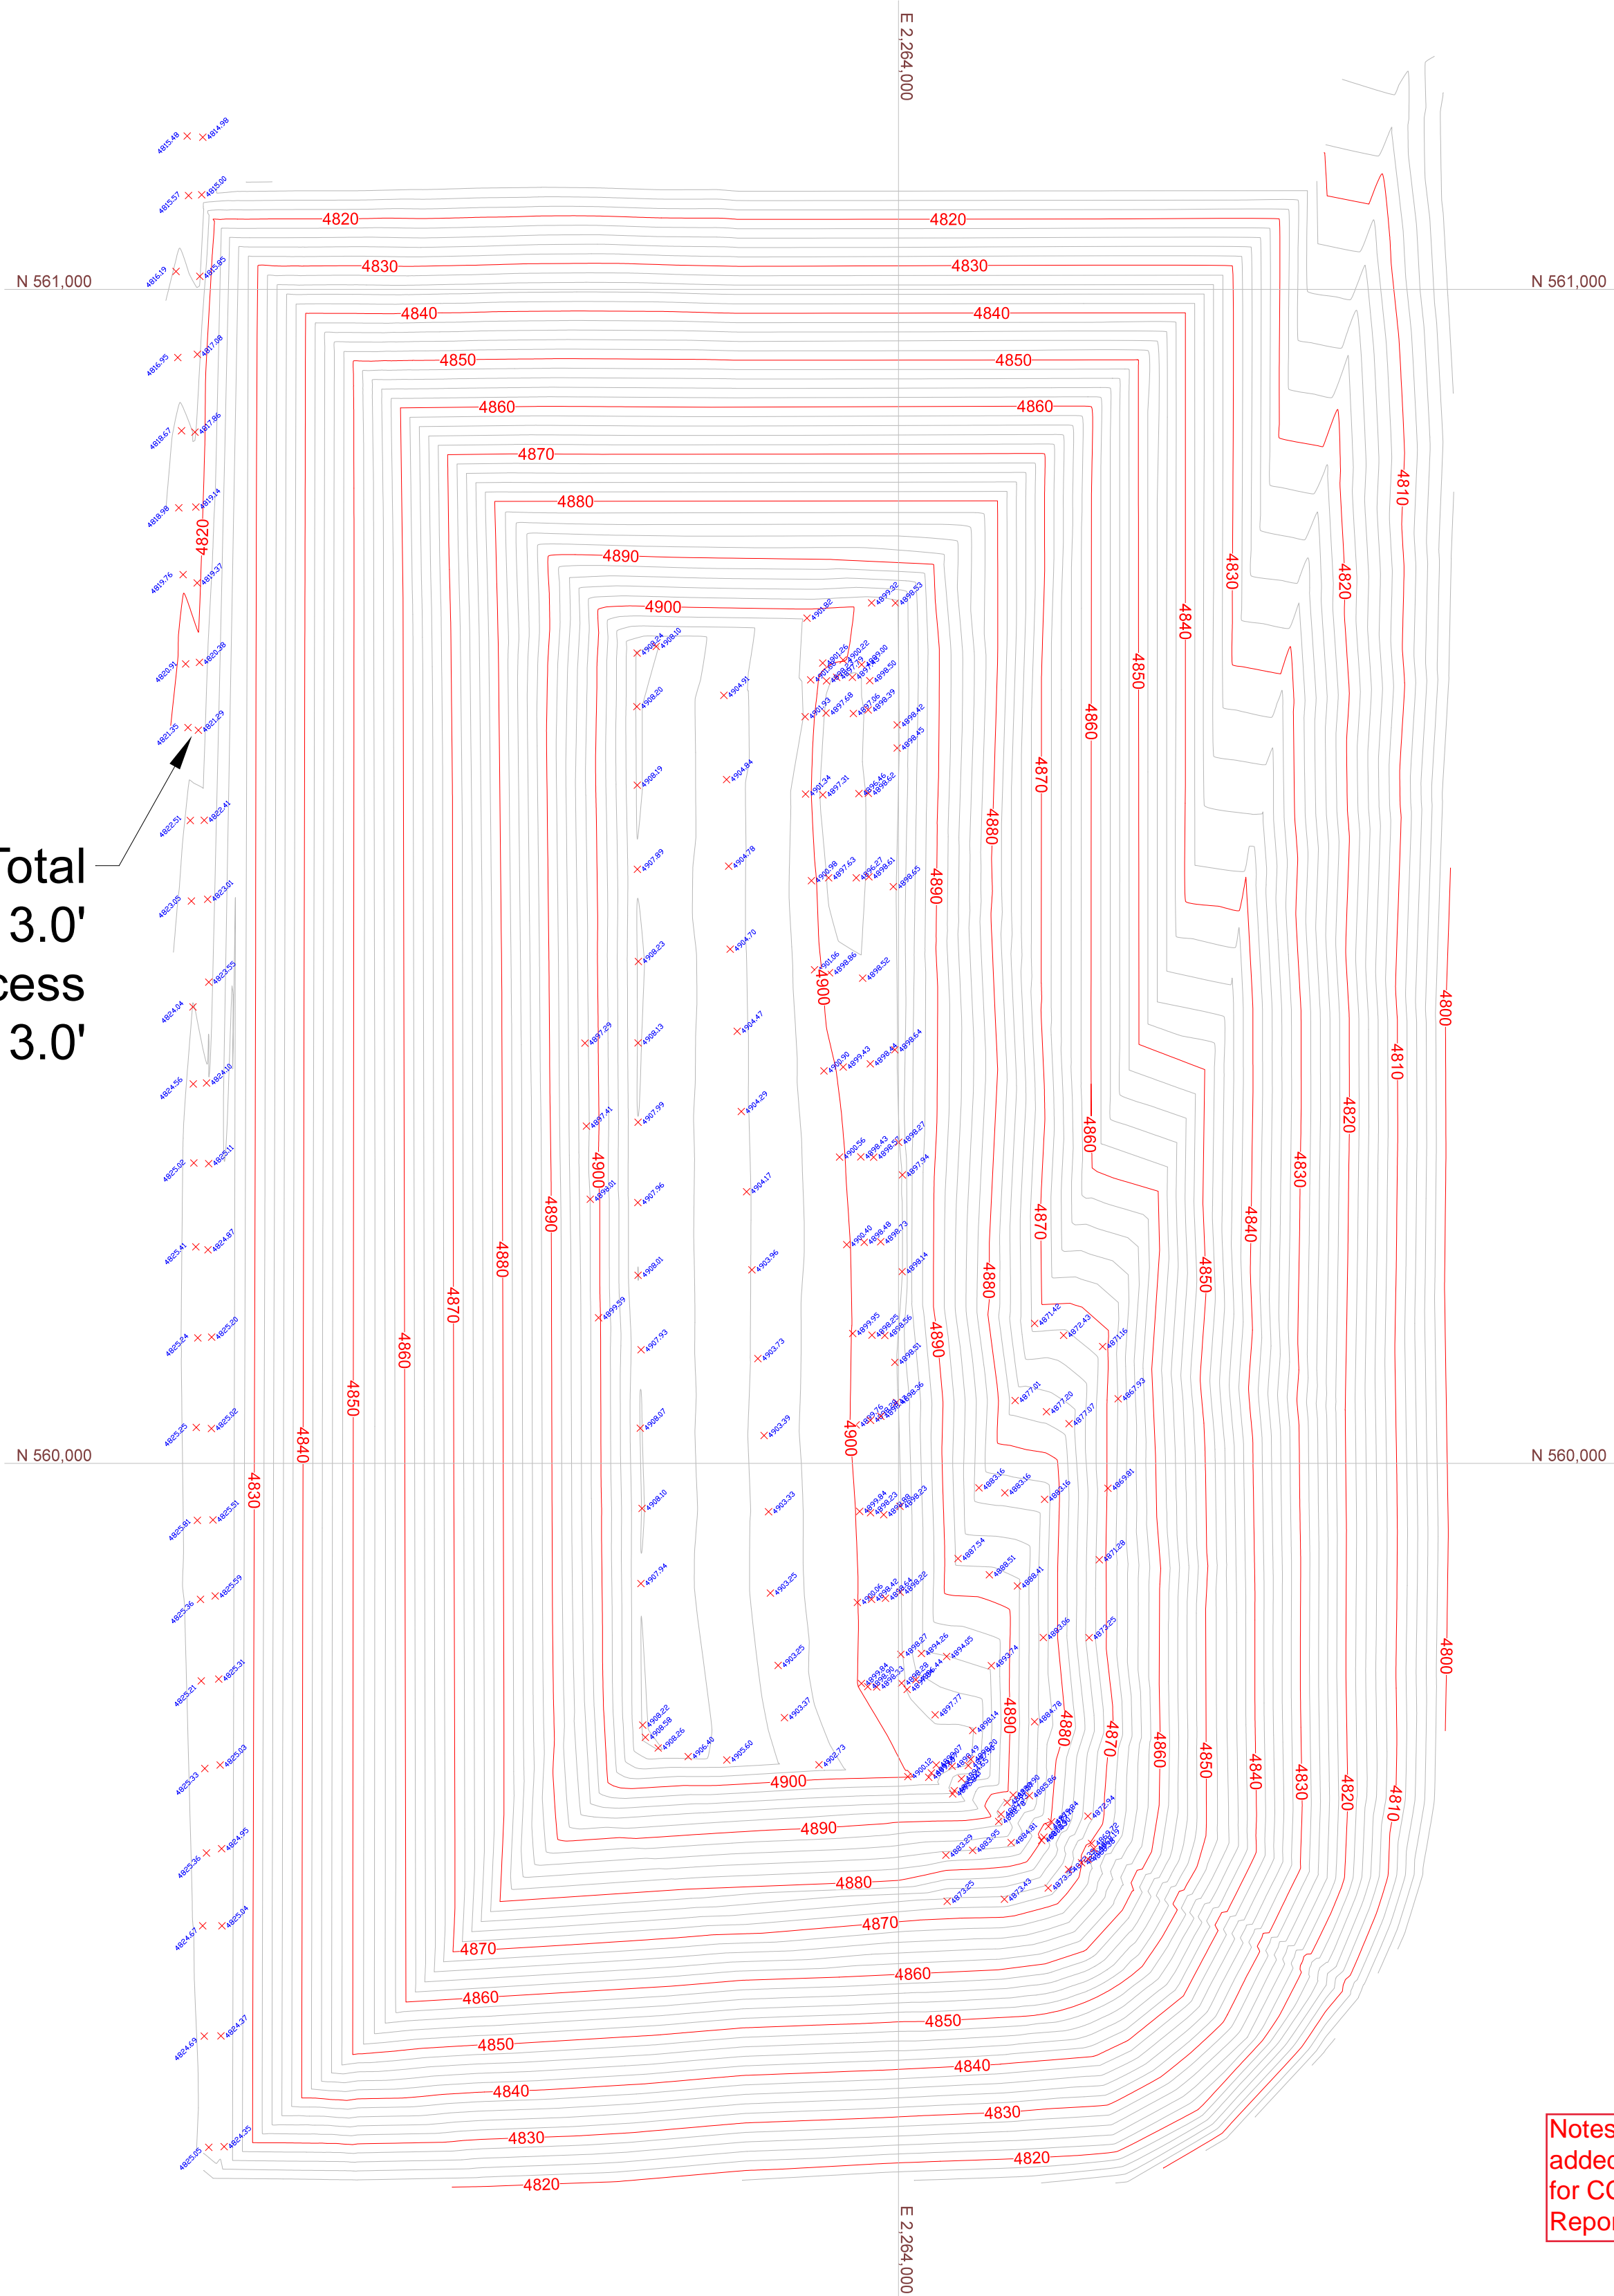
Appendix A – Cell 1 Topographic Survey

Volume Placed Dec. 2018 - Nov. 2019 - 90,735 CY
Current elevation of top of landfill - 4908'
Final elevation of landfill - 4910'

Volume shown
is for Cell 1 only.

Access Total
Length - 1713.0'
Average Access
Width - 13.0'

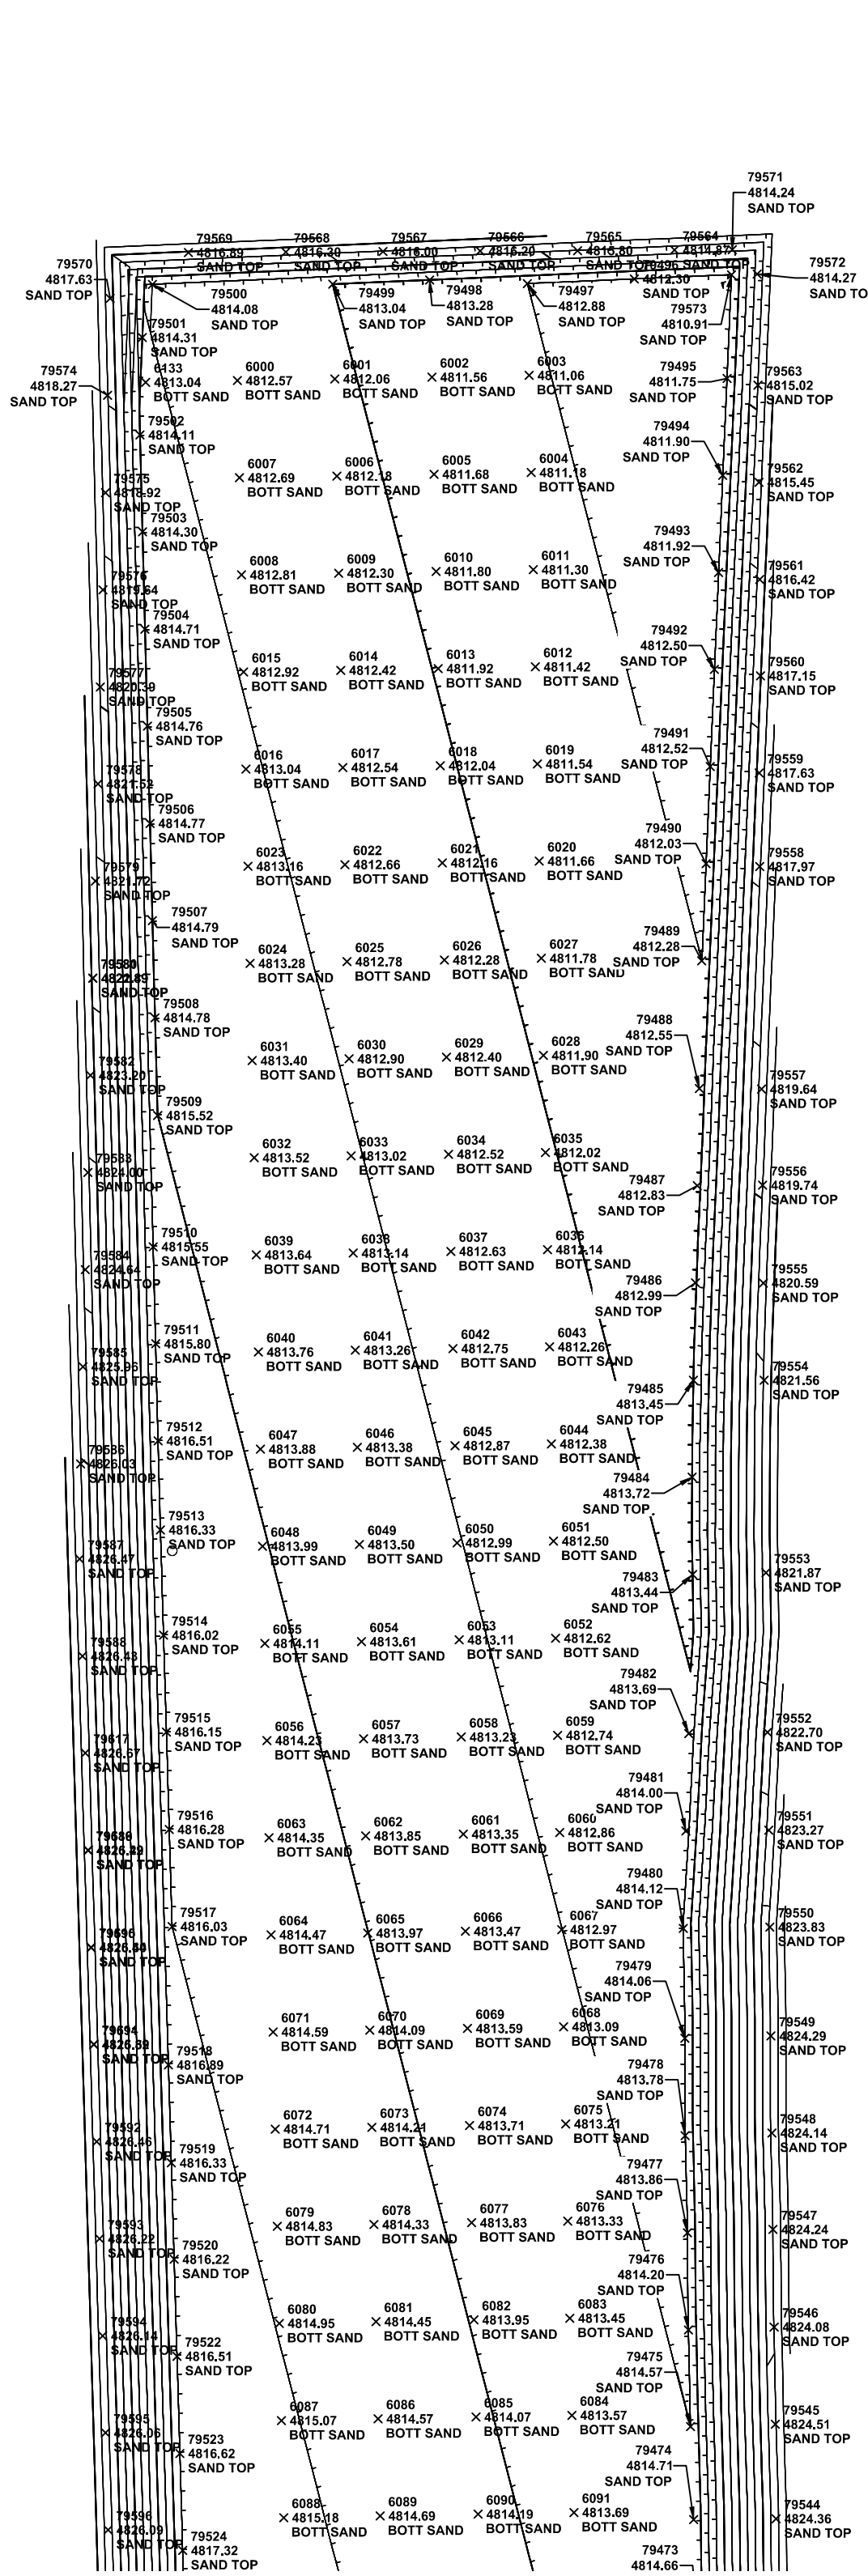
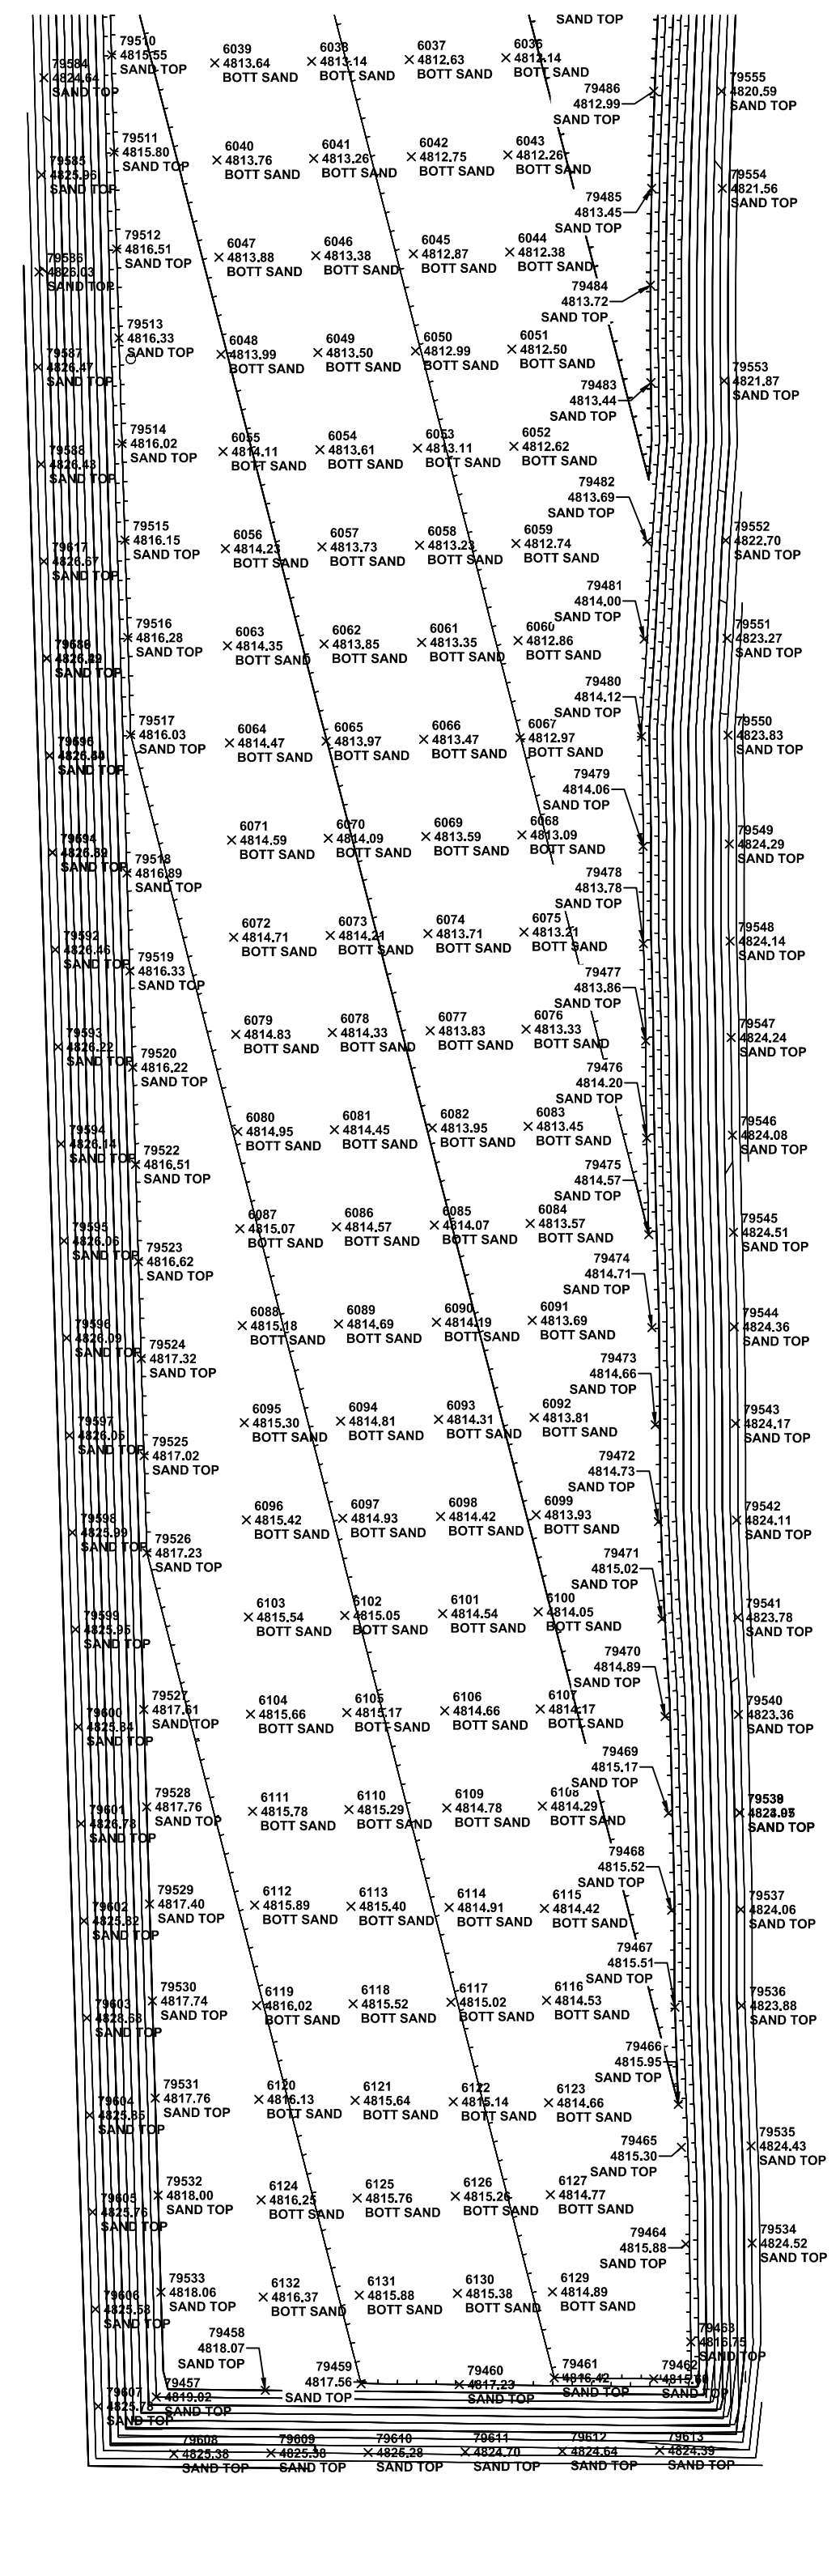
COMANCHE GENERATING STATION ASH LANDFILL CELL 2 EAST-AS BUILTS DRAINAGE LAYER

Approximately five feet of CCR placed above as-built grades - November 2019.
