## CAMPAIGN BULLETIN

Transverse Link

Reference: PC726  
Date: December 19, 2019

# PC726 - 2019 – LEAF TRANSVERSE LINK

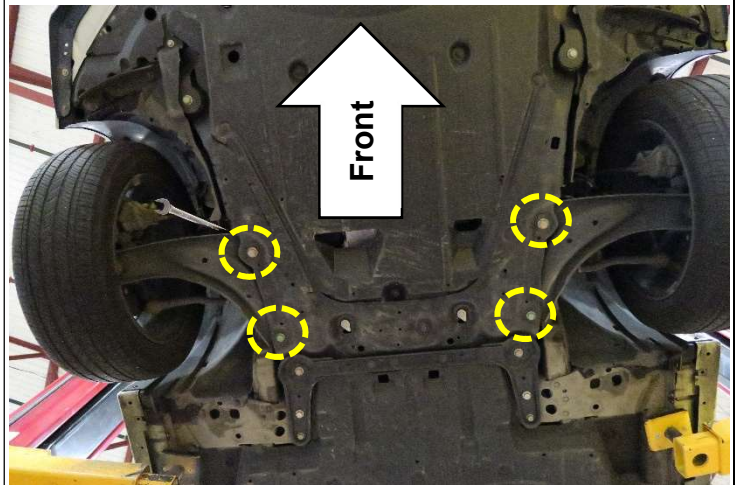
Figure 1

2. Locate all 4 Transverse Link Bolts (Figure 1).
