Device Errata

MPC801

Silicon Revision A.2 - Mask Set F87S
May 18, 1998 (Version - 4)

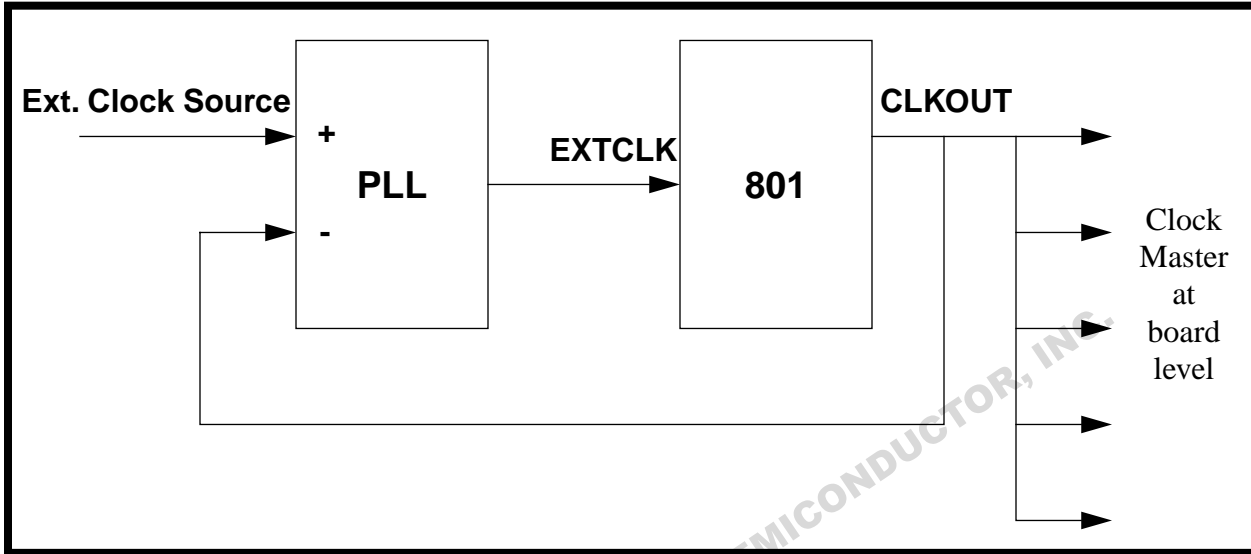
G5. Potential problems caused by skew between EXTCLK and CLKOUT.

The PLL of the MPC801 locks on the falling edge of the input clock EXTCLK. This will affect the skew between EXTCLK and CLKOUT at the rising edge. The skew is dependent on the duty cycle of the input clock (but for a 50% duty cycle will not exceed 2nS). This will affect synchronous designs where the same clock source is used as an input to EXTCLK, as well as to an external synchronous device (e.g. a peripheral or ASIC).

Insert a PLL between the external master clock and the EXTCLK pin of the MPC801. Connect the phase comparison pin of the PLL to the CLKOUT pin of the MPC 801. Also use the CLKOUT signal as the reference clock for distribution to the local external peripherals.

Important Note: The PLL has to be capable of operating with a permanent offset of -2nS, therefore the range of lock should extend to about -4nS.

A diagram of this concept is given below:
