Service Bulletin

SUBJECT: Special Coverage Adjustment – Engine Coolant Leak from the Water Pump

**MODELS: 2011-2014 Chevrolet Cruze
2012-2014 Chevrolet Sonic
With 1.4L Engine (RPO LUJ or LUV)**

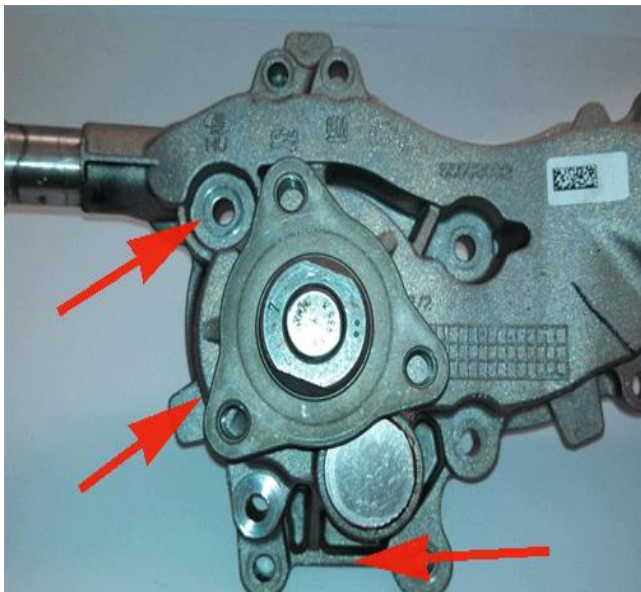
3609232

If the water pump is not obviously leaking and the housing only shows minimal coolant deposits as shown below, do not replace the pump. The water pump is functioning as designed and no further action is required.

No evidence of coolant leakage on the pump body.

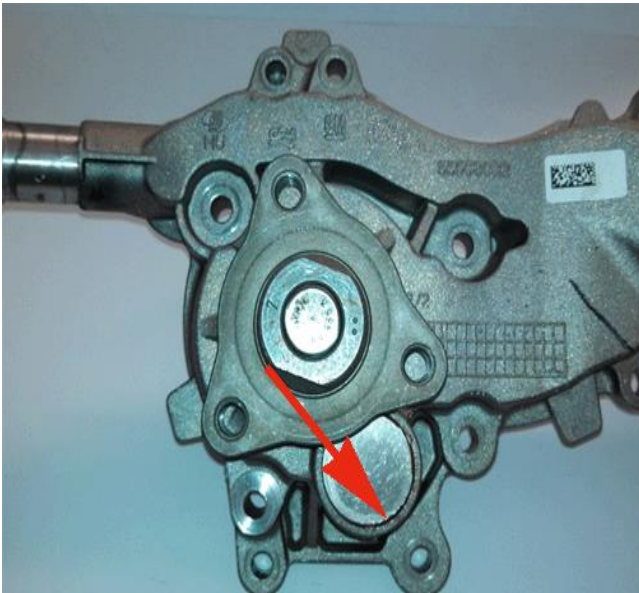
3609233

Only slight coolant staining around the perimeter of the cover plate.

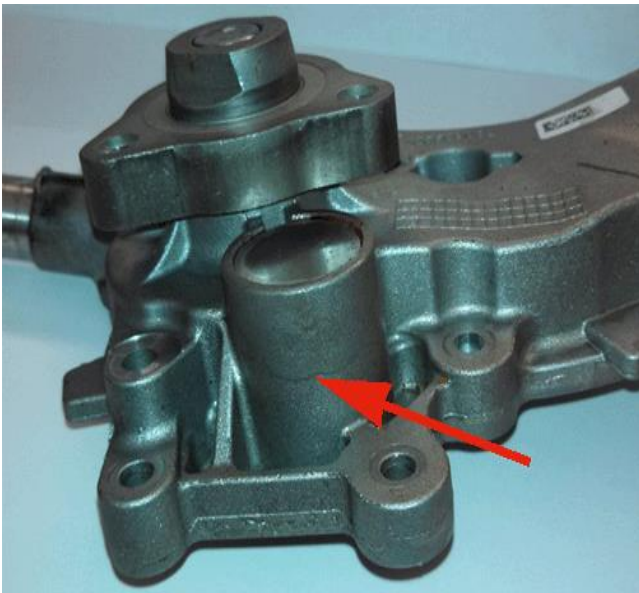
3609237

Only slight coolant staining on the underside of the housing.

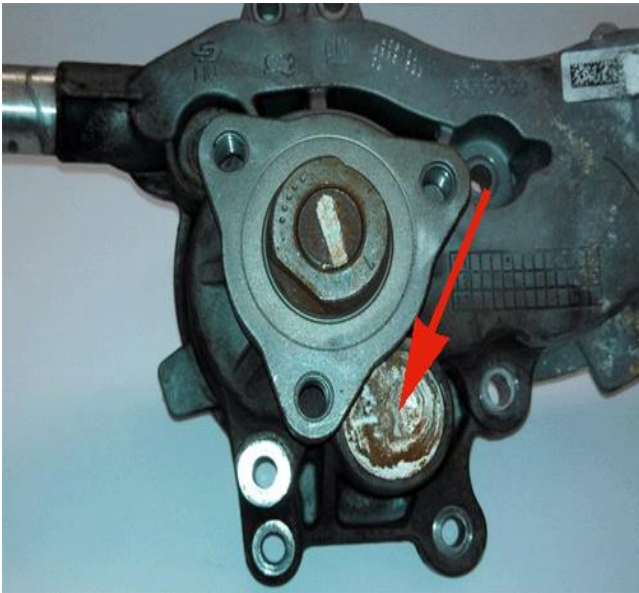
3609253

If the water pump is obviously leaking coolant or the water pump housing displays excessive evidence of leaking as shown below, continue to Step 2.

Significant coolant residue on the cover plate.

Remove and replace the water pump if it is obviously leaking coolant or if it has excessive evidence of coolant deposits as described above. Refer to *Water Pump Replacement* in SI for the replacement procedure, which also includes important information about specific bolts that should not be reused as well as all of the related torque specifications.

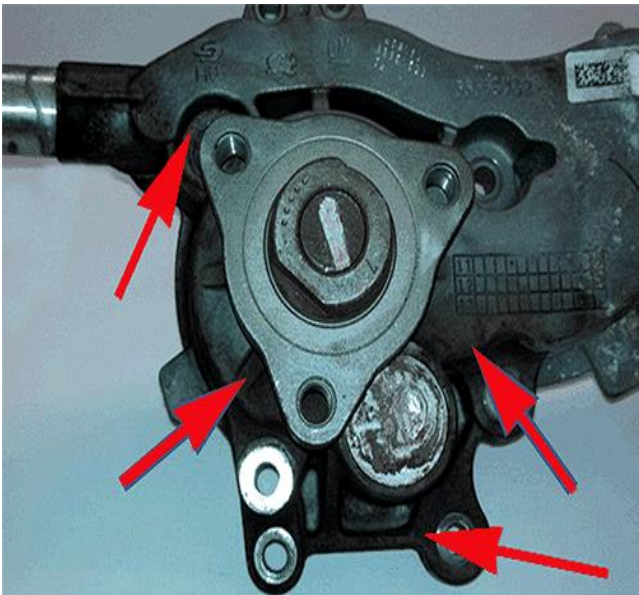
3610640

Evidence of coolant residue on the exterior surfaces of the pump housing.
