Inspection Notice
MSA PFL / SRL Rivets
2.4m and 2.7m V-Edge™ Cable PFL
6m V-Edge™ Cable SRL

June 4, 2019

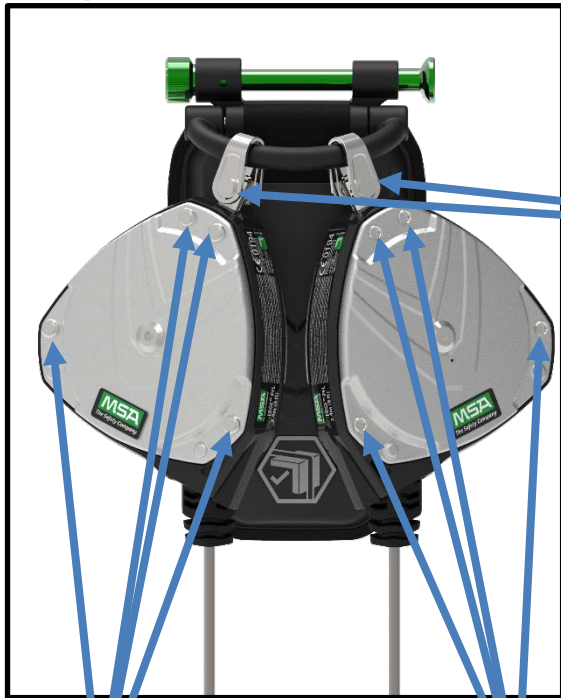
Figure B-1: 2.4m and 2.7m V-Edge Cable PFL Rivet Inspection Locations

Note: Although a twin leg unit is shown for illustrative purposes, single leg units are also to be inspected.

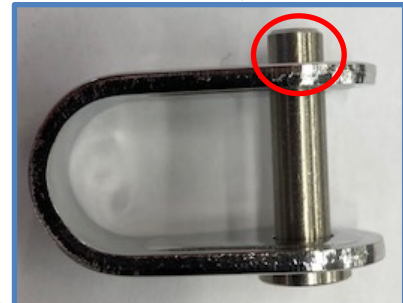
An unflared top eyelet rivet may eventually begin to dislodge from the PFL. If the rivet begins to dislodge from the PFL, the PFL may not arrest a fall.

Unflared Top Eyelet Rivet

Some small back and forth movement of the rivets is to be expected while pushing or pulling. If any of the rivets are able to be removed from the PFL/SRL, remove the PFL/SRL from service.

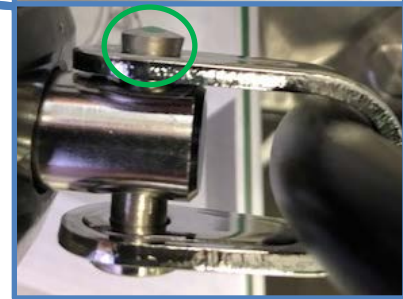
Flared Top Eyelet Rivet

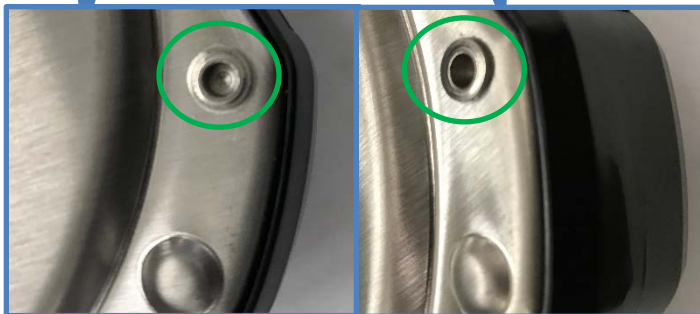
Flared Casing Rivets

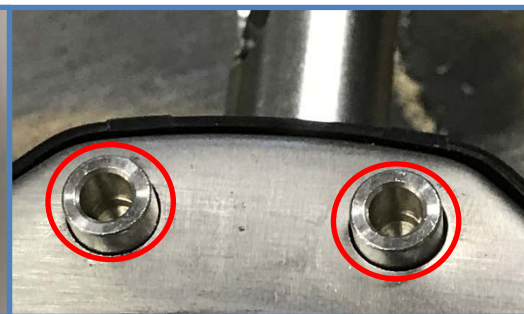
Unflared Casing Rivets

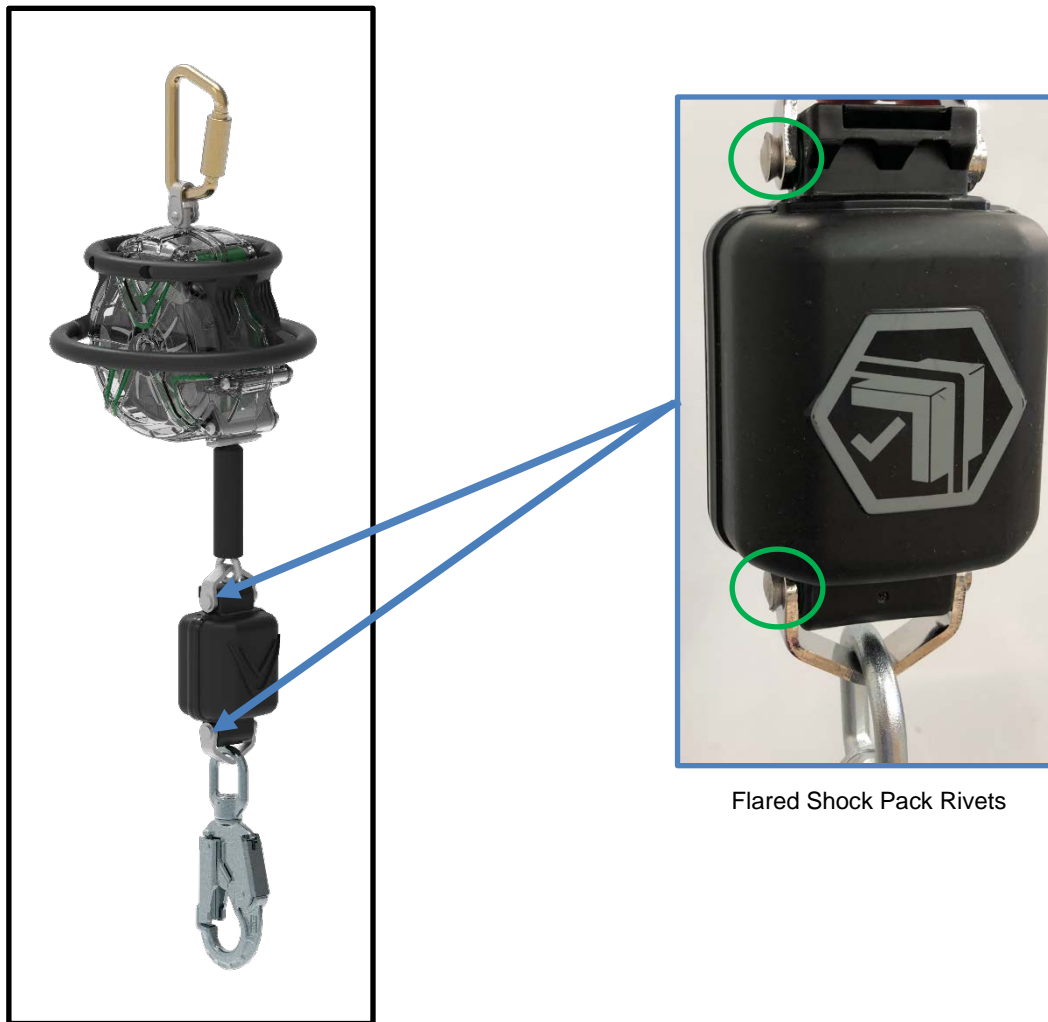
Figure B-2: 6m V-Edge Cable SRL Rivet Inspection Locations

Flared Shock Pack Rivets

- 1) Hold the SRL shock pack such that the shock pack does not make contact with a surface that would prevent movement of the shock pack rivets.
- 2) Attempt to remove the shock pack rivets by pushing the rivets.
- 3) Attempt to remove the shock pack rivets by pulling on the rivets.
