Device **TC26x**
Marking/Step **ES-BC, BC**
Package **see Data Sheet**

10212AERRA

This Errata Sheet describes the deviations from the current user documentation.

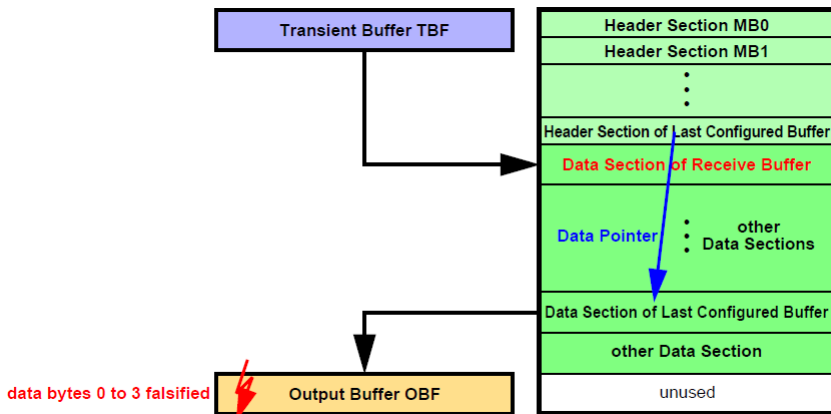
Figure 1 Message buffer transfer from Message RAM to OBF

When the message buffer has its payload configured to maximum length (**PLC = 127**), the OBF word on address 00h (payload data bytes 0 to 3) is overwritten with unexpected data at the end of the transfer.

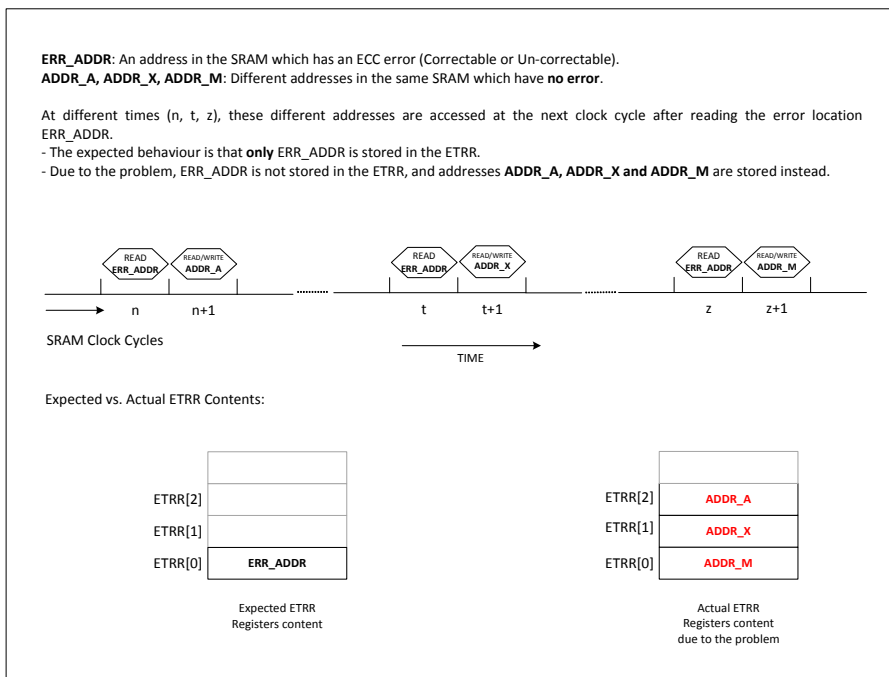
Figure 4 Example sequence showing how registers ETRRx may be filled with “Error Free” addresses

When such a consecutive access sequence (read from ERR_ADDR followed by read/write of different address(es)) happens multiple times, registers ETRRx are filled with addresses that have actually no error – and the SRAM address which actually has an error is not stored indeed. **Figure 4** shows such an example scenario.

The consequence of the scenario explained in **Figure 4** is that a single error in the SRAM – example just one correctable error at a location ERR_ADDR – can result in registers ETRRx getting filled with fault-free address, and thus potentially even triggering an ETRR overflow.

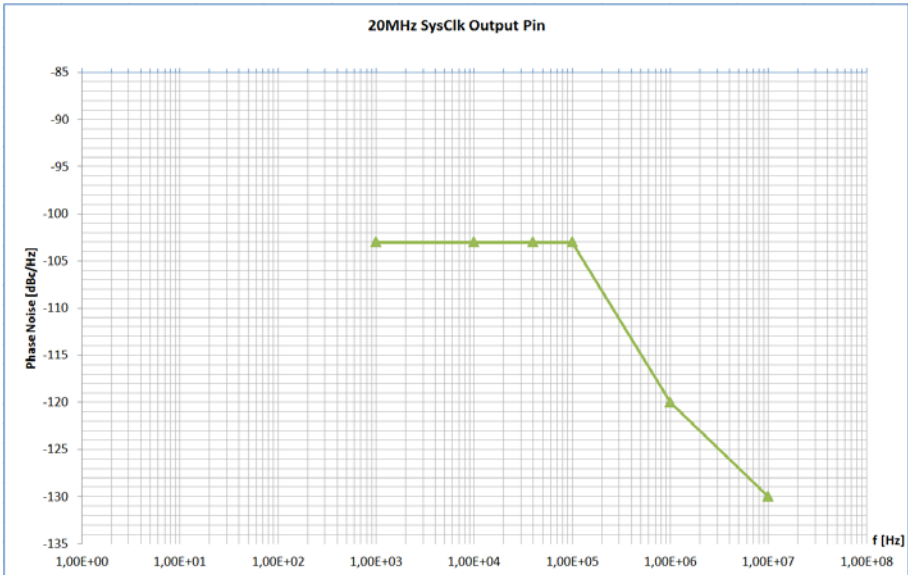
Figure 8 Phase Noise Density on SysClk Output Pin

The diagram below shows the phase noise density on the SysClk pin when no application pattern but only the HSSL/HSCT subsystem is running:

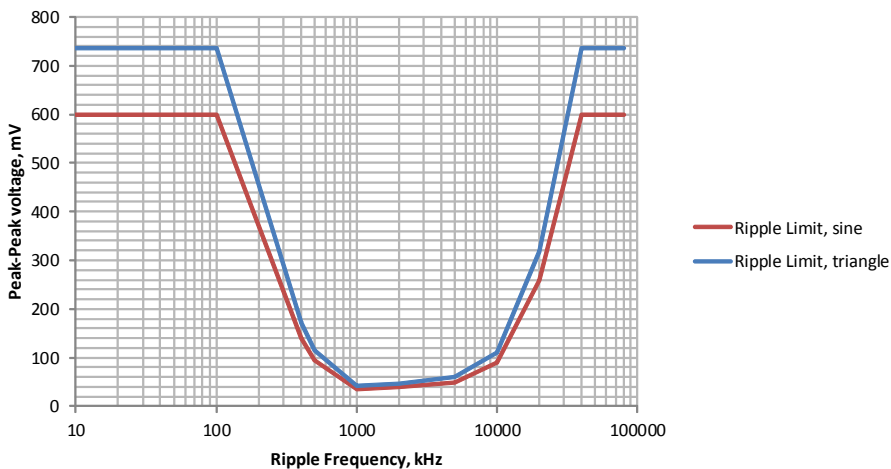
Figure 14 Ripple Voltage vs. Frequency Characteristic

The internal back-up clock is sensitive to specific power supply voltage disturbance/ripple caused by a voltage ripple intrinsic to DC-DC converters. Specific conditions such as insufficient filtering of the ripple may lead to improper behavior of the start-up scheme of the back-up clock, and thus stuck-at state during the start-up of the microcontroller until this condition is removed.

The diagram reflects acceptable ripple level during the cold start of the microcontroller at the respective VDDP3/VEXT/VEVRSB supply of the PMS subsystem, depending on the device and package type, as shown in the following table.

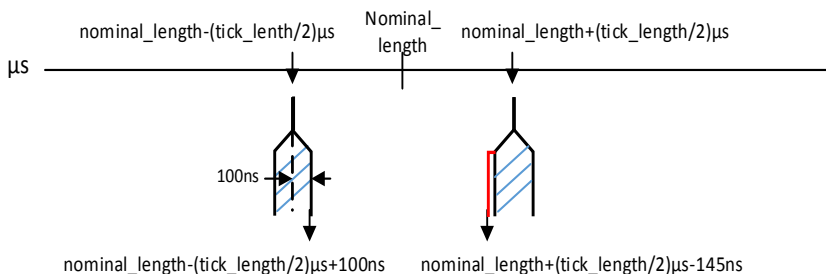
Figure 16 SENT Tolerance of this Design Step

- The lower border is $\text{nominal_value} - (\text{tick_length}/2) \mu\text{s} + 100 \text{ ns}$
- The upper border is $\text{nominal_value} + (\text{tick_length}/2) \mu\text{s} - 145 \text{ ns}$.

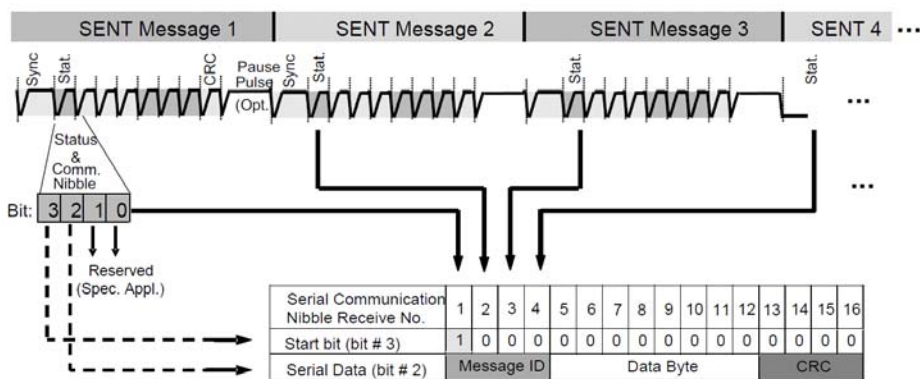
Figure 17 Short Serial Message, Serial Data Encoding over 16

Figure 17 shows a corrected version of this figure.
