## STM32F048C6/G6/T6 device errata

This document applies to STM32F048C6/G6/T6 devices and the device variants as stated in this page.

It gives a summary and a description of the device errata, with respect to the device datasheet and reference manual RM0091.

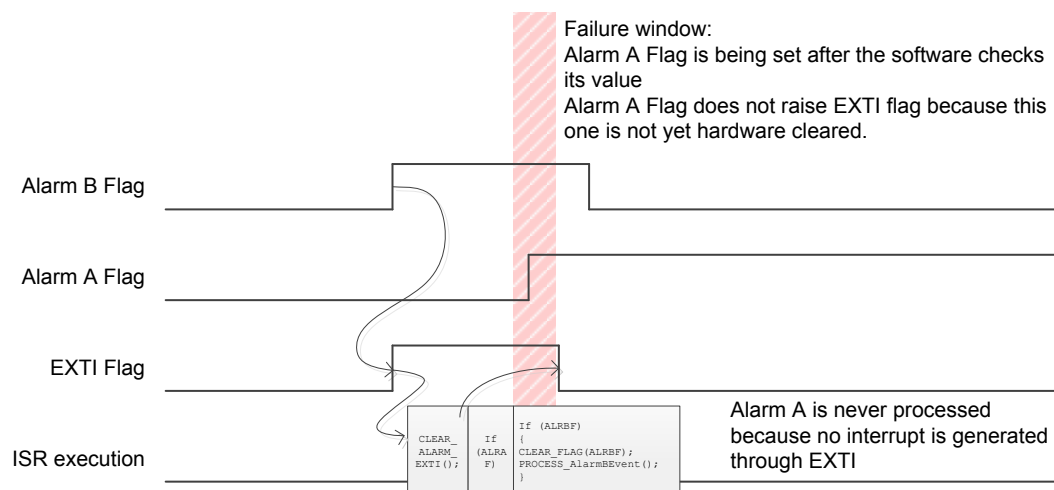
Figure 1. Masked RTC interrupt

The following code example and figure illustrate the failure mechanism: The Alarm A event is lost (fails to generate interrupt) as it occurs in the failure window, that is, after checking the Alarm A event flag but before the effective clear of the EXTI interrupt flag by hardware. The effective clear of the EXTI interrupt flag is delayed with respect to the software instruction to clear it.

In the interrupt service routine, apply three consecutive event flag checks - source one, source two, and source one again, as in the following code example:

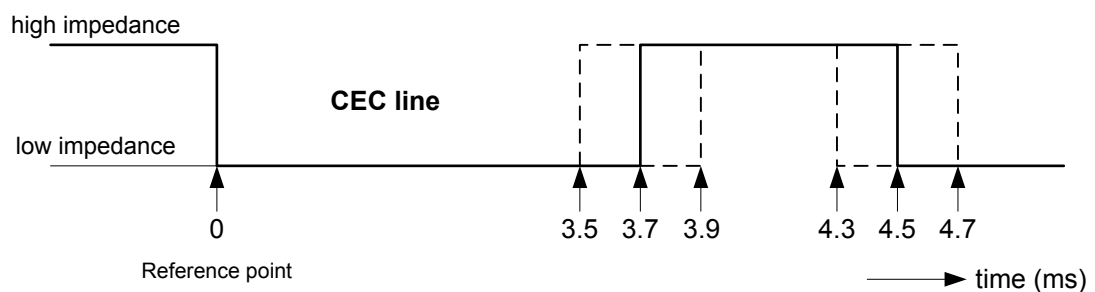
**Figure 2. HDMI-CEC start bit format with tolerances**

The start bit timing standard tolerances are shown in the following figure. The start bit is initiated by the device by driving the CEC line low (reference point). After 3.7 ms, the device releases the CEC line and starts checking its level. The following conditions must be met for the start bit to be valid:

If one of these conditions is not met, the transmission is aborted and never automatically retried. No error flag is set and the TXSOM (Tx start of message) bit is not cleared.

The only way to detect this error is for the application software to start a timeout when setting the TXSOM bit, restart it upon ARBLST or any RX event (as the transmission can be delayed by interleaved reception), and stop it upon TXBR (proof that the start bit was transmitted successfully) or TXEND event, or upon any TX error (which clears TXSOM). If the timeout expires (because none of those events occurred), the application software must restart the HDMI-CEC peripheral and retransmit the message.
