TMS320F2807x Piccolo™ MCUs Silicon Revisions C, B

This document describes the silicon updates to the functional specifications for the TMS320F2807x microcontrollers (MCUs).

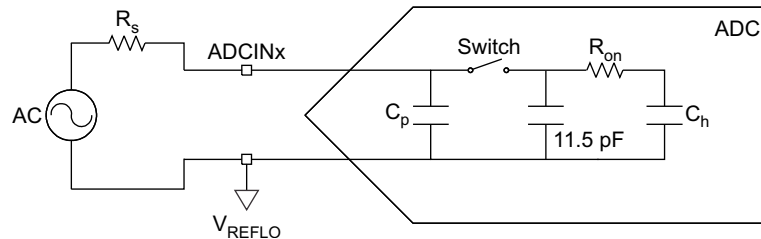
Figure 3. Single-Ended Input Model
Workaround(s)

Advisory
ADC: 12-Bit Input Capacitance When Switching Channel Groups
Revision(s) Affected
B
Details

The ADC input model should be used to select the sample-and-hold (S+H) duration for each ADC input. For the revisions affected, if the currently converting channel is an even-numbered channel and the previously converted channel was an odd-numbered channel (or vice versa), then the 12-bit input model will not accurately predict ADC input performance. Under these conditions, an additional capacitance should be added to the model. This capacitance has a value of 11.5 pF and should be placed between the S+H switch and R_{on} as shown in [Figure 3](#).

For the revisions affected, when subsequent conversions switch between channel groups, the S+H duration should be chosen to account for the additional capacitance.

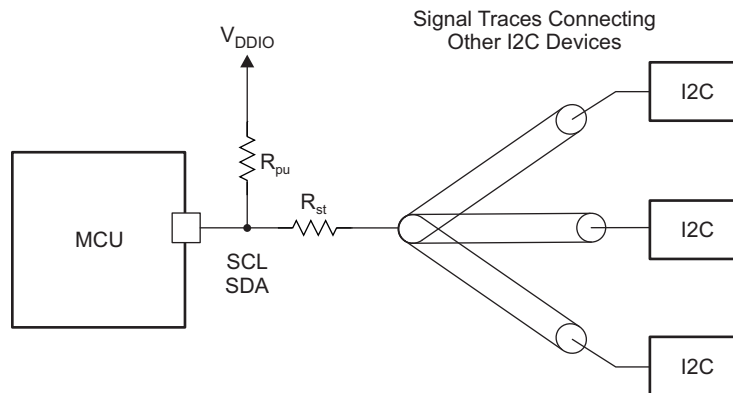
Figure 7. Placement of Series Termination Resistor and Pullup Resistor

The SDA and SCL outputs are implemented with push-pull 3-state output buffers rather than open-drain output buffers as required by I2C. While it is possible for the push-pull 3-state output buffers to behave as open-drain outputs, an internal timing skew issue causes the outputs to drive a logic-high for a duration of 0–5 ns before the outputs are disabled. The unexpected high-level pulse will only occur when the SCL or SDA outputs transition from a driven low state to a high-impedance state and there is sufficient internal timing skew on the respective I2C output.

This short high-level pulse injects energy in the I2C signals traces, which causes the I2C signals to sustain a period of ringing as a result of multiple transmission line reflections. This ringing should not cause an issue on the SDA signal because it only occurs at times when SDA is expected to be changing logic levels and the ringing will have time to damp before data is latched by the receiving device. The ringing may have enough amplitude to cross the SCL input buffer switching threshold several times during the first few nanoseconds of this ringing period, which may cause clock glitches. This ringing should not cause a problem if the amplitude is damped within the first 50 ns because I2C devices are required to filter their SCL inputs to remove clock glitches. Therefore, it is important to design the PCB signal traces to limit the duration of the ringing to less than 50 ns. One possible solution is to insert series termination resistors near the SCL and SDA terminals to attenuate transmission line reflections.

This issue may also cause the SDA output to be in contention with the slave SDA output for the duration of the unexpected high-level pulse when the slave begins its ACK cycle. This occurs because the slave may already be driving SDA low before the unexpected high-level pulse occurs. The glitch that occurs on SDA as a result of this short period of contention does not cause any I2C protocol issue but the peak current applies unwanted stress to both I2C devices and potentially increases power supply noise. Therefore, a series termination resistor located near the respective SDA terminal is required to limit the current during the short period of contention.

Insert series termination resistors on the SCL and SDA signals and locate them near the SCL and SDA terminals. The SCL and SDA pullup resistors should also be located near the SCL and SDA terminals. The placement of the series termination resistor and pullup resistor should be connected as shown in [Figure 7](#).

Table 6 provides series termination and pullup resistor value recommendations. The I2C signal level and respective V_{DDIO} power supply voltage is shown in the first column. Two resistor value combination options are provided for each voltage. One option supports a maximum high-level input current of 200 μA to all attached I2C devices, while the other option supports a maximum high-level input current of 100 μA to all attached I2C devices.
